**Appendix 7      Drainage and Flood Risk Assessment**

## DRAINAGE & FLOOD RISK STATEMENT

Proposed Residential Development – Cliffe Lane, Gomersal.

## **GEOENVIRONMENTAL DESK STUDY REPORT**

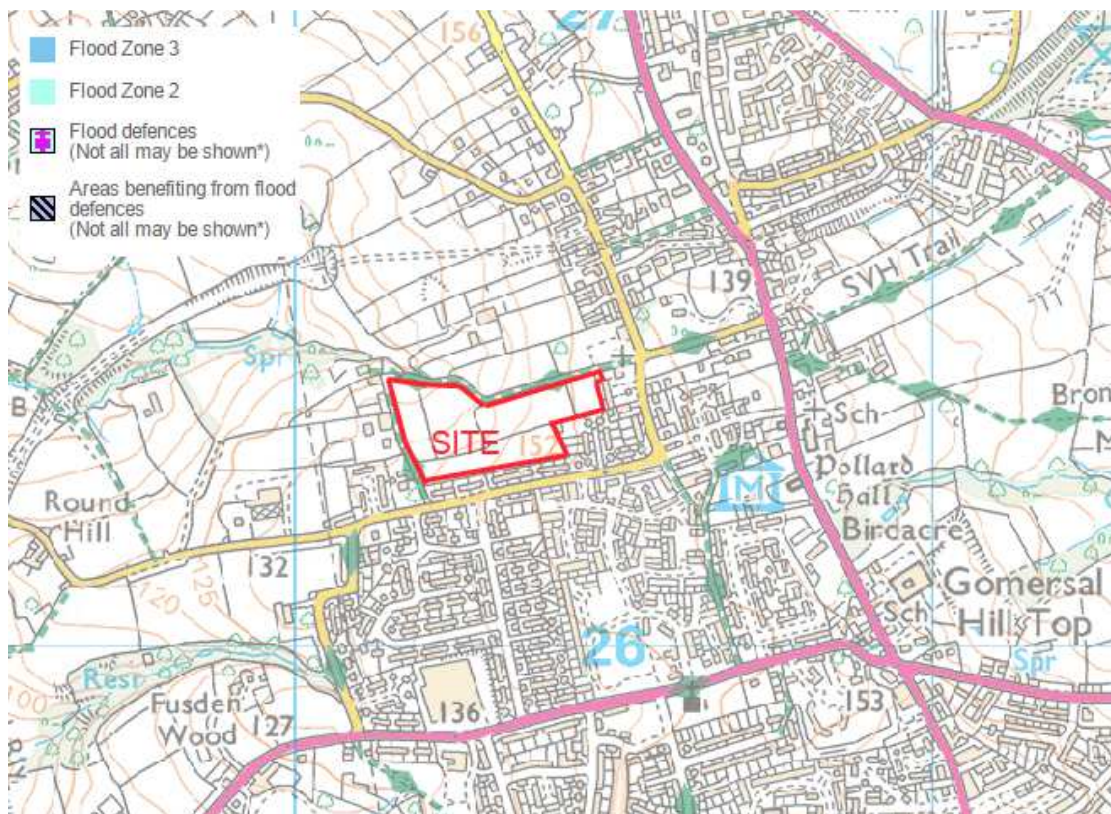
Publicly available information on flooding obtained from the Environment Agency (EA) website database is provided below:

The site is indicated to fall within Flood Zone 1 which comprises land assessed as having less than a 1:1000 annual probability of river or sea flooding.

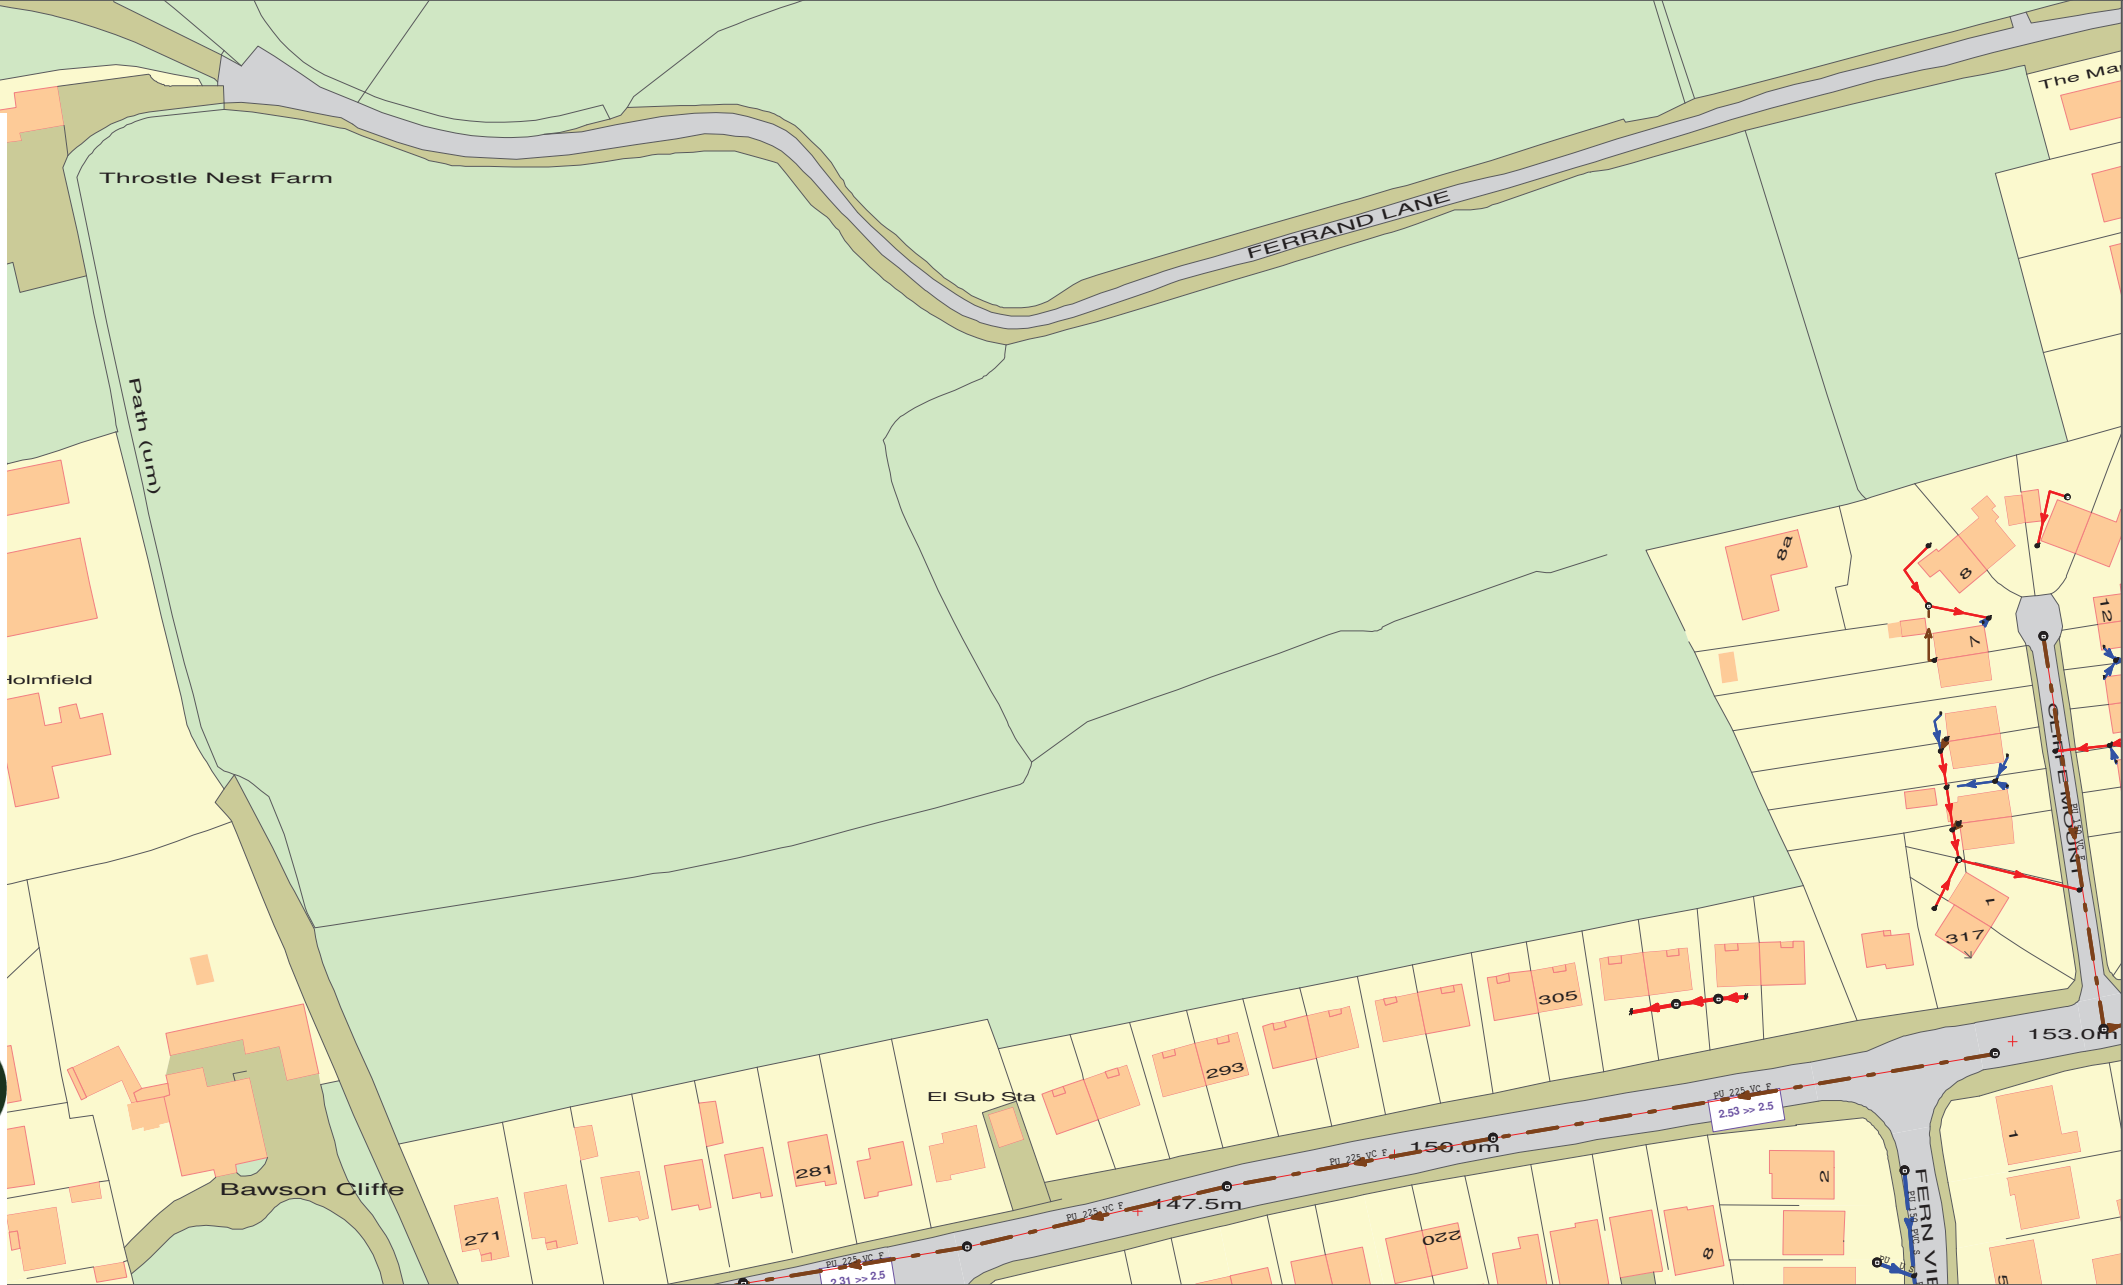
- A 225mm diameter foul public sewer is recorded in Cliffe Lane and a 150mm diameter foul public sewer is recorded in Cliffe Mount, both to the south of the site.
- A 150mm diameter surface water public sewer is recorded in Fern View to the south of the site.

A copy of the public sewer record plan is attached.

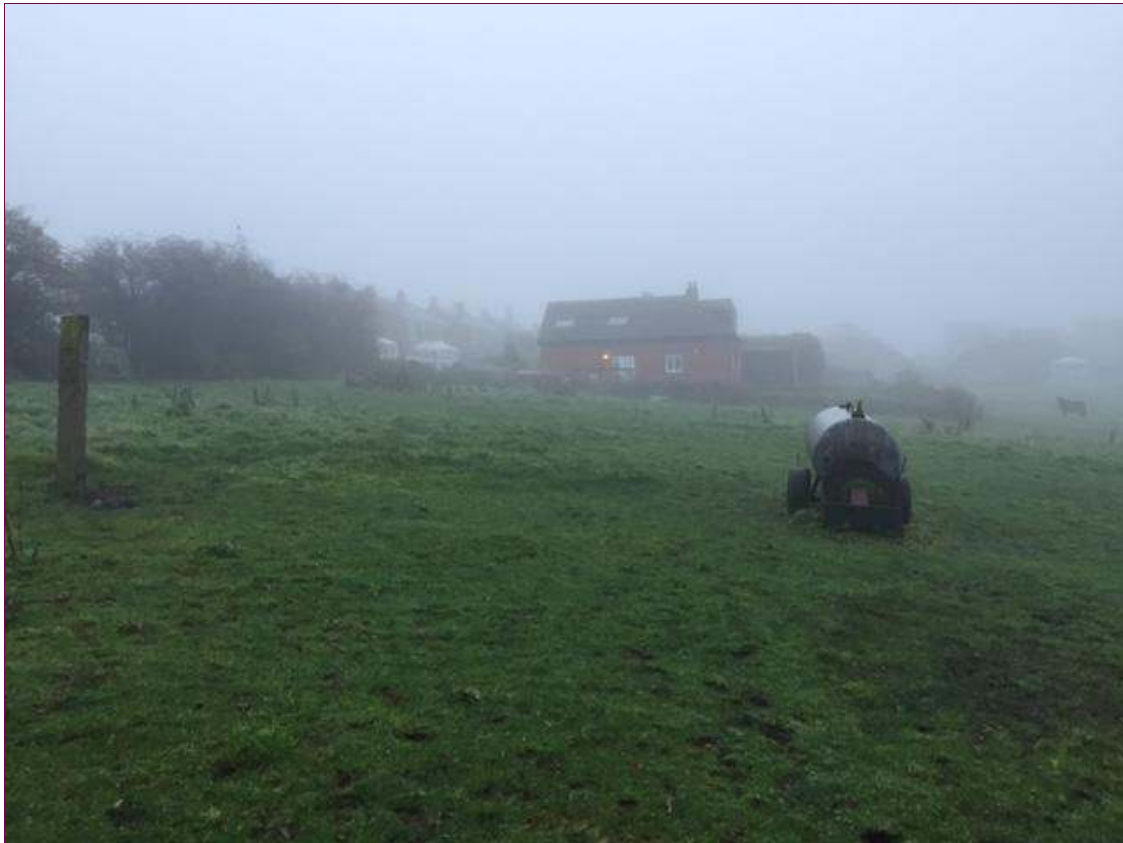
**Photograph 1: View looking south at the north eastern end of the site.**

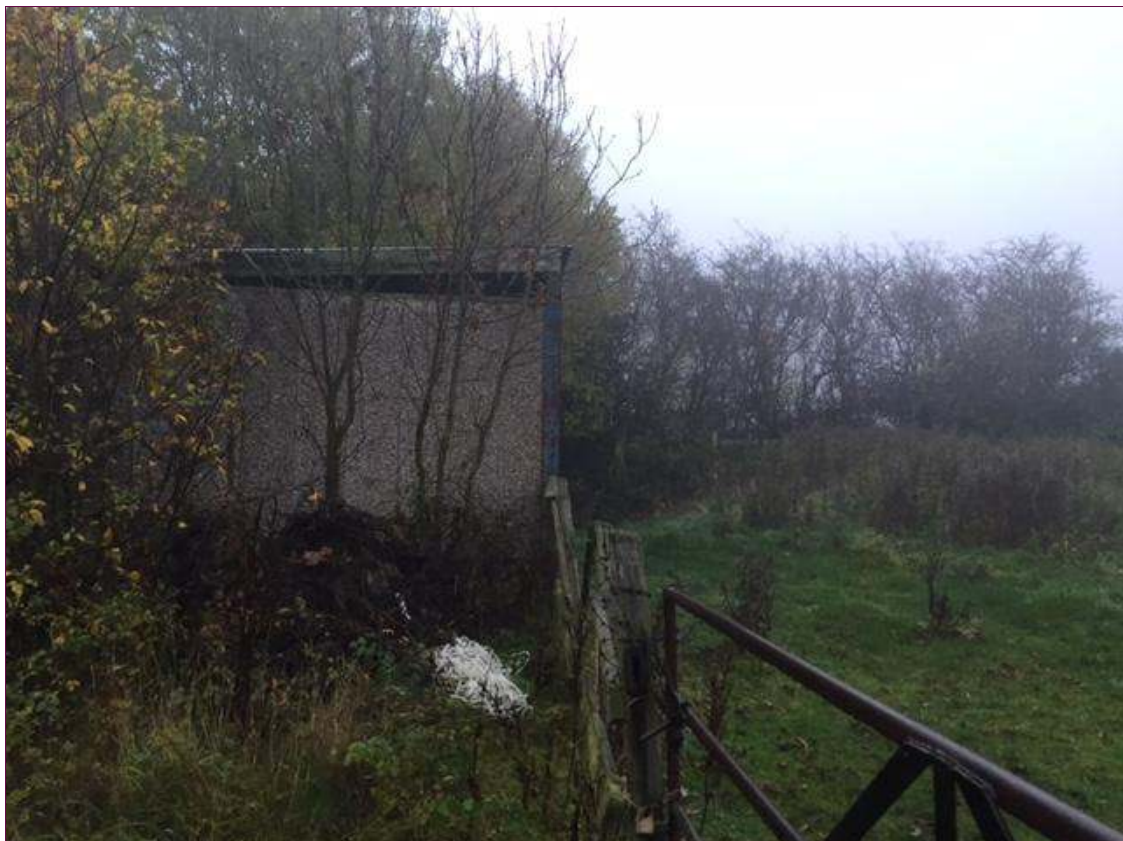
**Photograph 2: View east showing outbuilding at north eastern site boundary**

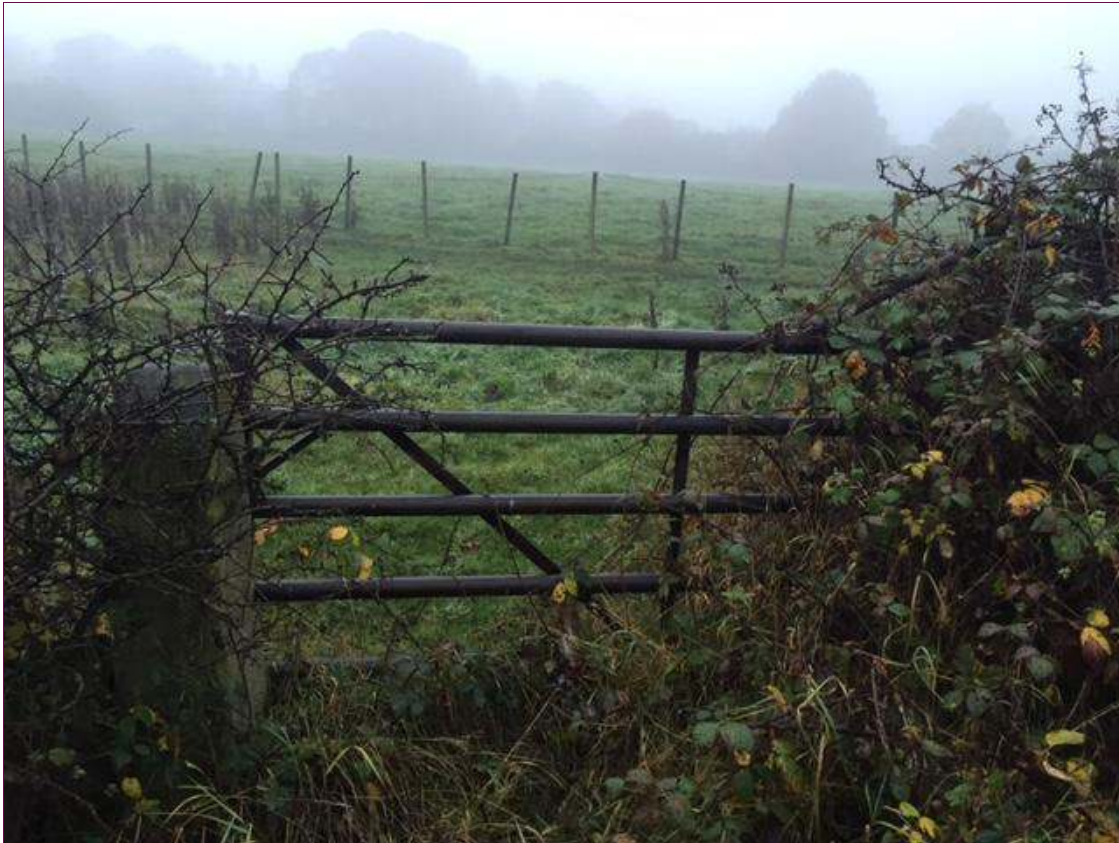
**Photograph 3: View looking south from Ferrand Lane**

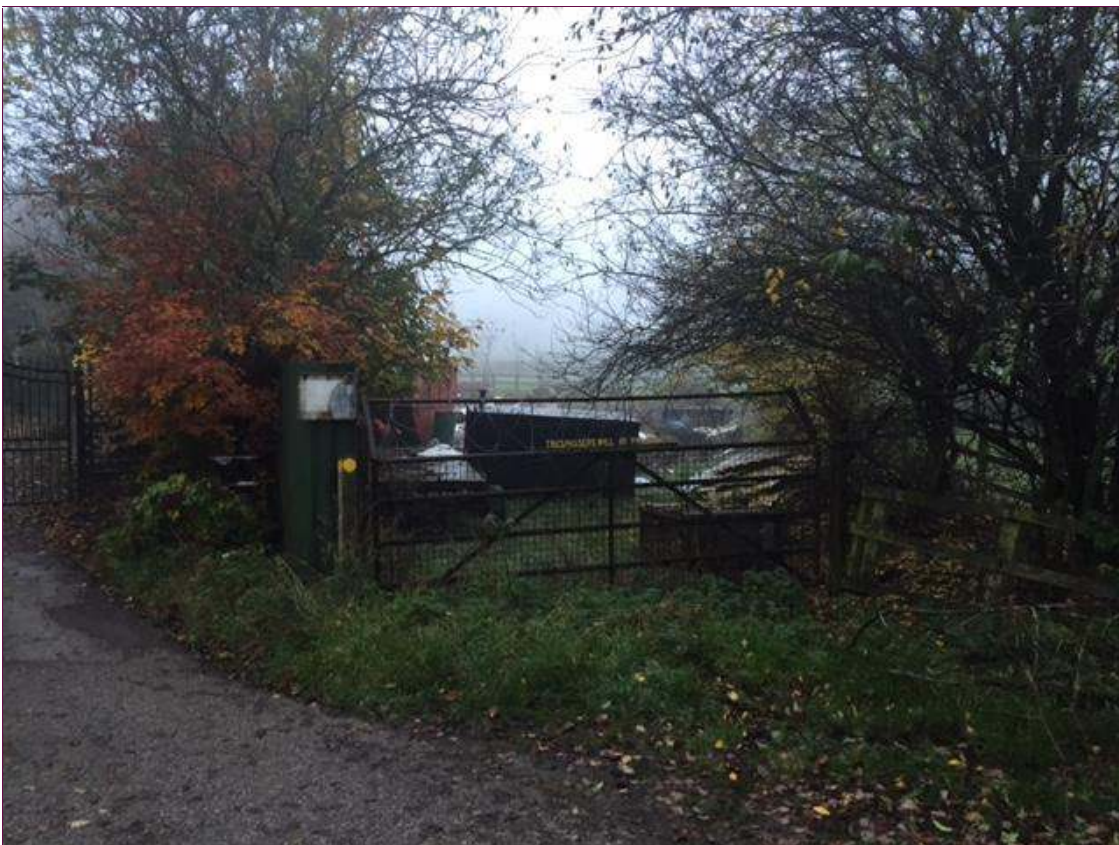
**Photograph 4: View looking towards entrance to field north of the site**

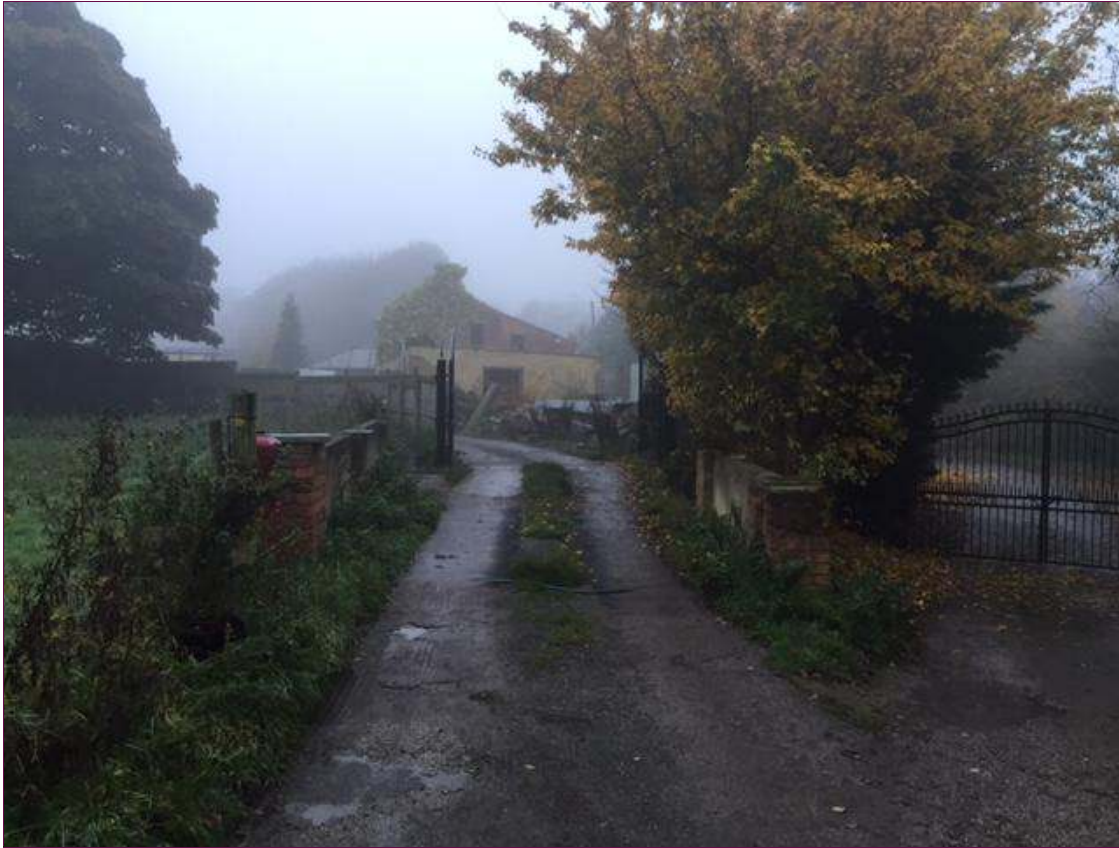
**Photograph 5: View towards Throstle Nest Farm**

Most of the site has a cover of short grass with mature trees and bushes along the field boundaries. Throstle Nest Farm was present at the north west corner of the site which was utilised by commercial plant vehicles. An above ground fuel tank was noted in the field at the north western boundary, along with some agricultural equipment.

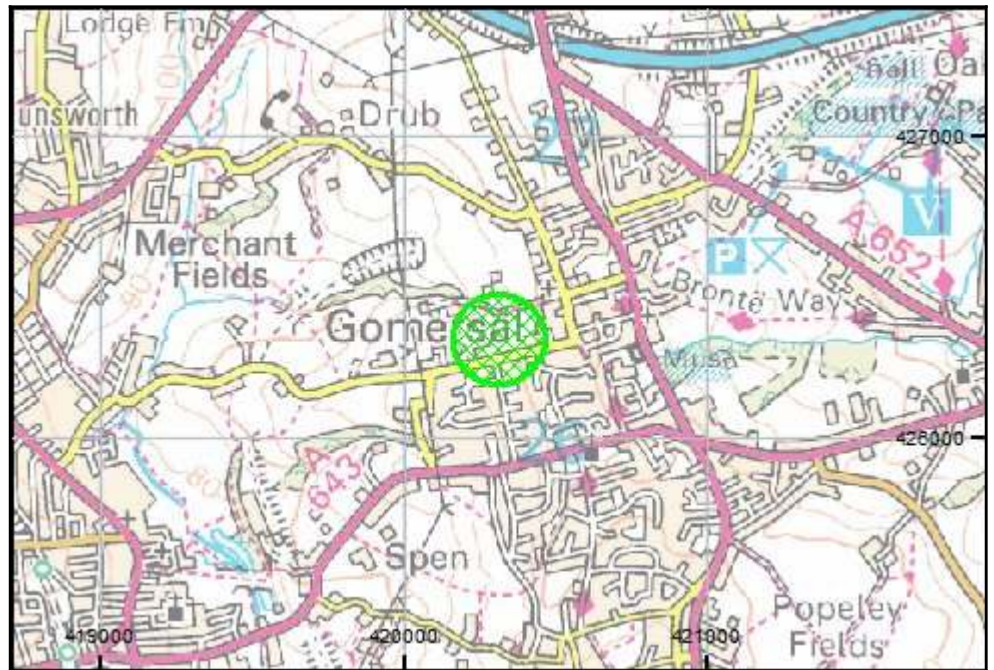
Approximate position of property

- There are three known coal mine entries within, or within 20m of, the boundary of the property. They have no records of any treatment details.
- The Authority is not aware of any evidence of damage arising due to geological faults or other lines of weakness that have been affected by coal mining.

The shaft reference 420426-003 was probably the former West Lane Colliery. The Coal Authority report states that this was searched for by drilling in 1983, but was not found and they have no record of any treatment.

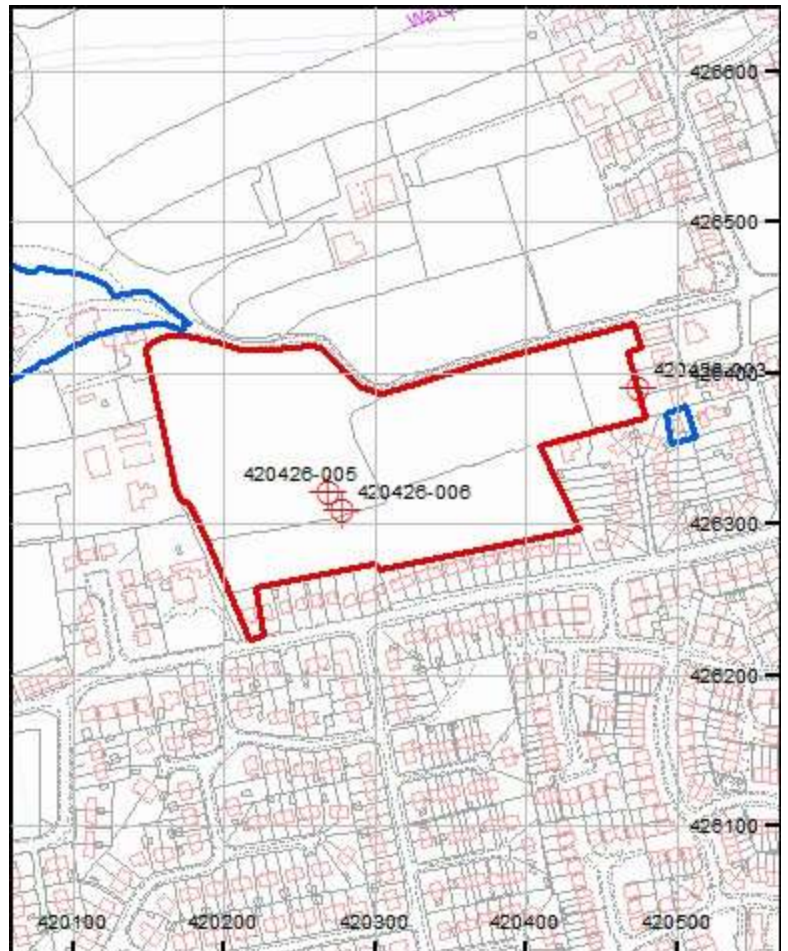
Disused Adit or Mineshaft

Coal Claims

420426-003. was searched for by drilling in 1983 but was not found. We have no record of what steps if any have been taken to treat this shaft.

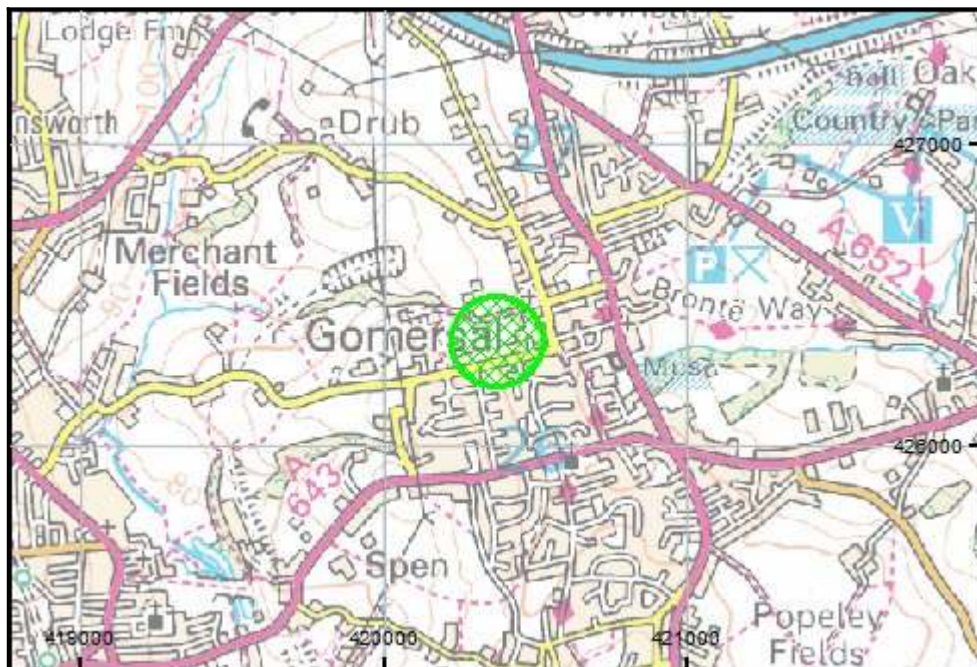
## Location map

This plan shows the approximate location of the disused mine entry / entries referred to in the attached mining report. For reasons of clarity, mine entry symbols may not be drawn to the same scale as the plan.

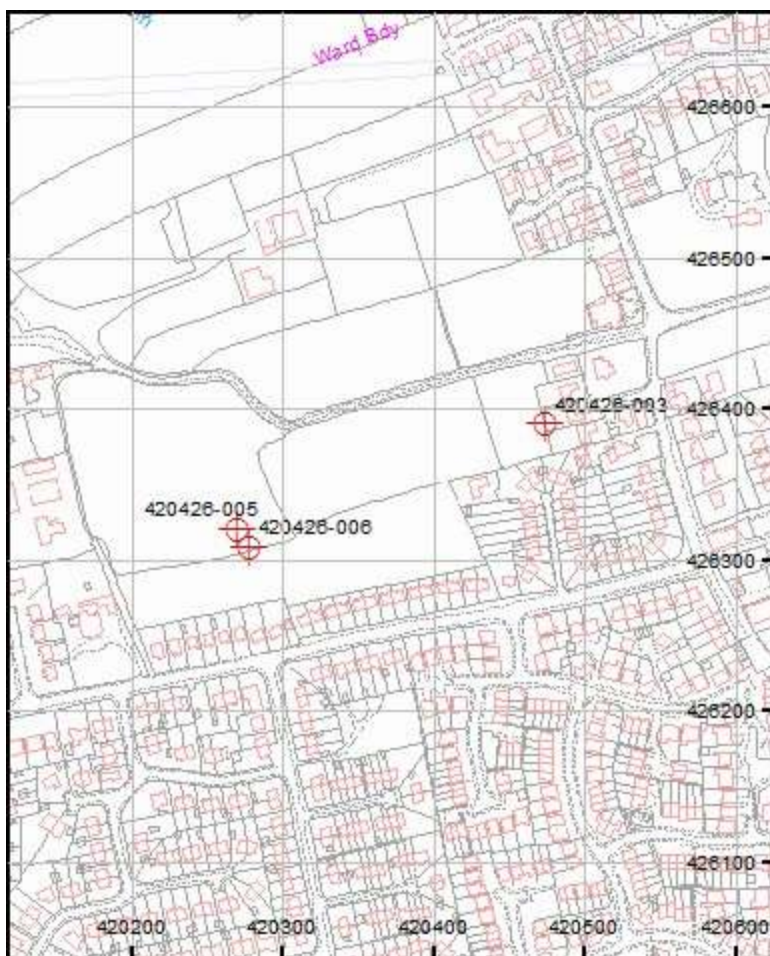
### Key

Disused Adit or Mineshaft

| Treatment details: | was searched for by drilling in 1983 but was not found. We<br>have no record of what steps if any have been taken to treat<br>this shaft |
