FLOOD RISK ASSESSMENT

**Land at
Cellars Clough,
Nr Marsden,
Huddersfield,
West Yorkshire
HD7 6NB**

E15/6518/FRA001C

**April 2016
REVISED September 2017
Revised June 2018**

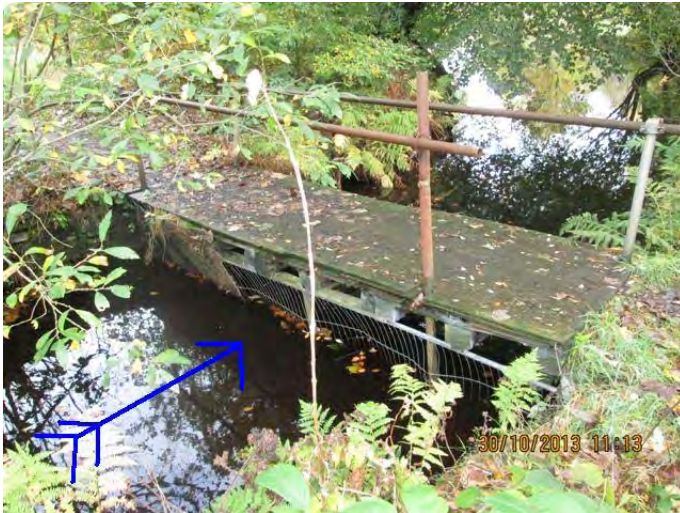
7. Scaffold access bridge over inlet channel

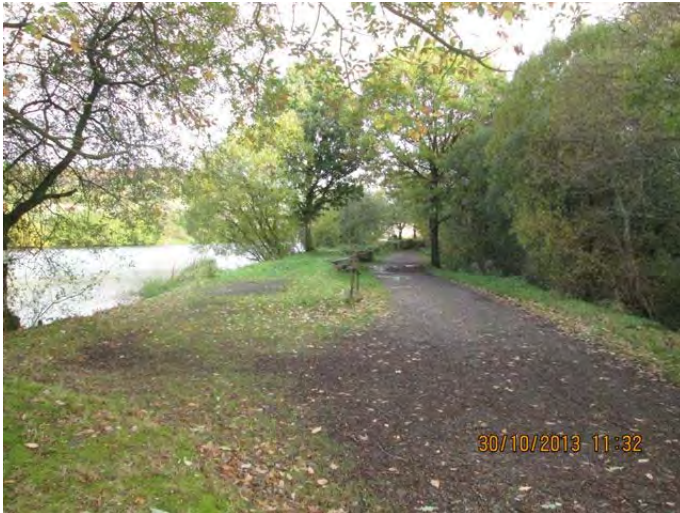
13. View looking north east across crest

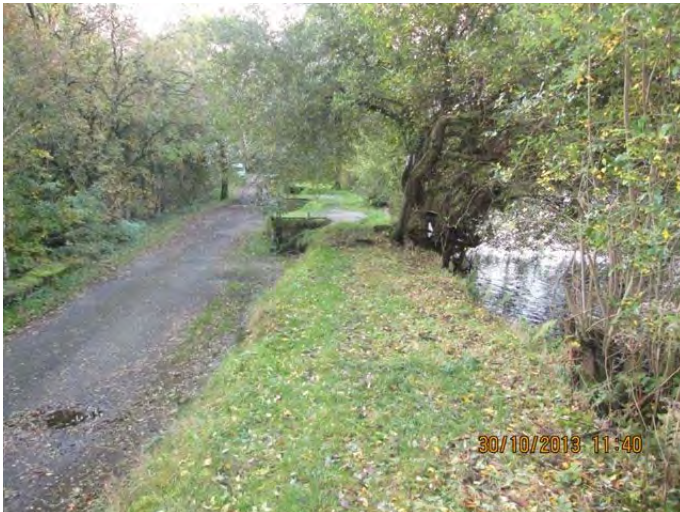
15. View looking south west across crest

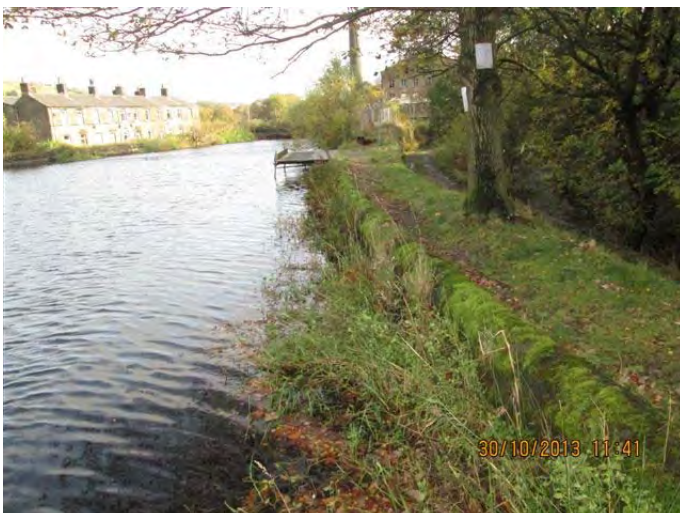
17. View looking east across upstream face

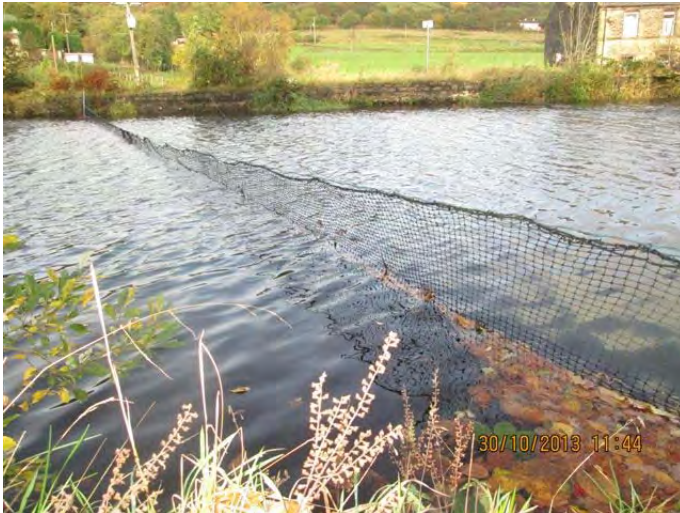
19. Weed/fish screen across pond

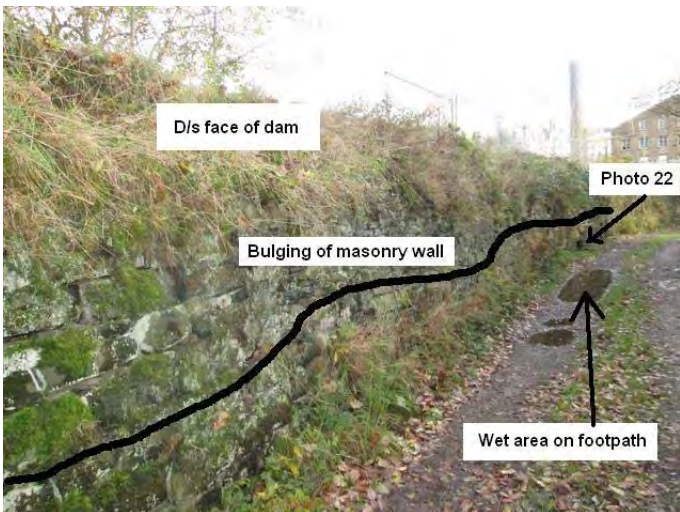
21. Bulging of masonry wall

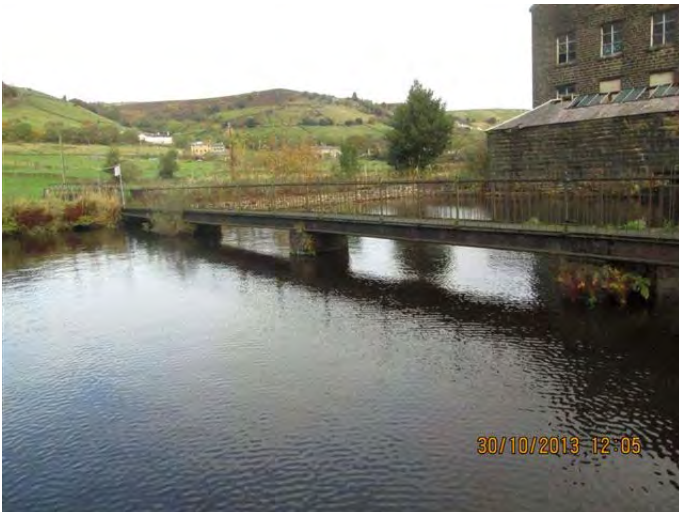
25. Footbridge over d/s (east reservoir)

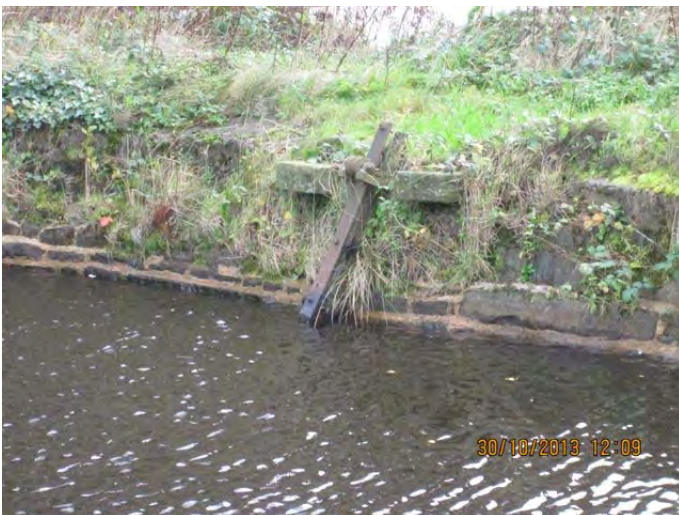
27. Possible draw-off point

- Structural assessment of all dams showing signs of leakage and movement to gain better understanding of their current condition.
- Investigation into the condition of the outlet arrangement from the eastern reservoir which may enter mill building on eastern boundary. (picture 26)
- Investigation of the scour within the inlet channel and possible undermining of the retaining walls.
- Investigation into condition and operability of the possible drawdown facility identified in picture 27.
