# **FLOOD RISK ASSESSMENT**

**Land at  
Cellars Clough,  
Nr Marsden,  
Huddersfield,  
West Yorkshire  
HD7 6NB**

**E15/6518/FRA001A**

**April 2016  
REVISED September 2017**

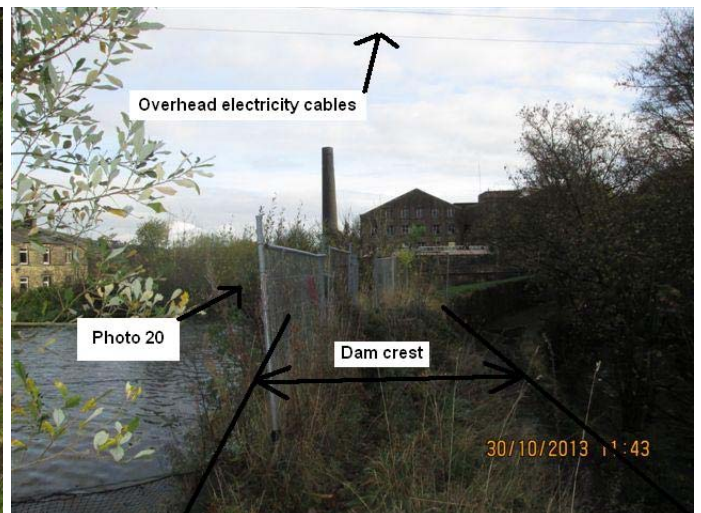
**18. View looking east across crest**

- Remedial works to stop the leakage from the northern dam along with repairs undertaken to Canal towpath (picture 28)
- Removal of the submerged boat within the reservoir.
- Maintenance of overflow spillway to reinstate missing masonry.
- Management and maintenance of trees within the inlet channel, on the upstream face and dam crest. (picture 5)
- Consideration given to the removal of the fencing panel on the overflow arrangement to reduce blockage risk. (picture 18)

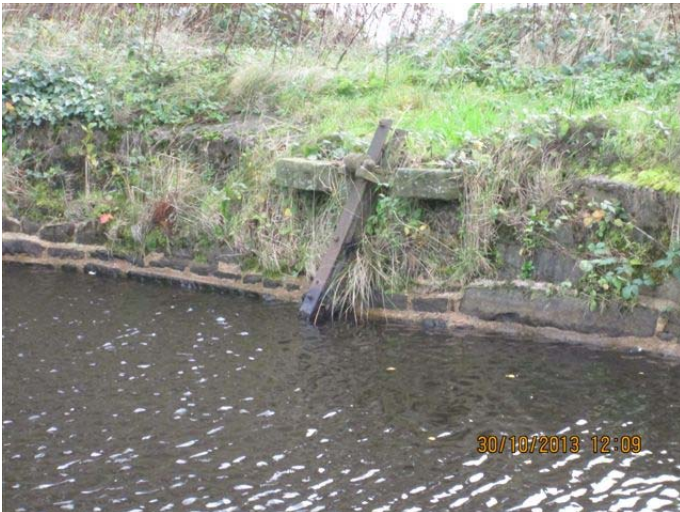
26. Outlet into mill building

- Structural assessment of all dams showing signs of leakage and movement to gain better understanding of their current condition.
- Investigation into the condition of the outlet arrangement from the eastern reservoir which may enter mill building on eastern boundary. (picture 26)
- Investigation of the scour within the inlet channel and possible undermining of the retaining walls.
- Investigation into condition and operability of the possible drawdown facility identified in picture 27.
