**Former Mill Building**

**Dobroyd Mills**

**Jackson Bridge, Hepworth**

**Client:** Mr Z Hinchcliffe  
**Project Number:** 15271  
**Date:** 22<sup>nd</sup> May 2016

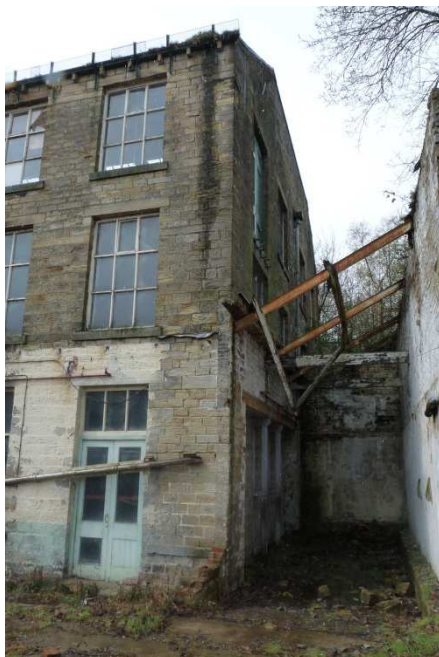
View down the side of the north elevation from 1<sup>st</sup> floor, only part access was available to about half way along the gable.

The remains of a lean-to roof is visible between the retaining wall and mail gable wall.
