# THE GEORGE HOTEL, HUDDERSFIELD STRUCTURAL CONDITION SURVEY

Revision P01  
Date 28/09/21  
Made by Stephen Twentyman  
Checked by Paul Maddison / Fay Newham  
Approved by Niall Meyers

Ref 1620012540-RAM-ZZ-XX-RP-S-001

To carry out a structural visual inspection and report on the current condition of the Grade II\* Listed George Hotel, Huddersfield. The defects identified and recorded will focus areas and locations for further investigations and inform proposals for future remedial measures

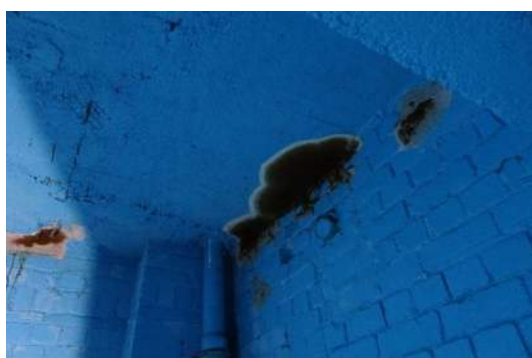
The basement of Block A was generally considered to be in reasonable structural condition. Areas with signs of water ingress and damp to the rear of the block were showing signs of dry rot, surface corrosion to beams and exposed reinforcement, and damage to finishes. Areas with improved ventilation were noted as having less problems with damp.

LOCATION	DESCRIPTION OF CONDITION
<b>99A-01 Basement Stores</b>	Area not directly accessible due to limitations as identified in the asbestos survey. Area could be viewed from doorway. Generally noted to have no visible structural defects, or signs of damp.
<b>99A-02 Basement Stores</b>	Area not directly accessible due to limitations as identified in the asbestos survey. Area could be viewed from doorway. Generally noted to have some areas of visible water ingress/damp with existing metal fittings starting to corrode.
<b>99A-03 Corridor space</b>	Corridor area generally noted to feel drier than adjacent spaces, likely due to position in building (i.e., away from perimeter retaining walls). Some areas of rising damp visible.
<b>99A-04 Basement Stores</b>	Storeroom has existing drainage outlet in floor, generally noted to feel damp but timber ceiling appears dry and in good structural condition.

<b>99A-05 Basement Stores</b>	Area not accessible due to limitations as identified in the asbestos survey.
<b>99A-06 Corridor space</b>	Generally damp at centre of building, visible corrosion on newly painted steel or iron beams suggesting recent water ingress. Origin of water presence is unknown.
<b>99A-07 Corridor space</b>	Area very damp, water ponding on the floor. Recently applied paint has started to peel (informed that paint was applied 3-4 months prior to inspection), visible corrosion on painted steel or iron beams. Salt stains on brick visible at low level and high-level suggesting moisture in the brick, large areas of dry rot at high level and exposed reinforcement corroding in the soffit of the slab above. Air bricks and openings appear blocked, reducing passive ventilation.
<b>99A-08 Basement store</b>	Area not directly accessible due to limitations as identified in the asbestos survey. Area could be viewed from doorway. Generally noted to have no visible damp.

<b>99A-09 Basement store</b>	Area well ventilated (vents open), exposed timber floor structure above is visible and appears in good condition.
<b>99A-10 Toilets</b>	Area well ventilated (vents open), exposed timber floor structure above is visible and appears in good condition and dry.

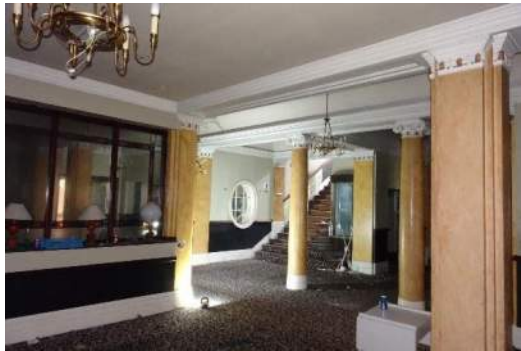
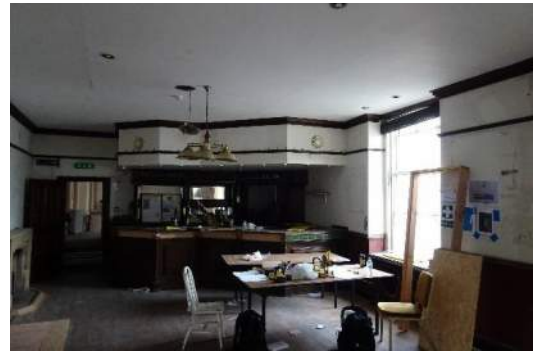
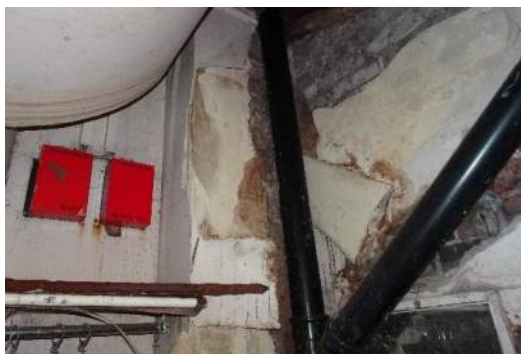
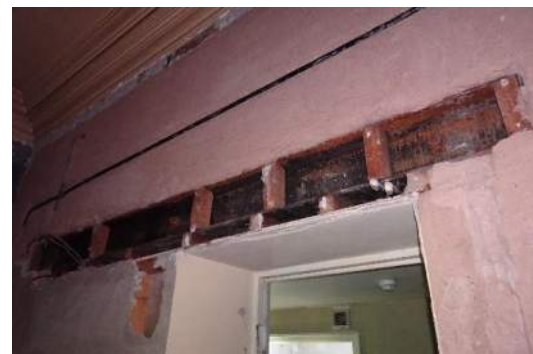
The Ground Floor of Block A was generally considered to be of good structural condition. Areas of water ingress were noted to the rear of this building where it interfaces with the 1930s ballroom of Block B.

LOCATION	DESCRIPTION OF CONDITION
<b>00A-01 Charter Suite</b>	Signs of water ingress by bay window of Charter Suite, due to staining. Structural beam noted in internal wall with minor surface corrosion. Lath and plaster to ceiling appears dry so water ingress may be historic. Floor appears to be raised or suspended timber structure, probably supported by brick piers, with ventilation panels set into floor.
<b>00A-02 Reception and entrance foyer</b>	Generally good condition, some signs of historic water ingress adjacent internal drainage down pipe. Steel or iron columns beneath finish appear in good condition where visible.
<b>00A-03 Bar area</b>	Generally good condition, staining in ceiling finishes near bar area suggesting historic water ingress.
<b>00A-04 Back of house corridor</b>	No structural comments, additional low ceiling installed in area, obscuring original finishes a high level.

<b>00A-05 Storage space</b>	Significant water ingress in space, walls damp, steel or iron elements showing signs of corrosion on the surface, and finishes have peeled away. This is at the interface with the Ballroom in Block B and suggests water originates from the drainage in the internal courtyard above.
<b>00A-06 Corridor space</b>	Wall adjacent to storage space (00A-05) shows signs of damp.

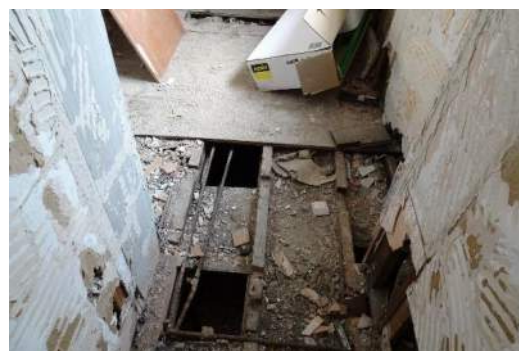
The First Floor of Block A was generally considered to be reasonable condition structurally. It is understood that much of this level has been re-plastered in the last 10 years. Areas of water ingress were noted in the stair core structure and the rooms adjacent.

LOCATION	DESCRIPTION OF CONDITION
<b>01A-01 Hotel rooms</b>	Historic damp patches on floor below window and finishes in bathroom have peeled. Floor structure visible in bathroom and appears to show structure is timber joists with a rubble infill in some areas. The rubble infill is thought to provide fire compartmentation.
<b>01A-02 Hotel rooms</b>	Ceiling plaster peeled/failed under bay window with signs of historic water ingress on floor finishes directly beneath.
<b>01A-03 Corridor</b>	Small inaccessible services vent provides natural ventilation to space, generally in good condition. Floor appears solid.
<b>01A-04 Stairs</b>	Visible areas of damp patches to wall finishes, timber floor boarding sagging on landing.
<b>01A-05 Main corridor</b>	Generally noted to be in reasonable condition, water staining visible around lift opening and previously filled wide crack by staircase with additional hairline cracks visible in plaster finish. Infilled crack showing no signs of further opening up.

<b>01A-06 Hotel rooms</b>	Damp staining in south-western corner of room with hairline cracks in ceiling finishes
<b>01A-07 Hotel rooms</b>	Area not directly accessible due to significant deterioration, but area could be viewed from doorway. Generally noted to have some areas of visible water ingress/damp with mould visible on the wall surfaces adjacent to the staircase.
<b>01A-08 Hotel rooms</b>	Generally noted to be dry and in good condition. Vertical hairline cracks are visible in new plaster in northern wall.

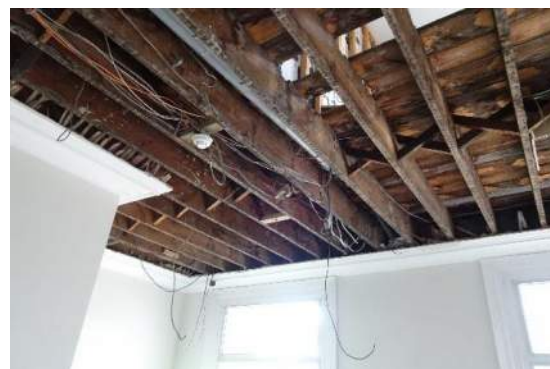
Structure is thought to be timber joisted floors supported by masonry load bearing walls. The Second Floor of Block A was generally considered to be in a reasonable structural condition. It is understood that much of this level has been re-plastered within the last 10 years, but it has been noted that hairline cracks have formed in the plaster in the return walls to the main façade. Areas of water ingress noted in the stair core structure and the rooms adjacent.

LOCATION	DESCRIPTION OF CONDITION
<b>02A-01 Hotel rooms</b>	Diagonal crack visible in plaster finishes and cornice adjacent to external wall in both rooms. Western façade wall has a damp patch in southern room with areas of mould and signs of the timber floor sagging. Pattern of cracking and gaps in finishes, suggests slight outwards lean of western external wall.
<b>02A-02 Corridor</b>	No comments
<b>02A-03 Hotel rooms</b>	Rooms in good condition, some diagonal hairline cracks visible in plaster finishes in walls. Timber joists visible above, appear in good condition. A partition wall has been installed on the timber floor above with, what is understood to be, a breeze block masonry infill. , Heavy partition does not align with the timber joists below and should be provided with additional support.
<b>02A-04 Stairs</b>	Clear signs of historic damp and recent damp in stairwell, suggesting water ingress in this area is a long-term problem. Large cracks in finishes to door lintel with paint and plaster peeling away from wall. Additional crack to the top of the arched feature window. Plaster ceiling in stair landing above has failed and fallen.

<b>02A-05 Hotel rooms</b>	Area not directly accessible due to significant deterioration, but area could be viewed from doorway. Generally noted to have some areas of visible water ingress/damp with finishes peeling away from wall and windows.
<b>02A-06 Hotel rooms</b>	Reasonable condition, hairline diagonal cracks in return wall plaster finishes.

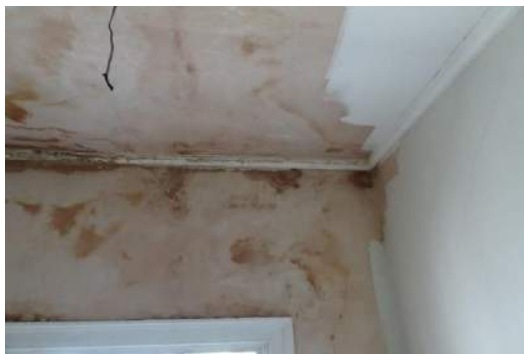
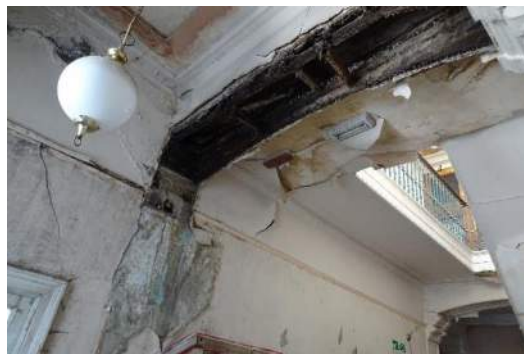
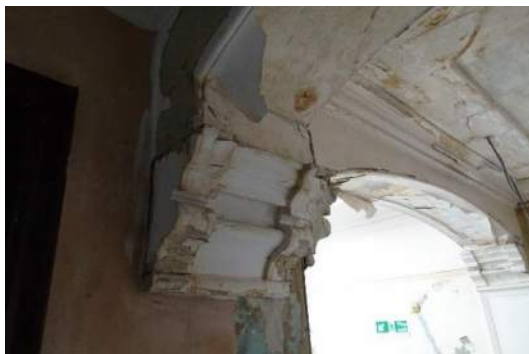
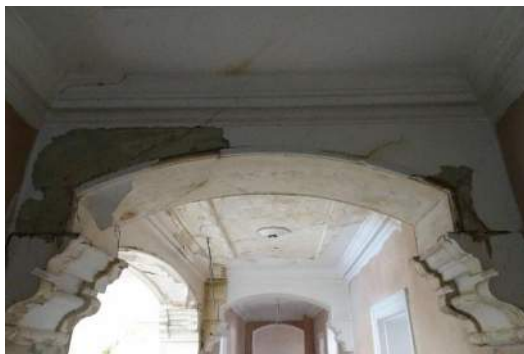
Structure is thought to be timber joisted floors supported by masonry load bearing walls. The Third Floor of Block A, similarly to the second and first floor was generally considered to be in a reasonable structural condition. It is understood that much of this level has been re-plastered in what is believed to be the last 10 years but it was noted that hairline cracks have formed in the plaster in return walls to the main façade. Areas of water ingress were noted in the stair core structure and the rooms adjacent as well as large areas of damp in the finishes to the majority of the external walls.

LOCATION	DESCRIPTION OF CONDITION
<b>03A-01 Hotel rooms</b>	Diagonal and vertical hairline cracks visible in plaster finishes in return walls. Internal face of external wall shows signs of damp in the finishes. Pattern of cracking and gaps in finishes similar at this level and levels above, suggests slight outwards lean of western external wall.
<b>03A-02 Corridor</b>	Clear signs of water ingress into cupboard space with dry rot in corridor at high level. Ceiling finishes have failed and structure above exposed.
<b>03A-03 Hotel rooms</b>	Visible damp at high level in all spaces on internal face of external wall. Hairline cracks visible in plaster finish. Masonry partition within space, possible later addition; this wall does not have any supporting structure beneath. Finishes have debonded from internal partition wall, possible sign of historic water ingress.
<b>03A-04 Corridor</b>	Damp at high level in corridor space, finishes are peeling extensively from ceiling and cracking apparent in finishes.

<b>03A-05 Stairs</b>	Area not directly accessible due to significant deterioration, but area could be viewed from doorway. Clear signs of historic and current damp in stairwell. Decorative plaster arch finishes beneath beam have collapsed, signs of water ingress to timber beam structure above. Finishes at apex of arched window also failed. Wide cracks visible in wall finishes. Fine cracks run diagonally from door opening to wall corner with large sections of render debonding from masonry wall and failing. Masonry wall beyond finishes appears in generally reasonable condition. Damp visible on most surfaces.
<b>03A-06 Hotel rooms</b>	Area not directly accessible due to significant deterioration. Area could be viewed from doorway. Generally noted to have some areas of visible water ingress/damp with finishes peeling away from wall and windows in corner of room adjacent to stair core.
<b>03A-06 Hotel rooms</b>	Visible damp at a high level, large patches of mould on external walls. Vertical hairline crack in northern room that aligns with similar crack noted on levels below.

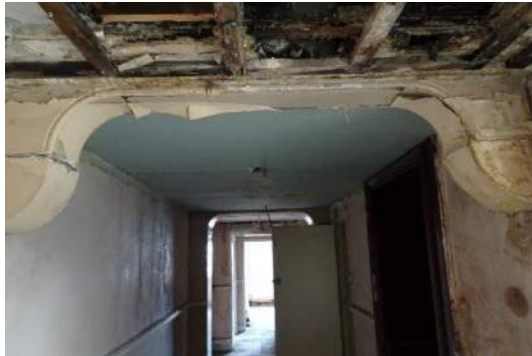
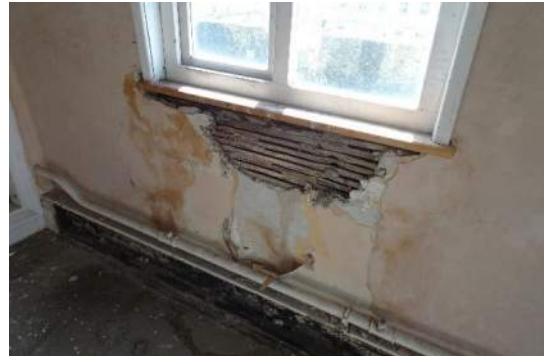
Structure is thought to be timber joisted floors supported by masonry load bearing walls. The Fourth Floor of Block A showed significant areas of water ingress at window locations set within the mansard roof, with existing finishes having failed in many spaces. Additional water ingress was noted in the stair core and the rooms adjacent.

LOCATION	DESCRIPTION OF CONDITION
<b>04A-01 Hotel rooms</b>	Damp by window opening and plaster finish has collapsed leaving lath and timber mansard roof beneath exposed. Hairline crack in new plaster finishes in walls.
<b>04A-02 Hotel rooms</b>	Visible damp at high level in all spaces on exterior wall, worst affected areas are directly adjacent to existing window openings. Hairline cracks visible in plaster finish at high level.
<b>04A-03 Corridor</b>	Ceiling sagging and visible damp in corridor spaces. Temporary water collection butt located adjacent to the stairs in the corridor, clear sign of ongoing water ingress. Damp patches across ceiling finishes with some finishes fallen away from the ceiling.
<b>04A-04 Stairs</b>	Area not directly accessible due to significant deterioration. Visible damp and failed finishes. Rooflight above assumed to be source of water ingress.
<b>04A-05 Hotel rooms</b>	Area not directly accessible due to significant deterioration. Area could be viewed from doorway. Generally noted to have some areas of visible water ingress/damp with finishes peeling away from wall and windows.

<b>04A-06 Hotel rooms</b>	Rooms damp with plaster failed locally around window openings. Small crack visible in back wall adjacent to Block C that aligns with noted cracks on levels below.

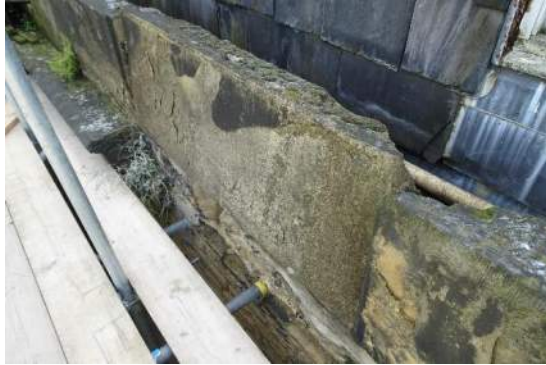
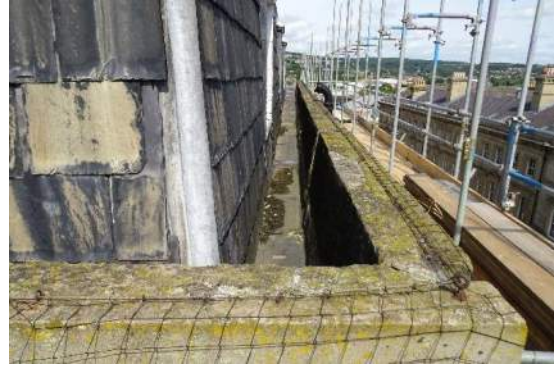
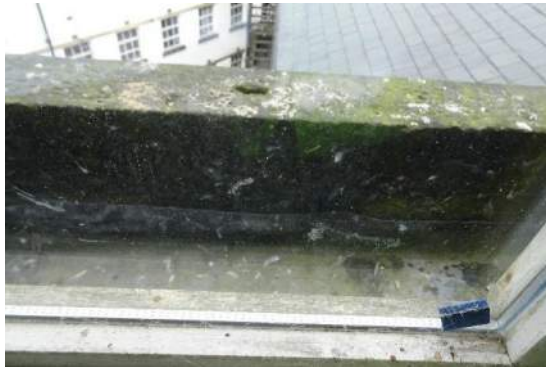
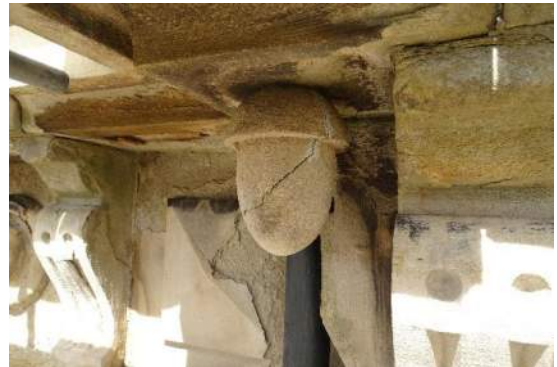
It was noted that the existing flashing detail seemed in good condition with suitable falls to drainage points on the western, southern, and eastern facades. The northern façade was unavailable for access for inspection but is understood to have an inferior flashing detail compared to the other facades. This is based on views from the Level 4 windows. This inferior flashing detail correlates with the water ingress visible on levels below in the staircase and adjacent rooms on the northern façade of Block A.

It was noted that large parts of the stonework parapet had delaminated in the exposed environment and one large parapet stone was unrestrained laterally and had been tilted towards the building (with temporary packs/shims) to reduce the risk of it falling outwards. Additionally, stonework was noted to be cracking and deteriorating, potentially due to corroded fixings.

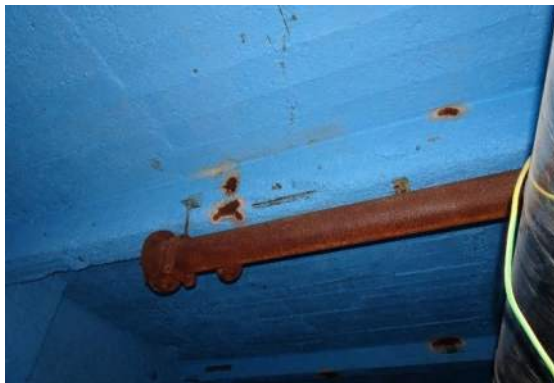
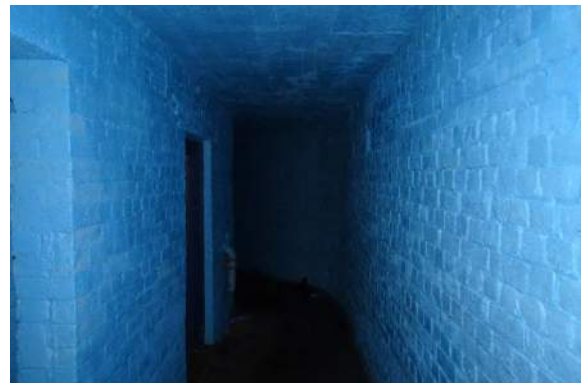
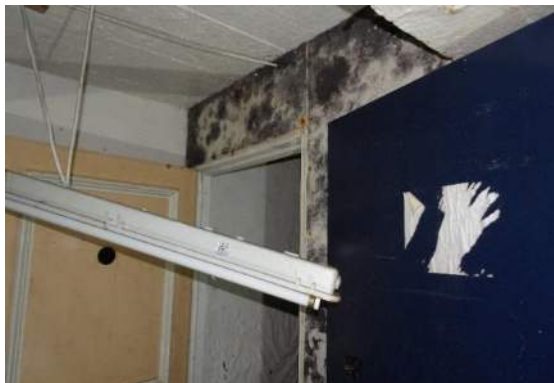
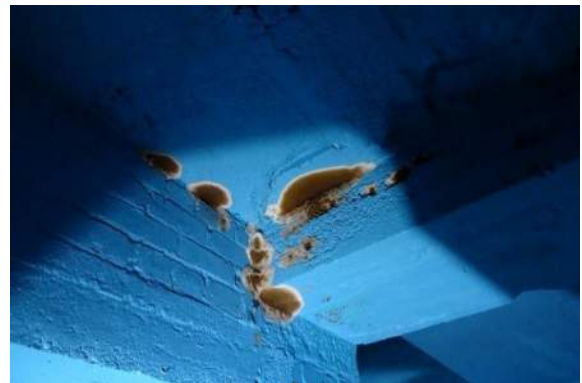
The basement of Block B was generally considered to be in reasonable structural condition. Areas with signs of water ingress and damp to the rear wall of the block were showing signs of dry rot, surface corrosion to beams, and damage to finishes. Areas with improved ventilation were noted as having few problems with damp.

LOCATION	DESCRIPTION OF CONDITION
<b>99B-01 Plant Room</b>	Plant room has visible damp patches on walls. Recently applied paint has run from walls at foot of masonry retaining wall, assumed to be related to rising damp in the masonry. Structure exposed above with assumed steel or iron beams encased in concrete, exposed elements show signs of corrosion. Steel reinforcement in slab above also exposed locally in the ceiling soffit.
<b>99B-02 Plant Room</b>	Area very damp, water ponding on the floor. Recently applied paint has started to come off with water, visible corrosion on painted steelwork also noted. Salt stains visible at low level and high level, large areas of dry rot at high level and exposed reinforcement corroding in slab above. Air bricks and openings appear blocked, reducing passive ventilation.
<b>99B-03 Corridor space</b>	Damp space with ponding water on floor, patches of dry rot and mould at high level and in cupboard spaces. Rebar visible above and exhibiting signs of corrosion.

<b>99B-04 Corridor Space</b>	End corridor space has improved ventilation and timber exposed in ceiling structure appear dry on the day of visit.

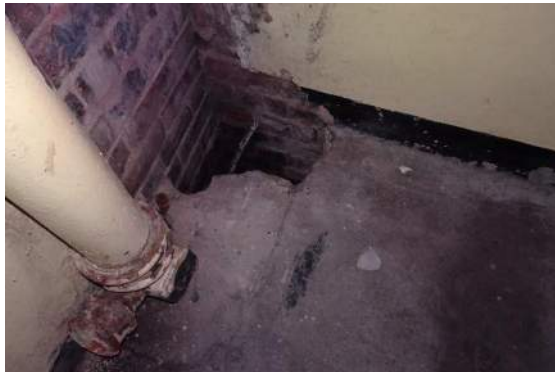
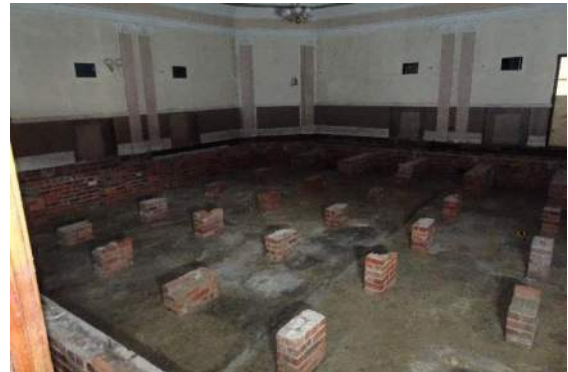
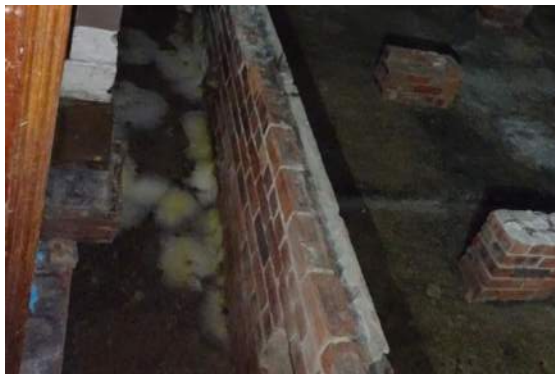
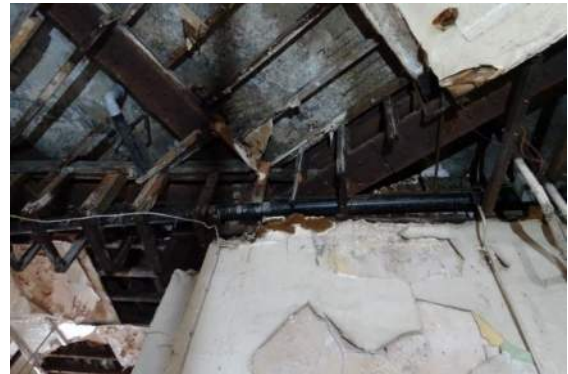
The ground floor level of block B had areas of significant water ingress, structure at high level appeared generally in reasonable condition but due to limited access this was difficult to review.

LOCATION	DESCRIPTION OF CONDITION
<b>00B-01 Chair storage</b>	Area generally dry. Large hole in floor in the northern corner of the room, with a crack leading from the hole, suggesting movement and weakness in the floor structure.
<b>00B-02 Ballroom</b>	Area not directly accessible due to significant deterioration. Area could be viewed from doorway. The area has a large area of mould growth adjacent to largely damp areas in Block A. The former timber floor has been removed due to its deterioration from water ingress from above, exposing dwarf masonry piers. Additionally, finishes in the ceiling are noted to have collapsed. The ballroom is susceptible to water ingress due to location below internal courtyard and position between interfaces of different blocks of the building.
<b>00B-03 Kitchen</b>	There are large areas of significant water ingress and failure of finishes in the kitchen. Ceiling finish has failed, exposing the steel beams above that appear to be showing signs of corrosion. There is the presence of mould and damp surfaces throughout. Above the existing cold store the ceiling finishes have collapsed, revealing the timber joists above, these appear dry and reasonable condition. Kitchen area is adjacent to the susceptible ball room area (as referenced above) and is at the interface with Block C and the escape stairs. Therefore based on observations elsewhere, these are weak points for water ingress.

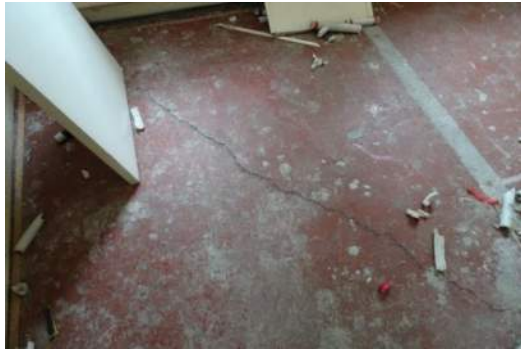
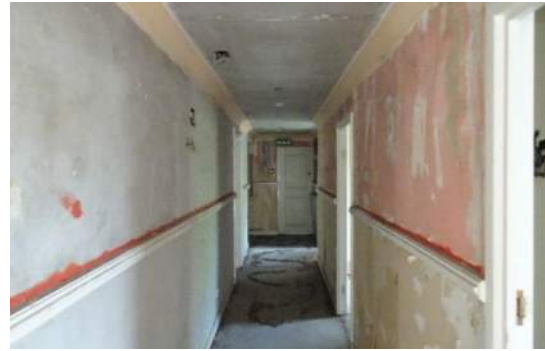
The structure is thought to be concrete framed or steel encased concrete with a reinforced concrete slab, this slab is assumed to be supported by load-bearing masonry walls. It appears a non-structural screed is present above the existing structural slab. The first-floor level of Block B appeared in good condition structurally; previous opening up works revealed beam locations above and there were some localised areas of water ingress and significant signs of ingress towards the northern corridor end.

LOCATION	DESCRIPTION OF CONDITION
<b>01B-01 Hotel Rooms</b>	Area noted to be generally dry. Cracks noted in floor, but likely to be in the screed finish rather than in the structure. Some mould noted locally on cornices and ceiling finishes at a high-level.
<b>01B-02 Hotel Rooms</b>	Mould and damp towards end of the corridor, noted locally on cornices and ceiling finishes at a high-level in hotel rooms and bathroom. Ceiling finishes have collapsed and finishes starting to detach from structure above at the end of the corridor at interface with external escape stairs .

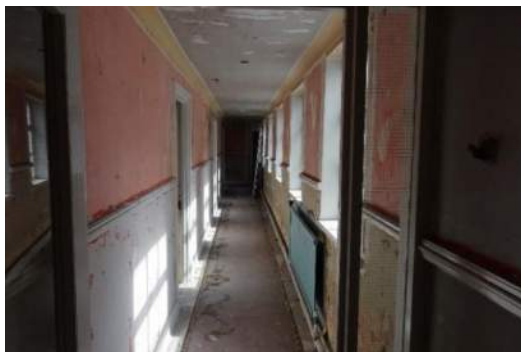
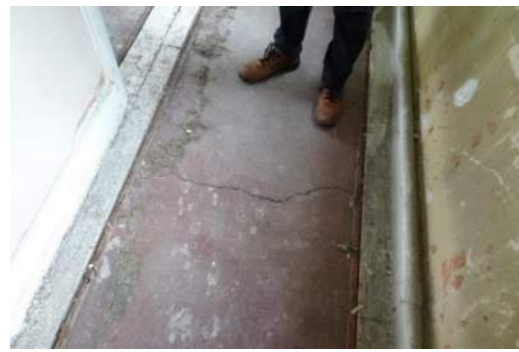
The second-floor level of block B appeared in good structural condition; previous opening up works have exposed some beam locations above and it was generally noted that this area was not damp.

LOCATION	DESCRIPTION OF CONDITION
<b>02B-01 Hotel Rooms</b>	Area noted to be generally dry. No structural defects identified.
<b>02B-02 Hotel Rooms</b>	Area noted to be generally dry, wide cracks present in floor. Suspected to be cracks in a non-structural screed finish above the structural slab and therefore are assumed to be non-structural

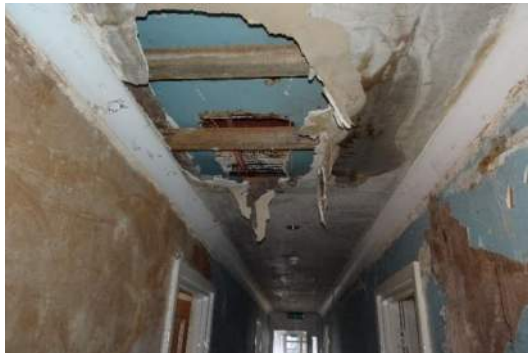
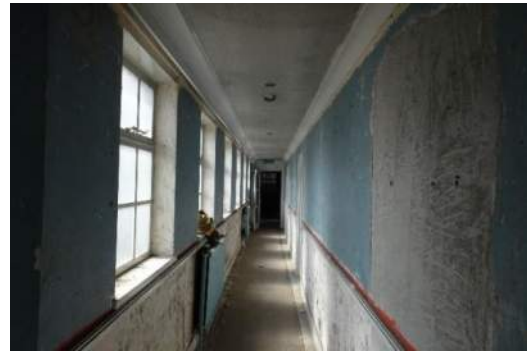
LOCATION	DESCRIPTION OF CONDITION
<b>03B-01 Hotel Rooms</b>	Area of roof dripping in corridor onto floor finishes below (this started during the inspections). Ceiling finishes have collapsed locally, and the straw panel roof above has been exposed. This suggests ponding of water above and possible failure of finishes.
<b>03B-02 Hotel Rooms</b>	Large patches of damp in this area with ceiling finishes peeling from the ceiling and staining on the floor and external walls, indicating historic issues with water ingress.

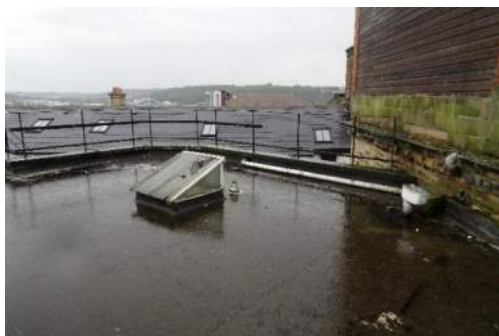
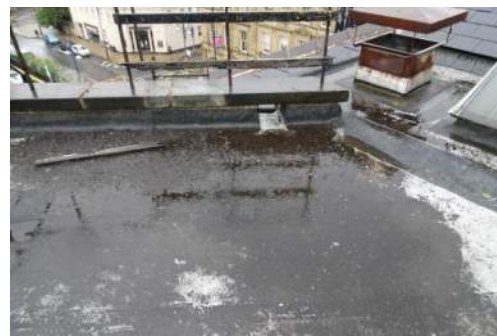
Direct access to the roof of block B was available from the internal courtyard. Large areas of the existing roof had standing water present that was unable to drain properly due to a blocked outfall on the eastern elevation. Standing water was present at both the northern and southern ends of the roof and in some locations around rooflights (potential weak points in the finishes). The drainage outlets to the roof appeared to be blocked and/or not functioning which would explain the actively dripping water directly below, noted during the inspection. It was also noted that any water that does discharge from this roof, is discharged onto the roof below, directly above the ballroom; this has already been identified as susceptible to water ingress

The photograph also shows that an attempt has been made to direct water from other roof areas through a hopper and to the outfall, off the roof. However this water is being discharged directly onto the flat roof and the arrangement of hopper and pipe is redundant and is actually blocking the outfall from the flat roof, exacerbating the ponding of water. This area of ponding correlates with dripping water on the level below.

Existing outfalls are blocked on the Block B roof. It is recommended to unblock down pipes and outfalls and remove debris that may be creating blockages to immediately relieve some of the water ponding. Ponding water can apply excessive loads to the structure and may exceed the capacity.

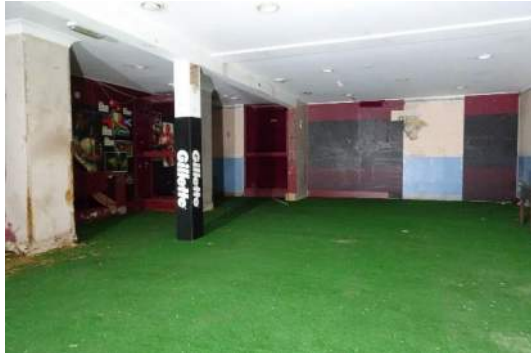
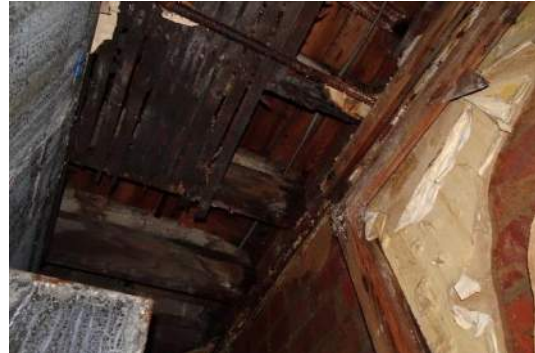
LOCATION	DESCRIPTION OF CONDITION
<b>99C-01 Museum</b>	This space is noted to be generally damp. Salt stains visible on masonry retaining structure suggesting leeching of salts due to water ingress. Rising damp visible around columns and mould has grown on remaining museum cabinets.
<b>99C-02 Plant</b>	Area by door very damp with timber structure directly above visibly wet and finishes have collapsed to the floor. Timber step on floor below has rotted and collapsed.
<b>99C-03 Basement Stores</b>	Room noted to have damp ceiling finishes with ceiling sagging. Unknown condition of structure above. Water ponding on floor in space and above doorway a large fruiting body is present.
<b>99C-04 Basement Stores</b>	Space drier than adjacent spaces and nearer end of corridor ventilation.

It is also noted that existing vents in the basement have been blocked and therefore it is recommended that a review of the basement ventilation strategy should be undertaken to reduce the risk of moisture build-up and the continual spread of dry rot and corrosion of metal work.

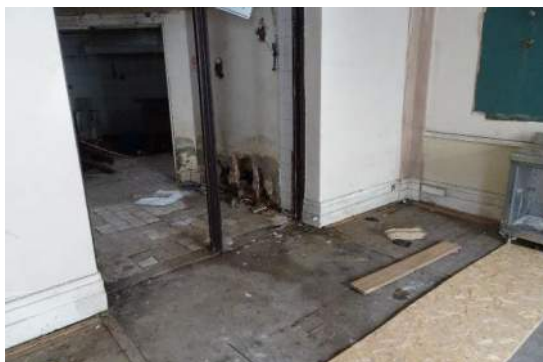
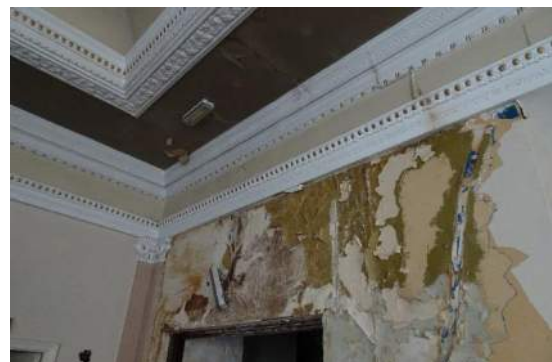
LOCATION	DESCRIPTION OF CONDITION
<b>00C-01 Restaurant</b>	There are two large areas of damp in this space. Located at the two internal corners of the space, notably these are the junctions with the two other blocks. This damp runs for the height of the space, at both high level and low level. Cracks are visible in the finishes to the north of the space and a localised area of the ceiling finishes is starting to crack.

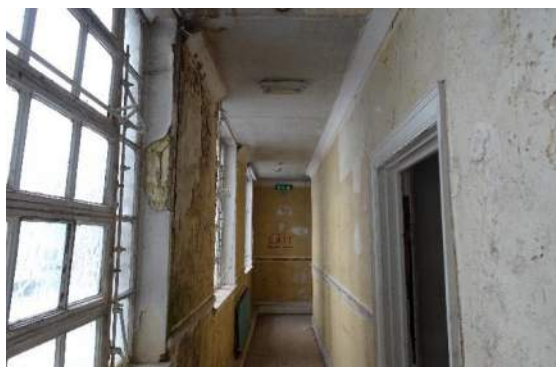
LOCATION	DESCRIPTION OF CONDITION
<b>01C-01 Corridor</b>	Corridor shows signs of significant water ingress and staining. Internal wall appears to be locally bowing. Water noted to be ponding on flat roof above.
<b>01C-02 Hotel Rooms</b>	Staining in rooms on wall adjacent to main corridor, finishes in ceiling have failed and you can see up to floor above. Steel beams visible in ceiling that span across the building. Wide cracks and sign of movement in three walls of room, large diagonal crack above doorway lintel and external wall finishes have moved away from internal partitions to form gap. Signs of water ingress in stained floor. Pattern of cracking and gaps in finishes, suggests outer lean of wall and may be related to previous strengthening works or changes to the roof structure.
<b>01C-03 Hotel Rooms</b>	Main rooms are generally in reasonable condition. Wide vertical crack on internal wall opposite diagonal crack noted in 01C-02. Strengthening detail visible above, understood to provide structural support to existing beams in the L02 floor structure. The reason for strengthening is not fully understood; may be due to fatigue or movement of structure over time. Refer to Appendix C for indicative sketch of the understood roof structure and strengthening detail. Wall at end of corridor by escape door shows signs of significant water ingress with finishes peeling and large areas of staining.

It was noted that cracks and gaps in the finishes in Block C suggested movement of the eastern wall. This area was previously strengthened and altered at roof level to create a new attic space (with floor strengthening structures hung from the new attic structure). It is recommended that in the areas of cracking, as identified on the First Floor Plan in Appendix A, the finishes are to be removed to establish if cracking is present in the underlying structure. It is also recommended to check the interface of the floor with the walls to see if there is sufficient bearing of the timber joists with any outward movement of the existing wall. Floor/ceiling finishes above and below this floor structure are to be removed local to the cracking to assess floor/wall interfaces.

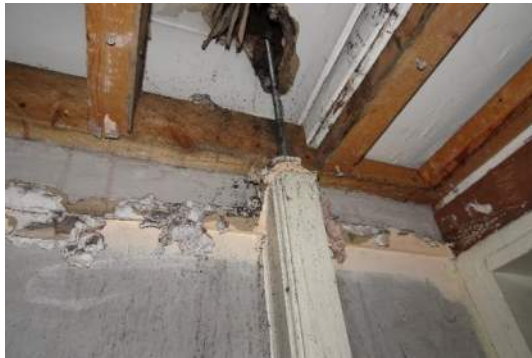
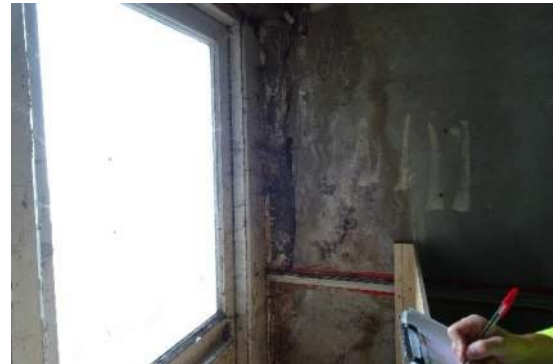
LOCATION	DESCRIPTION OF CONDITION
<p><b>02C-01</b> <b>Corridor and rooms</b></p>	<p>Corridor shows signs of significant water ingress and staining. Main areas of water ingress are adjacent to the internal courtyard doorway. Here there are multiple wide cracks in the finishes and fine cracks in the window lintel. Water collection tank located on by door, clear sign of ongoing water ingress. At this level tie bars are visible that are understood to support the floor below. These appear in good condition, but care needs to be taken to ensure these are not damaged in any ongoing works. Refer to Appendix C for indicative sketch of the roof structure and strengthening detail as currently understood.</p>

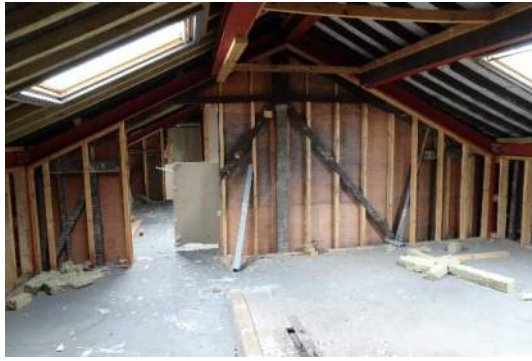
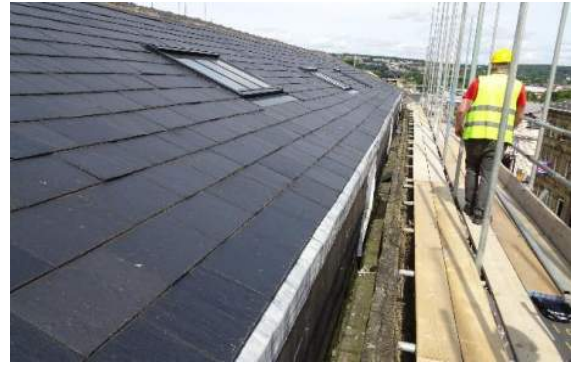
The stability of the new roof structure is assumed to be achieved with portal action (although it is noted that the portal connections look nominal rather than fixed). The longitudinal stability system is unclear it is assumed that infill panels are required to provide rigidity to the structure, although these appear incomplete. Rafters do not appear to be connected to purlins or the perimeter wall plate. These observations suggest that the construction of the roof structure is incomplete.

LOCATION	DESCRIPTION OF CONDITION
<p><b>03C-01</b> <b>Roof Internal</b></p>	<p>Roof structure is in good condition. New parapet wall made of blockwork also appears in good condition, although it appears to have been built following the existing wall position below and therefore has not been formed straight and plumb.</p>
<p><b>03C-01</b> <b>Roof External</b></p>	<p>The roof externally appears in good condition, it was noted that there is vegetation growth and a visibly damp patch of stonework at the most northern extent of the John William Street Façade. Access was not available to this section of the roof externally.</p>

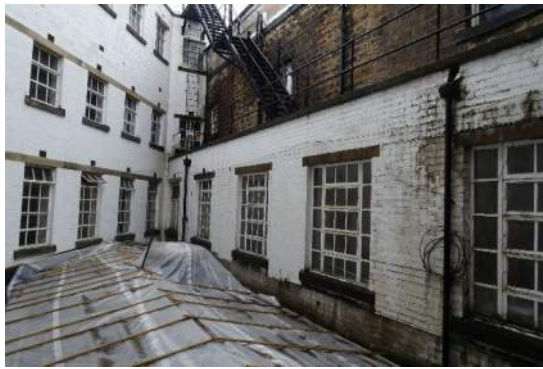
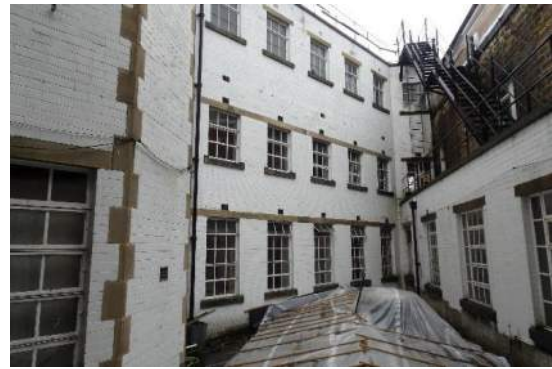
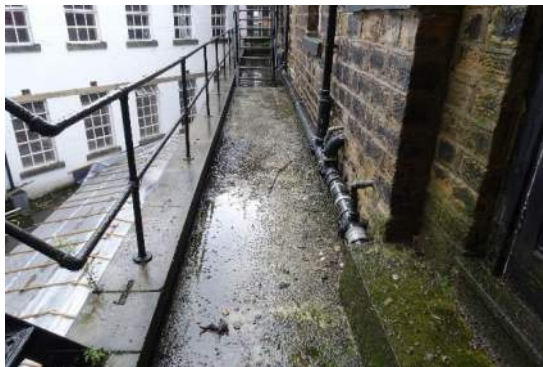
LOCATION	DESCRIPTION OF CONDITION
<b>Eastern Elevation</b>	Signs of damp on eastern façade. White paint has run from the masonry surface, vegetation is growing from ledges across elevation and fine cracks in the brickwork mortar joints are present. Main areas of vegetation, ponding in southern end of elevation correlate with water ingress in internal spaces below and adjacent, as referenced in earlier sections of this report.
<b>Western Elevation</b>	Elevation generally in good condition, two hairline cracks beneath the second-floor window and some signs of staining at the parapet
<b>Southern Elevation</b>	Elevation is visibly damp with algal and vegetation growth across wall. Areas behind southern elevations noted to in earlier sections of the report to show signs of water ingress.

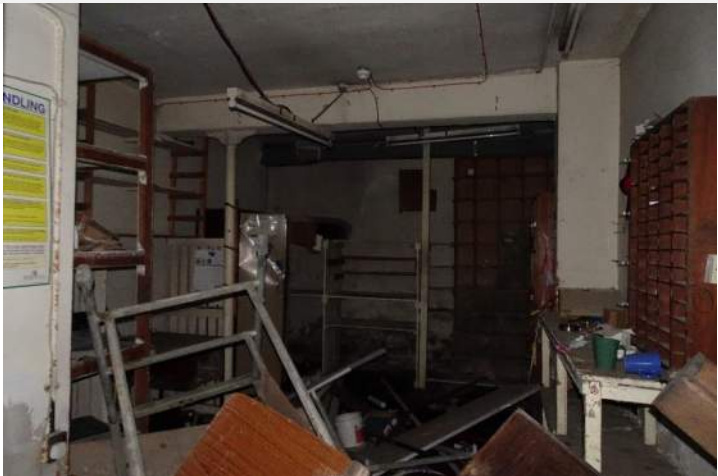
**99A-02**  
General space 1  
(inaccessible)

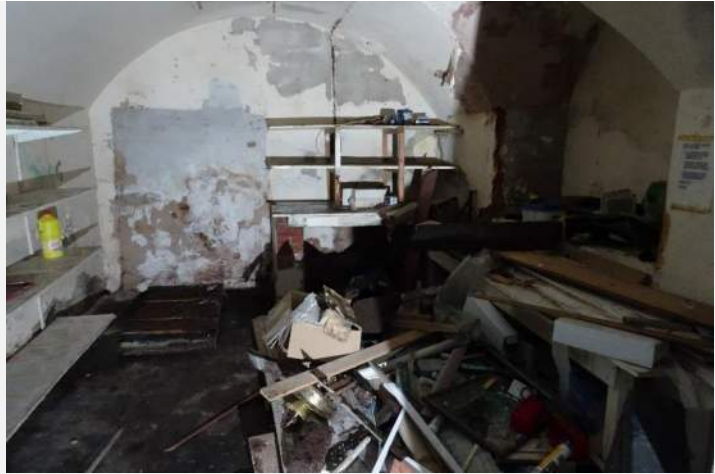
**99A-02**  
**General space 2**  
**(inaccessible)**

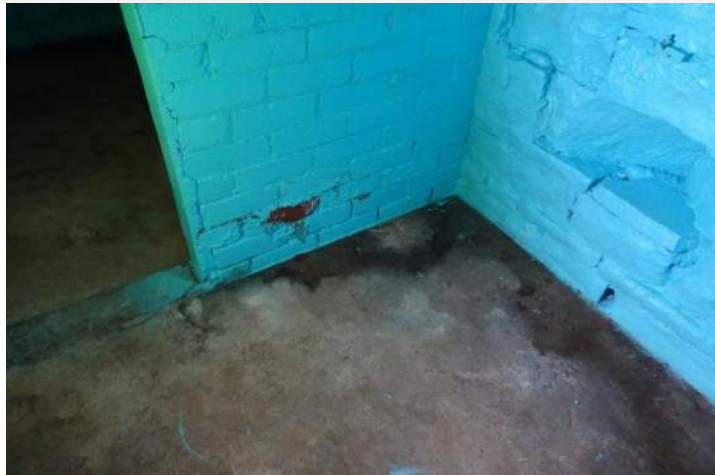
**99A-03**  
**Rising damp**

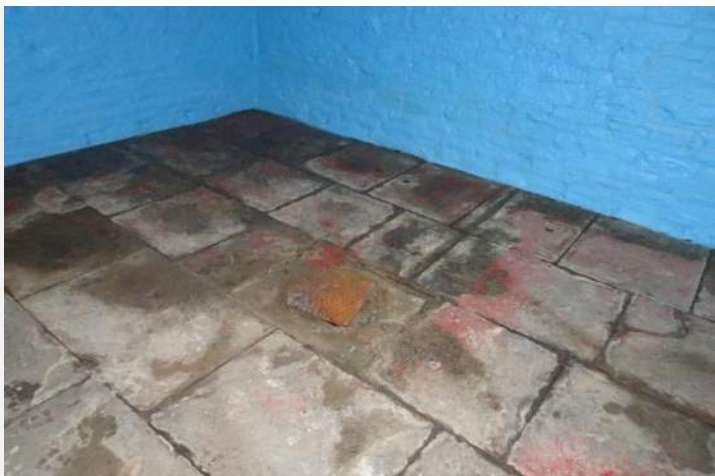
**99A-04**  
**Drain at centre of floor**

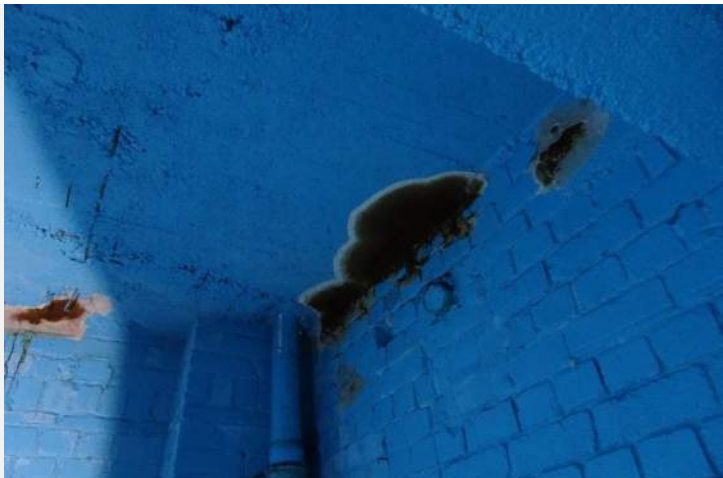
**99A-07**  
**Dry rot and exposed reinforcement**

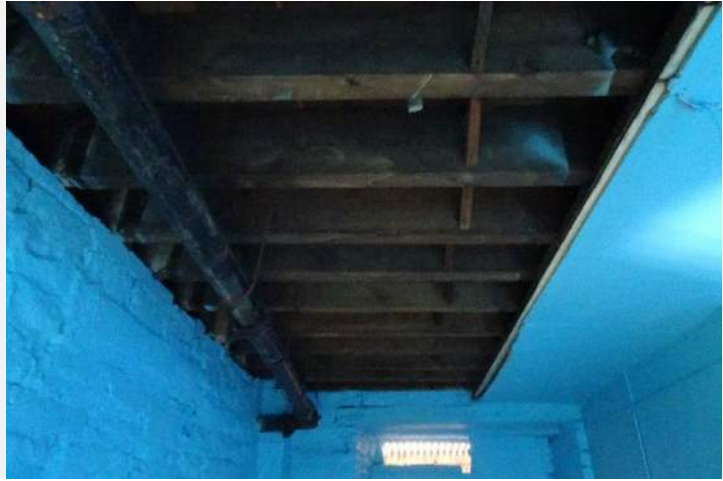
**99A-09**  
**Timber floor exposed**

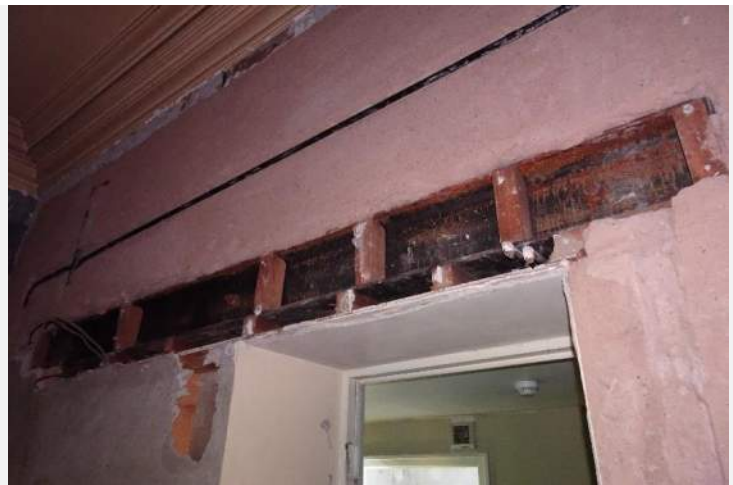
00A-01  
Existing steel beam with  
signs of corrosion

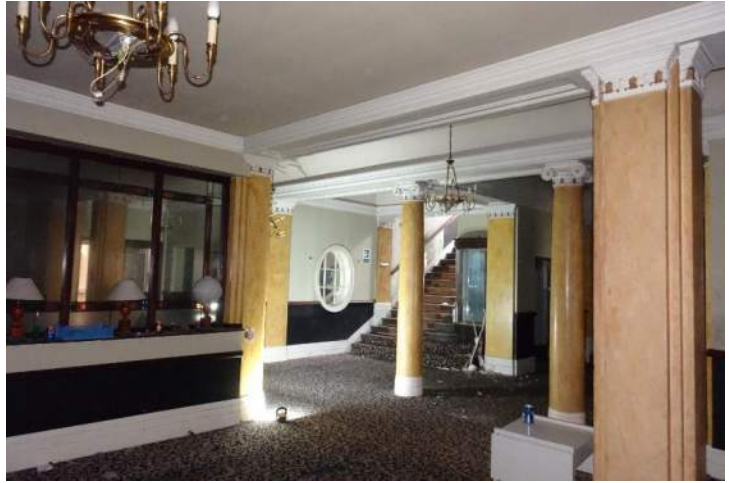
**00A-02**  
**General photograph of**  
**space**

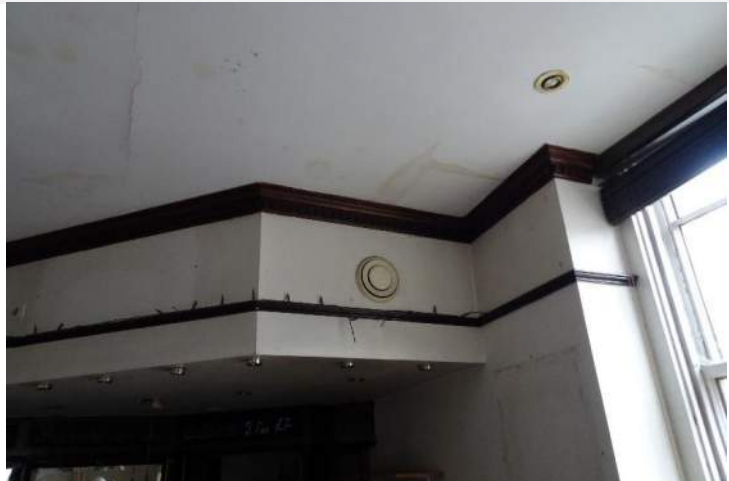
**00A-03**  
**Water staining in ceiling**  
**finishes**

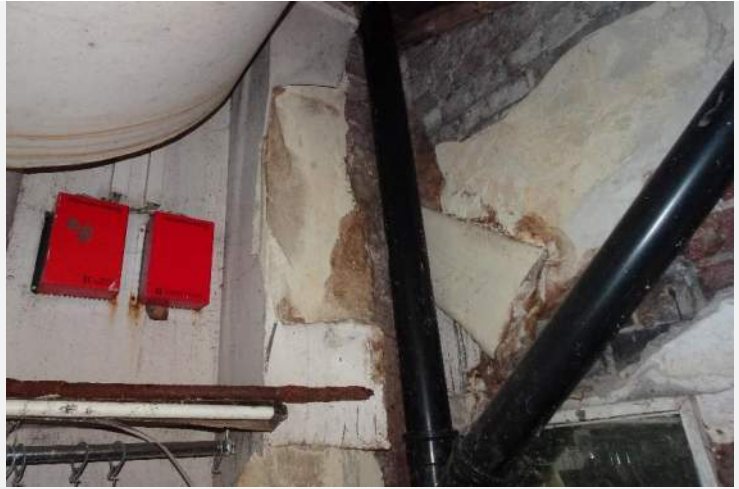
**00A-05**  
**Water ingress in storage cupboard**

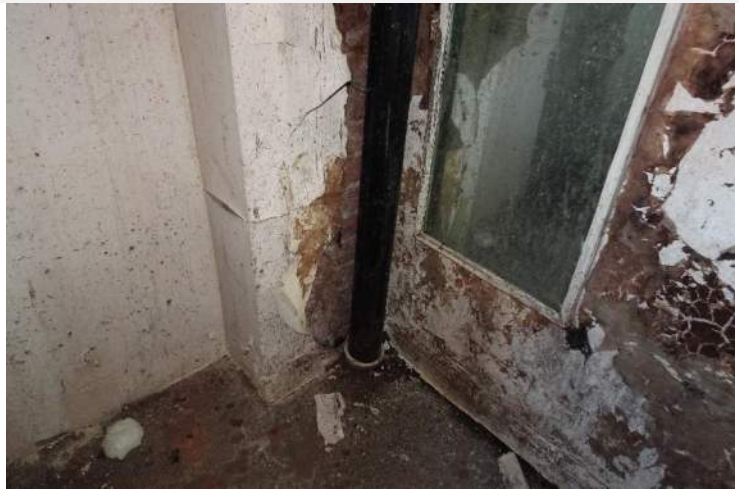
**00A-05**  
**Water ingress in storage cupboard**

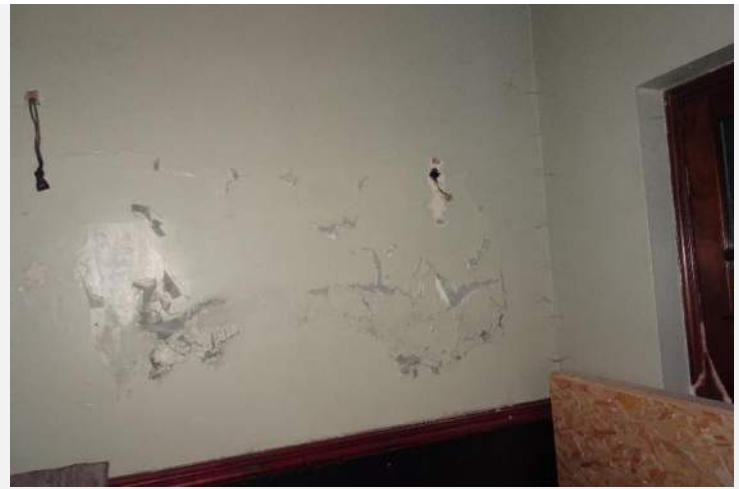
**00A-06**  
**Damp wall**

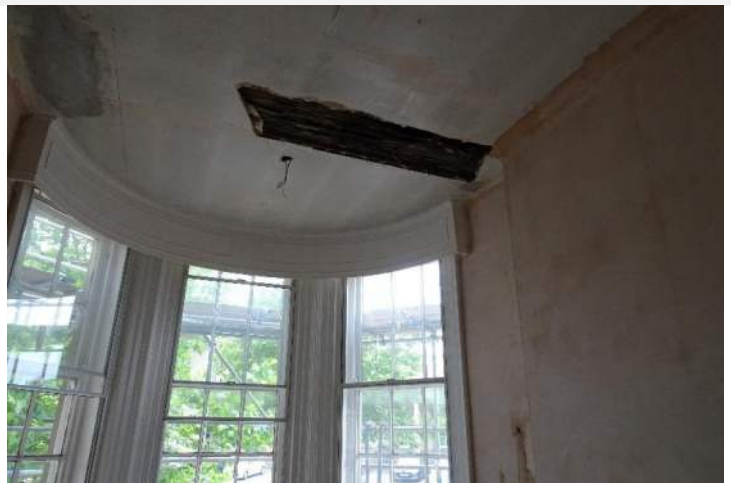
**01A-02**  
**Ceiling plaster failed**

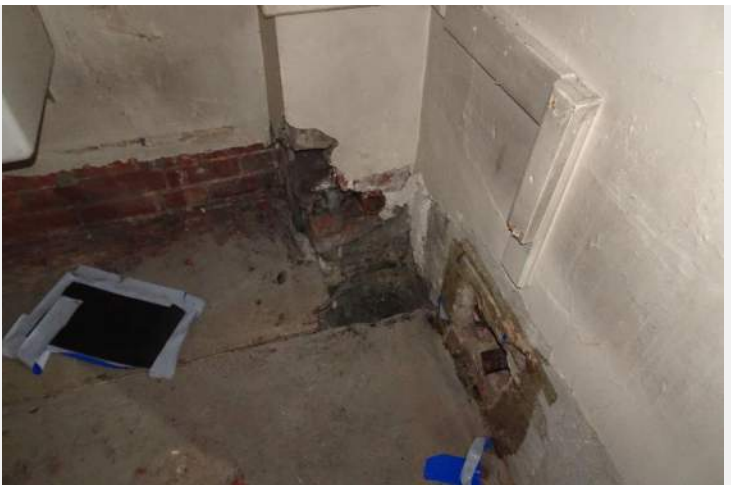
**01A-03**  
**Storage room adjacent  
to small courtyard**

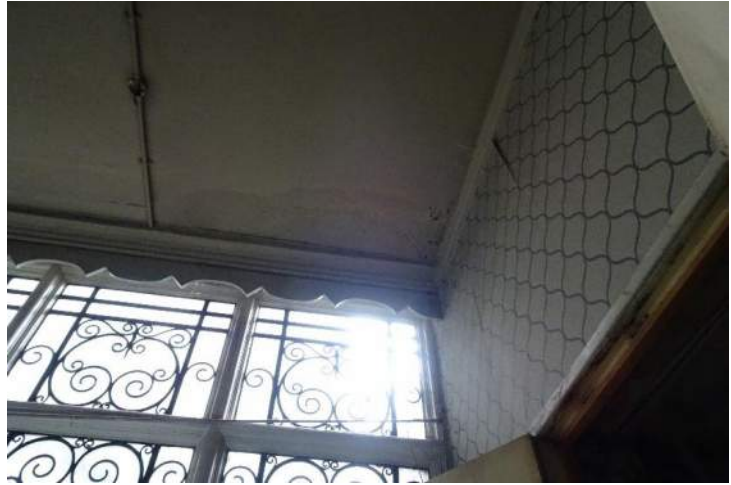
**01A-04**  
**Finishes peeling**

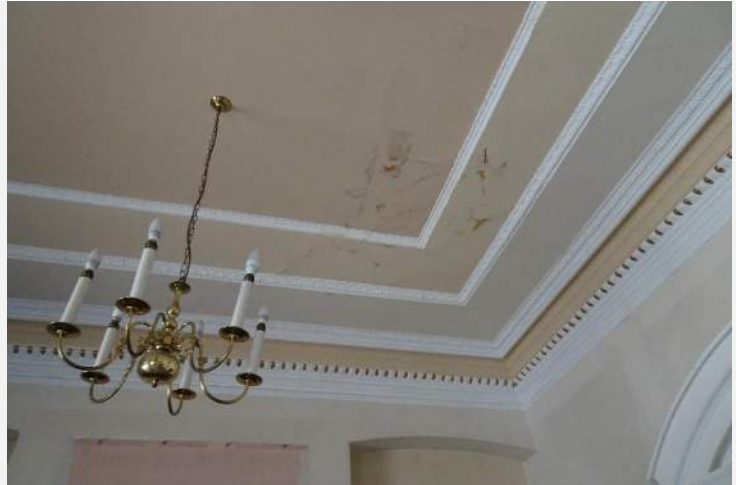
**01A-06**  
**Damp staining and**  
**hairline cracks in ceiling**  
**finishes**

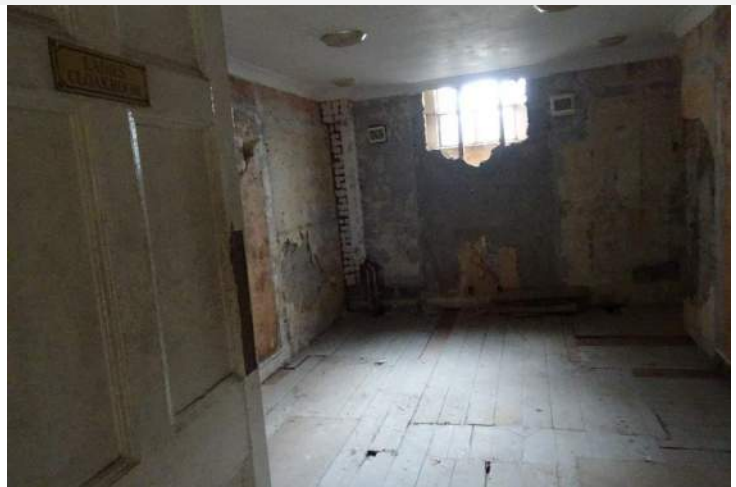
**01A-07**  
**General photograph of**  
**space (not accessible)**
