# THE GEORGE HOTEL, HUDDERSFIELD STRUCTURAL CONDITION SURVEY

Revision P01  
Date 28/09/21  
Made by Stephen Twentyman  
Checked by Paul Maddison / Fay Newham  
Approved by Niall Meyers

Ref 1620012540-RAM-ZZ-XX-RP-S-001

To carry out a structural visual inspection and report on the current condition of the Grade II\* Listed George Hotel, Huddersfield. The defects identified and recorded will focus areas and locations for further investigations and inform proposals for future remedial measures

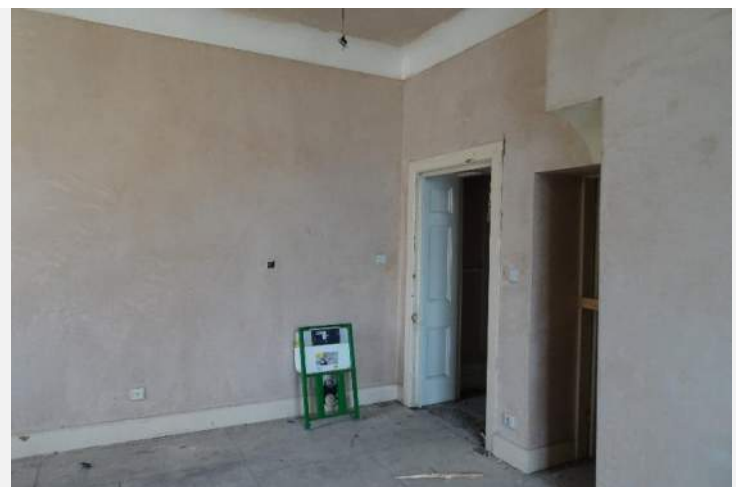
**01A-08**  
**General photograph of**  
**space**

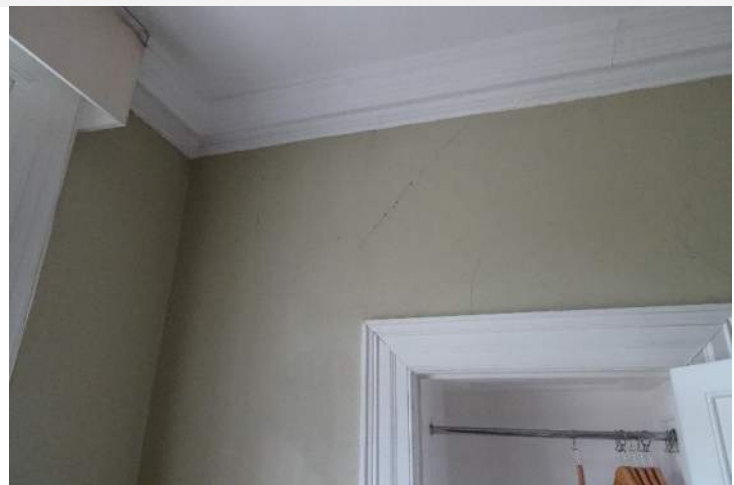
**02A-01**  
**Diagonal hairline crack in**  
**plaster finishes**

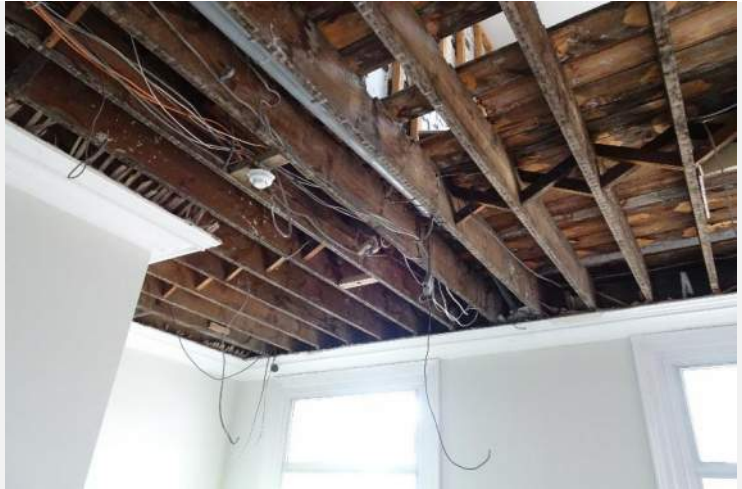
**02A-03**  
Timbers visible above.  
Cinder filled partition  
(heavy construction)  
built directly off timbers  
above

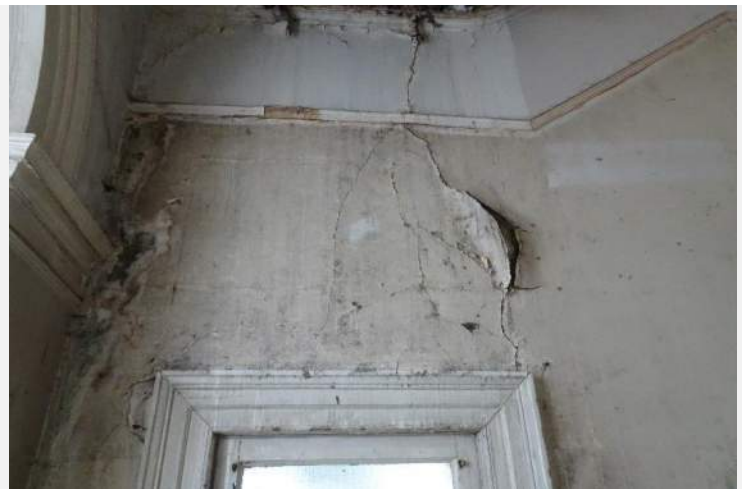
**02A-04**  
Large cracks in wall  
finishes

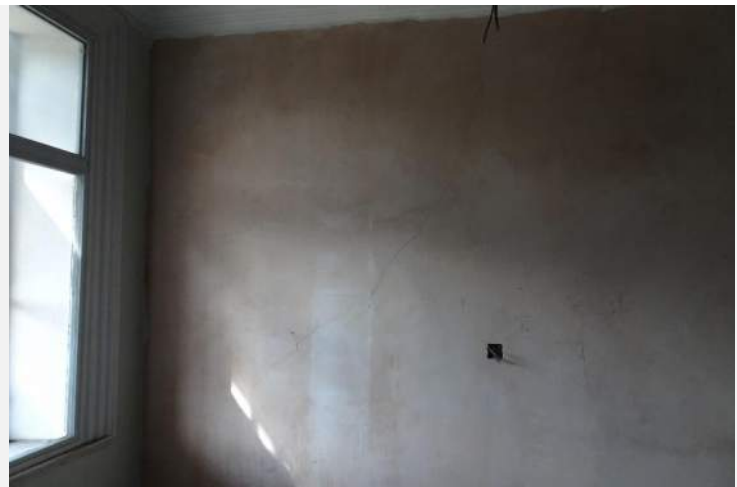
**02A-06  
Diagonal hairline cracks  
in plaster finishes**

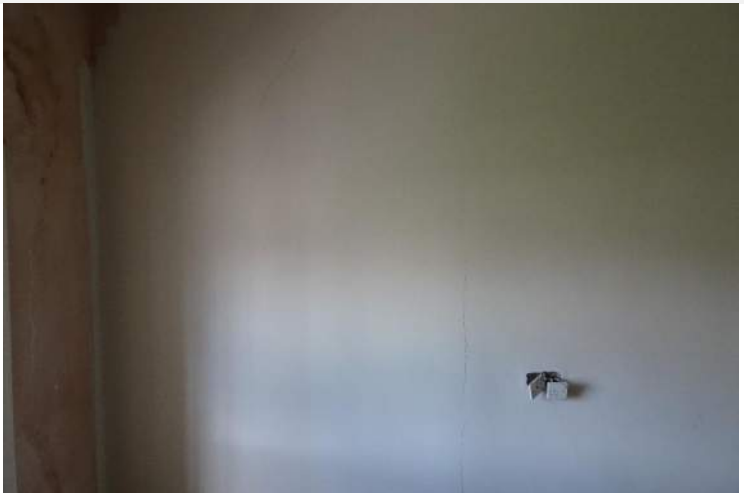
**03A-01  
Vertical crack in plaster  
finish**

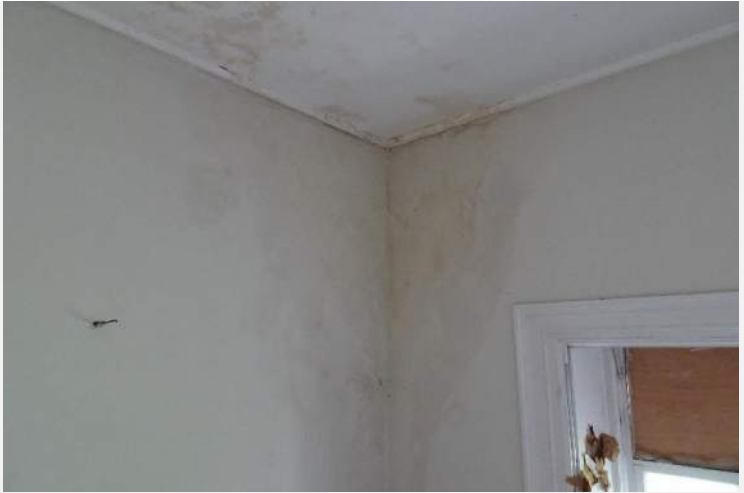
**03A-01  
Damp in exterior wall  
finishes**

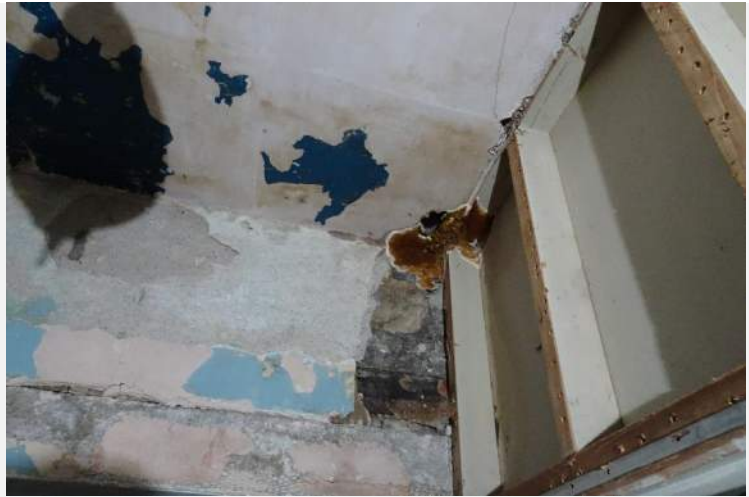
**03A-02**  
**Dry rot and water**  
**ingress in corridor**

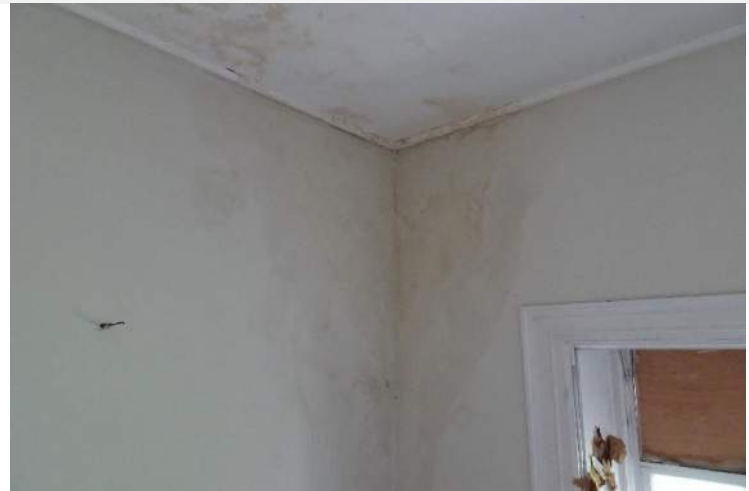
**03A-03**  
**Damp in exterior wall**  
**finishes**

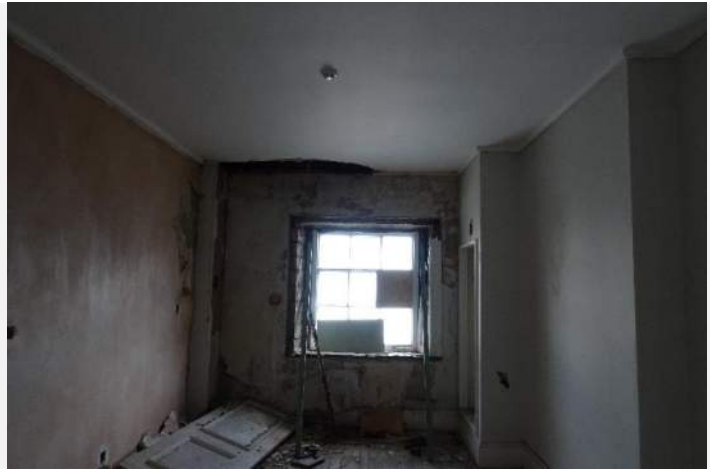
**03A-06**  
**Failed finishes in corner**  
**of room adjacent to stair**  
**core**

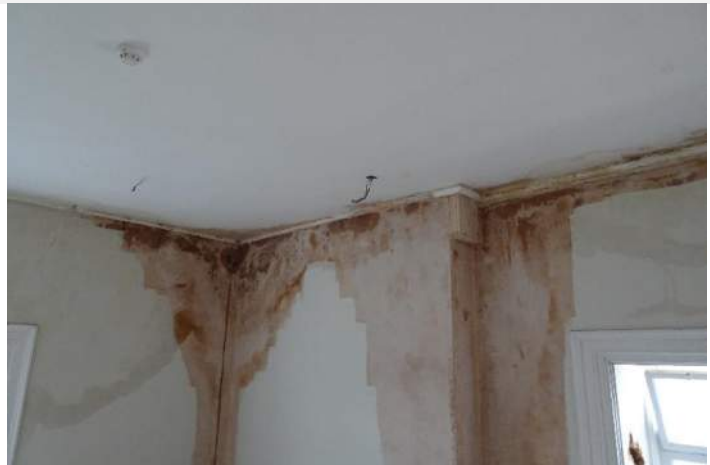
**03A-07**  
**Damps patches in ceiling**  
**and wall finishes at high**  
**level**

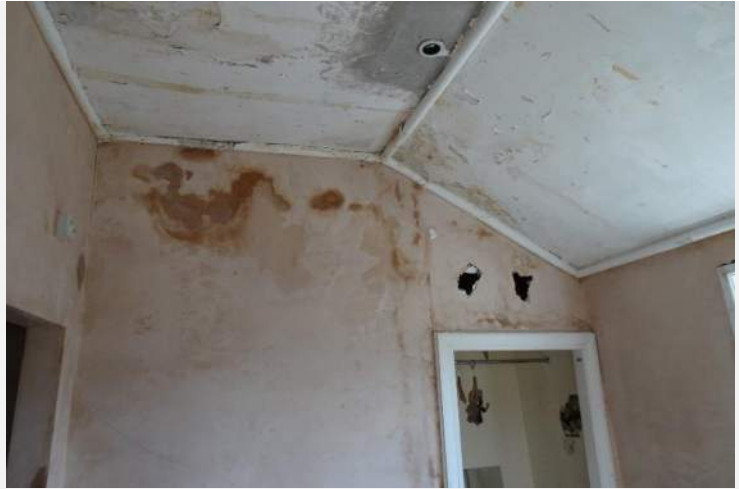
**04A-01**  
Damp internal partition

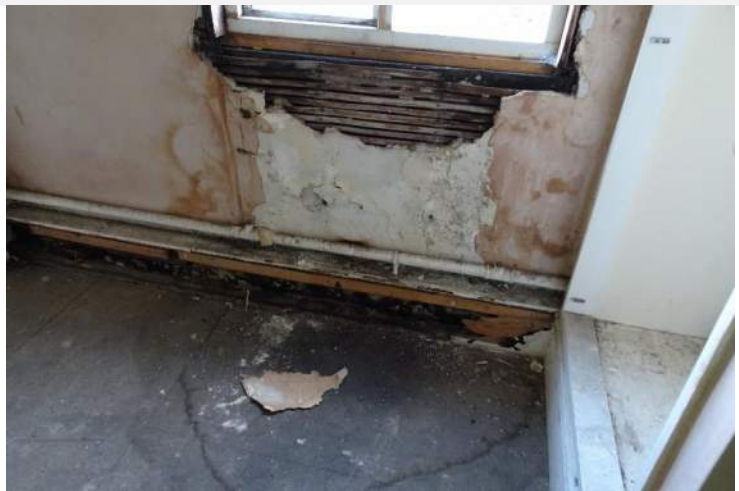
**04A-01**  
Collapsed plaster finish  
by window opening

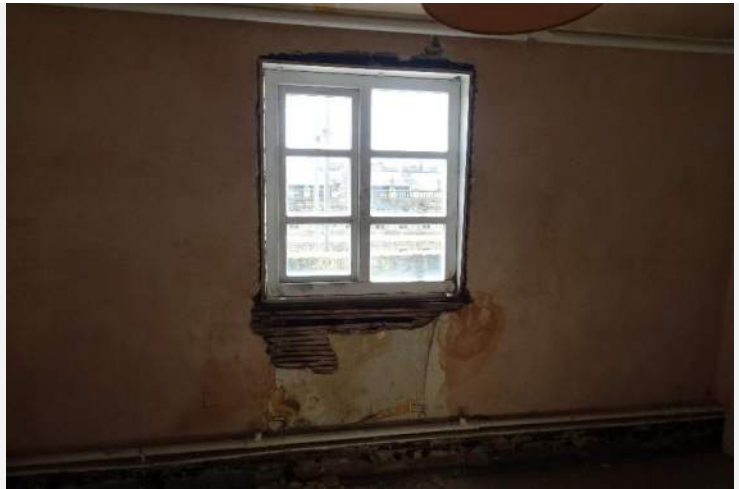
**04A-02**  
Collapsed plaster finish  
by window opening

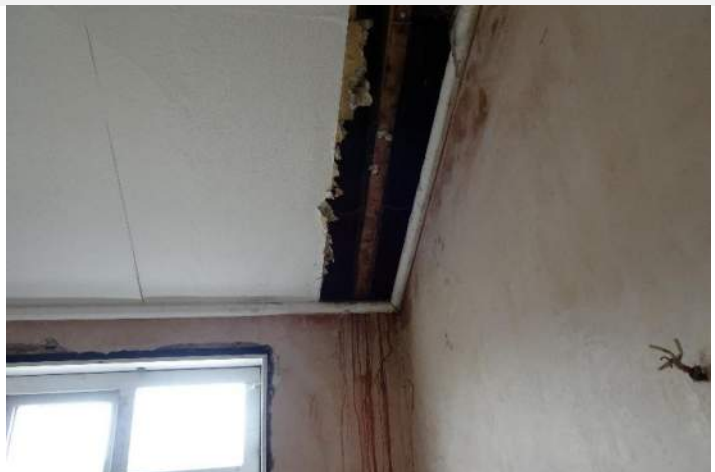
**04A-05**  
**Water ingress and failed plaster finishes**

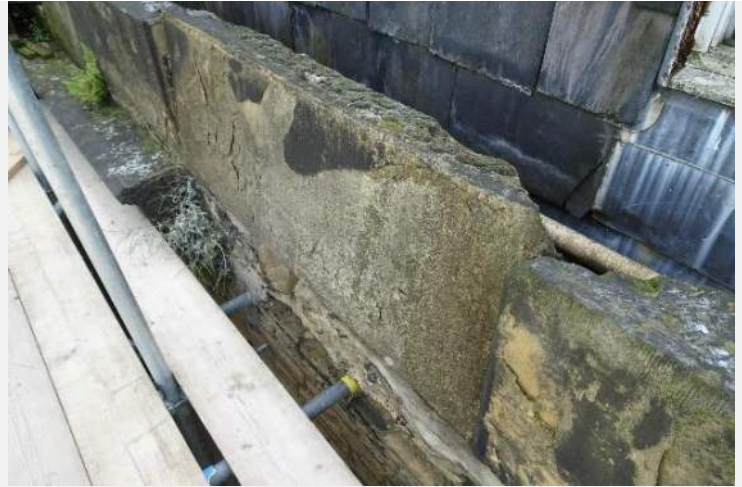
Some exposed high level stone parapets showing signs of delamination due to the bedding of the stone and also cracking/deterioration probably due to corroded fixings.

**Unrestrained parapet stone**

Now that the external perimeter is fully accessible it would be recommended to Ferrosan the parapets, to identify any ferrous dowels/cramps in the stonework between parapets, and between the parapet and wall below. If there are ferrous dowels, and deterioration and/or delamination in some of these stones, it is likely that water may penetrate through and corrode the dowels, which in turn can split the stone. A detailed stone by stone survey may be required to identify which parapet stones are adequate, which may require an in-situ repair and which may require replacement

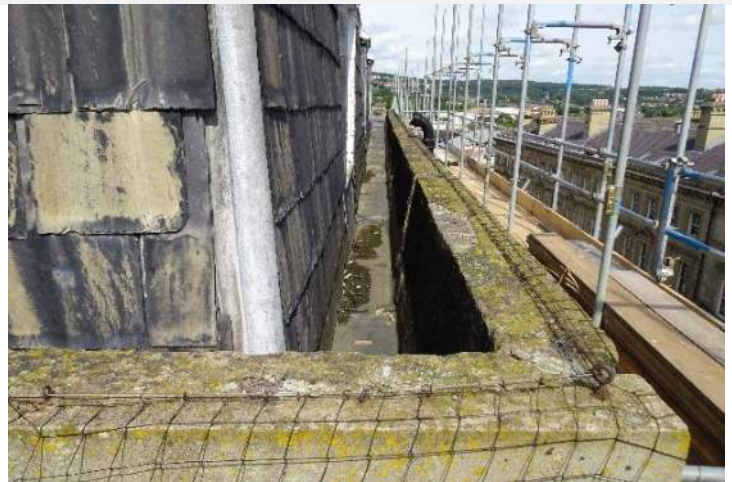
**Drainage gutter on southern facade**

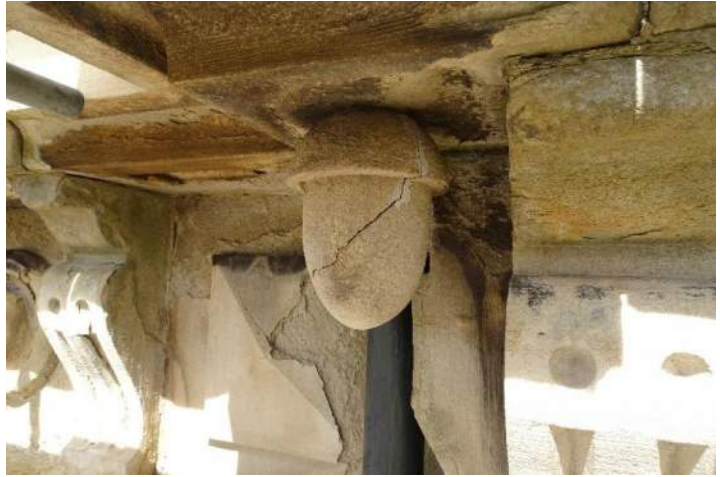
**Stonework detailing  
deterioration**

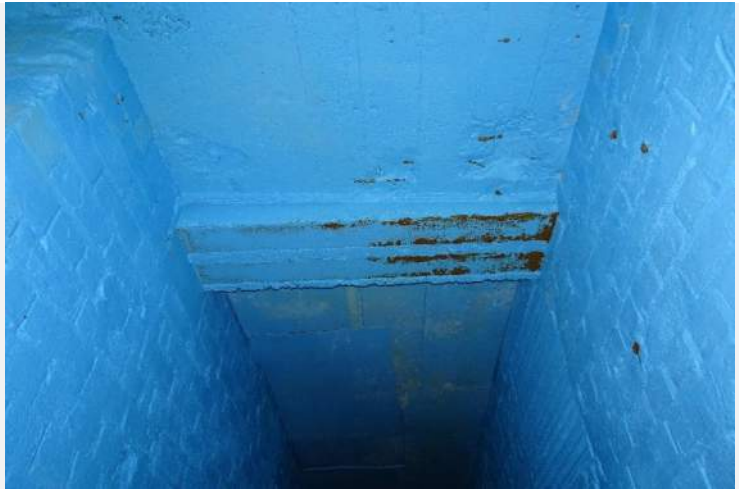
**99B-03**  
**Steel/cast iron beam**  
**showing signs of**  
**corrosion**

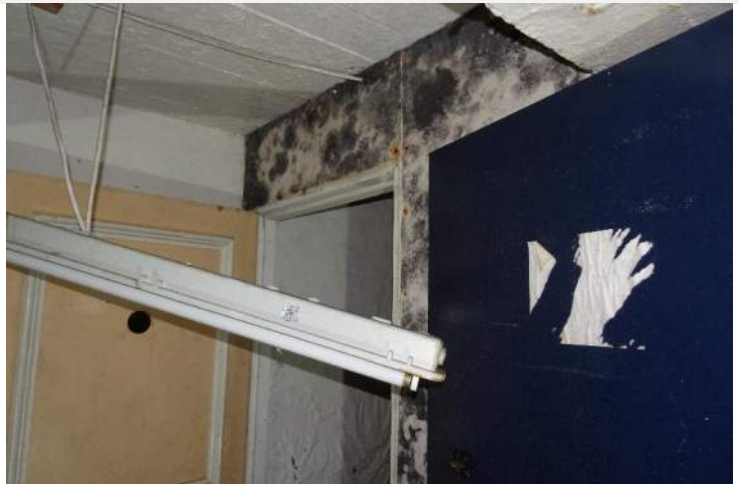
**99B-03**  
**Mould growth in**  
**cupboard space**

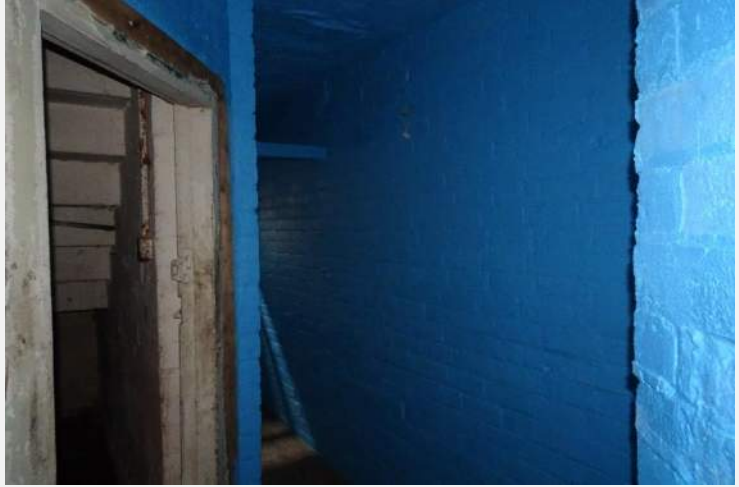
**99B-04**  
**General Photograph of**  
**space**

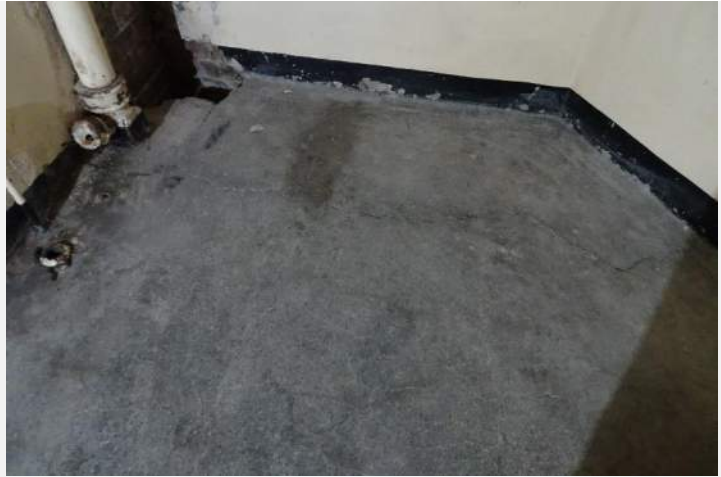
**00B-01**  
**Cracked slab adjacent to existing hole**

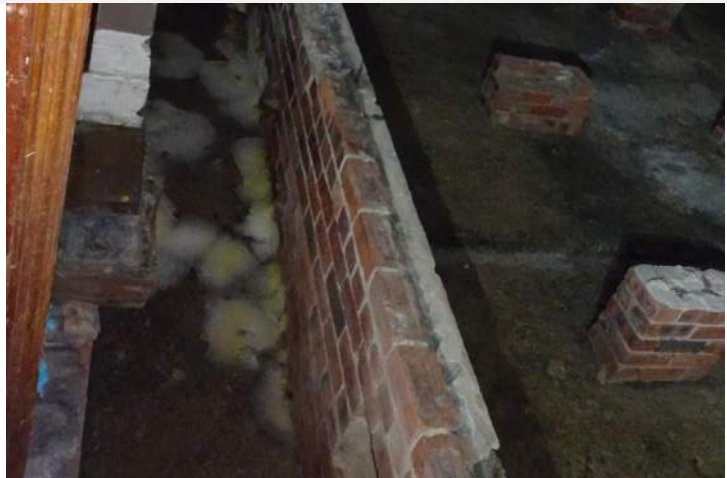
**00B-02**  
**Mould growth**

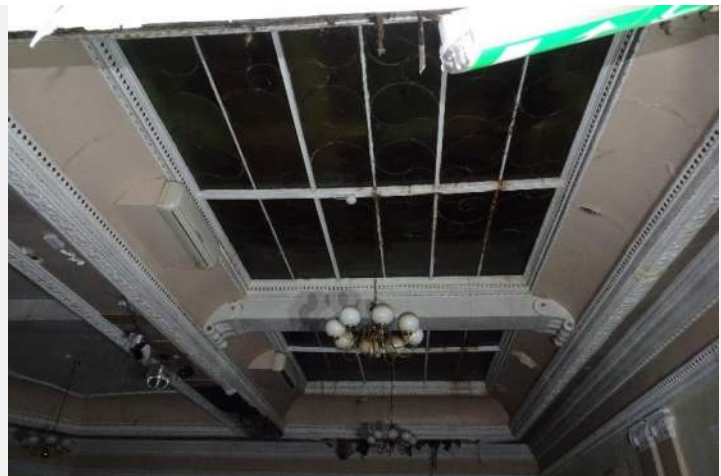
**00B-02**  
**Ceiling finishes partially collapsed**

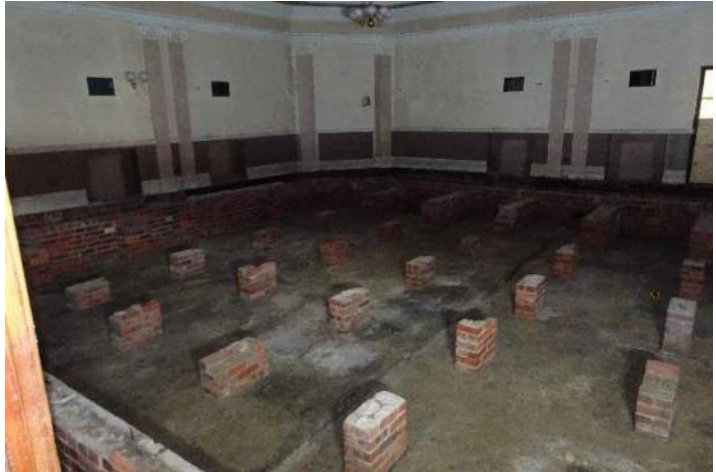
**00B-02  
Remnant floor structure**

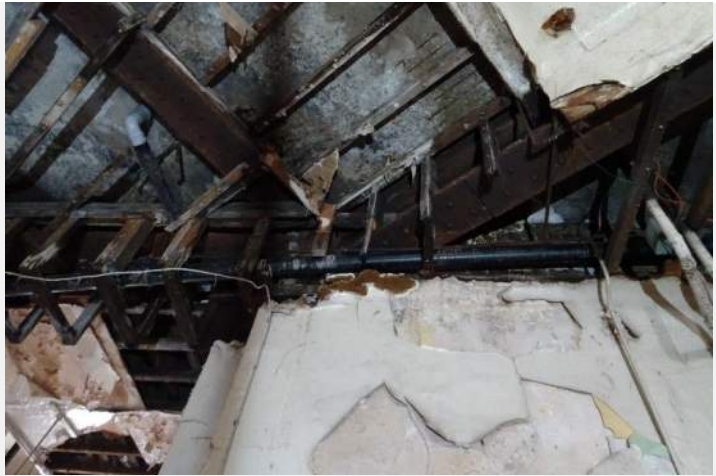
**00B-03  
Concrete slab rebar visible above, plaster finishes collapsed, and steel beams exposed**

Areas were noted throughout the building of exposed reinforcement in concrete slabs (as generally indicated on the plans in appendix A). It is recommended that to check the extent of corrosion a tap test is undertaken in all areas of exposed reinforcement and a suitable remedial concrete repair is completed to protect the reinforcement. (as described in section 7.2)

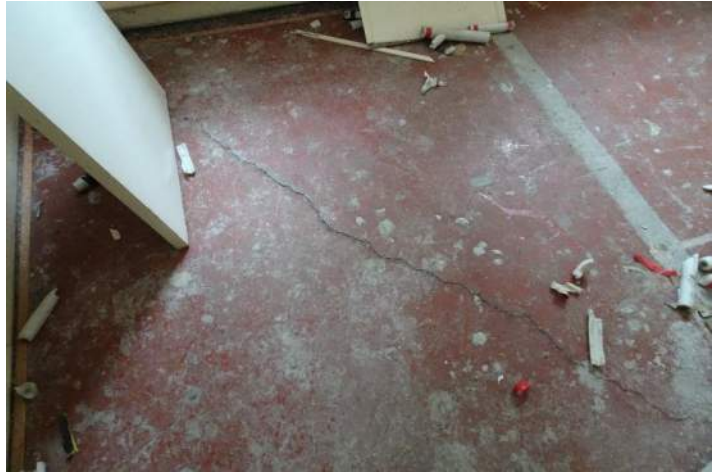
**01B-01**  
**Fine crack in floor,**  
**possibly just screed**  
**finish**

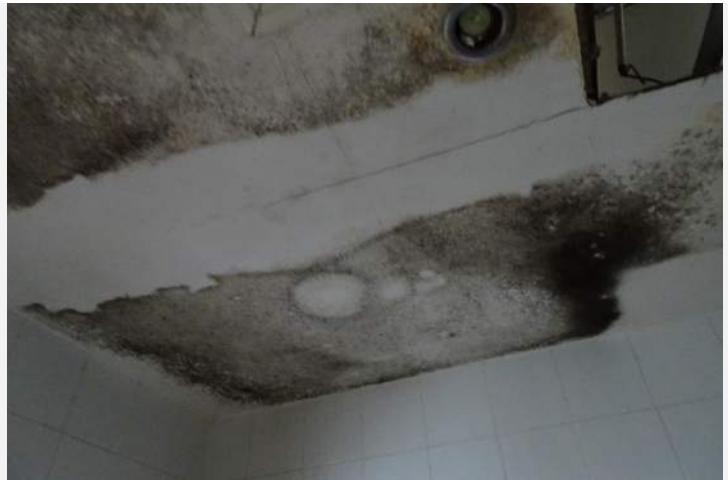
**01B-02**  
**Mould growth**

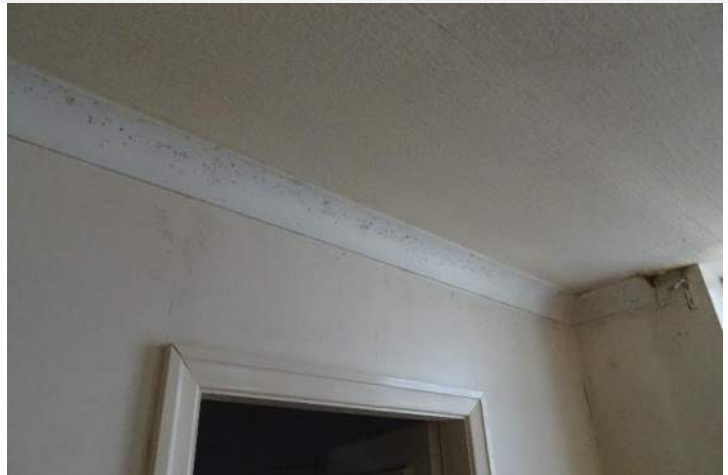
**01B-02**  
**Mould growth**

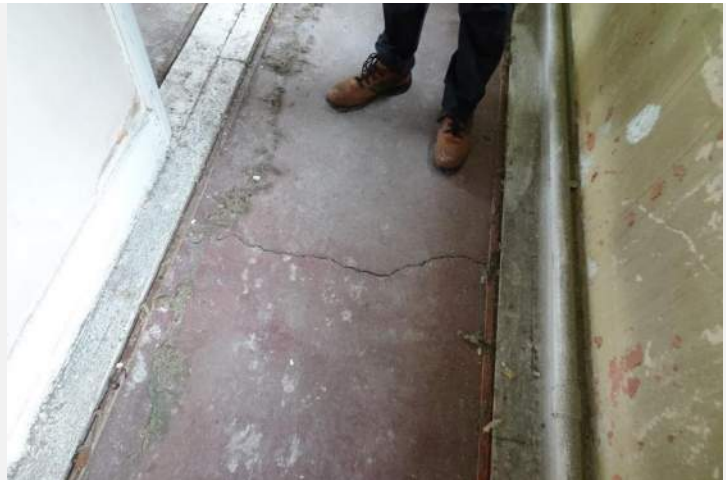
**02B-02  
Large rack in presumed  
screed**

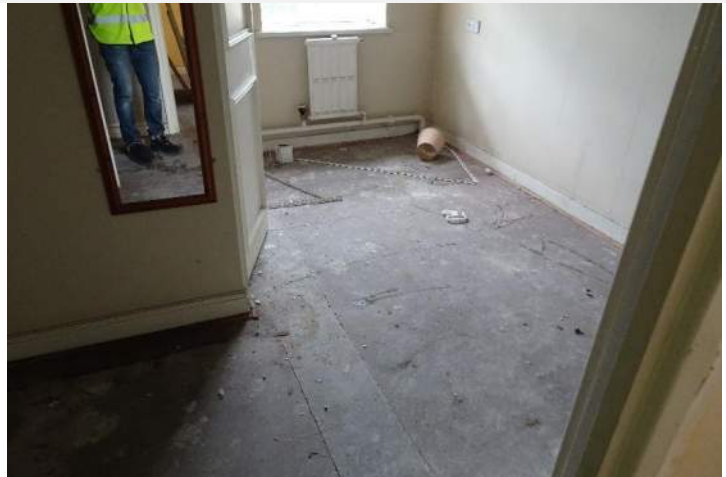
**02B-02  
Beam visible with screed**

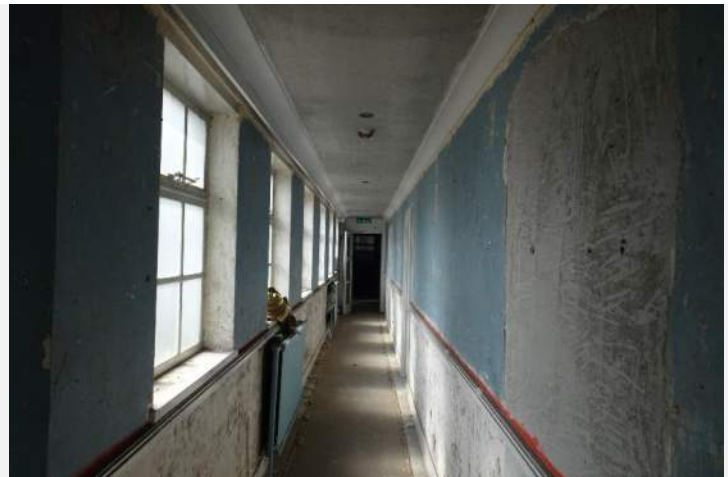
**03B-02  
Corridor general  
photograph**

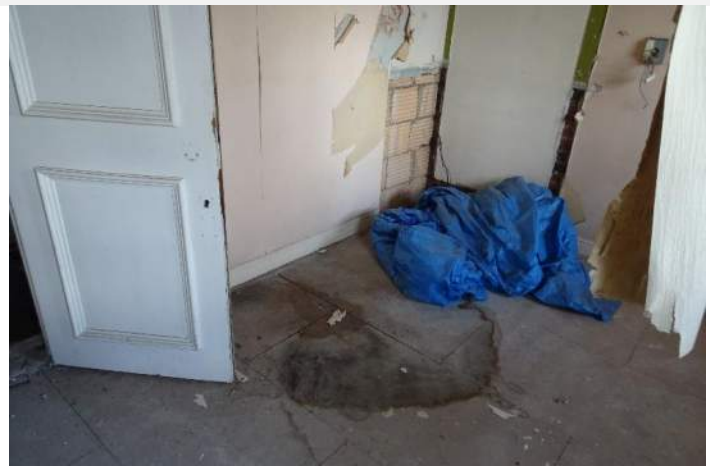
**03B-02  
Historic water ingress**

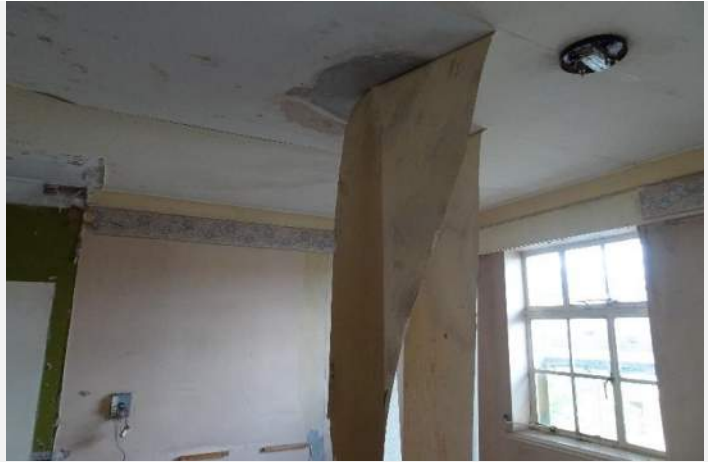
**03B-02**  
**Ceiling finishes peeling**

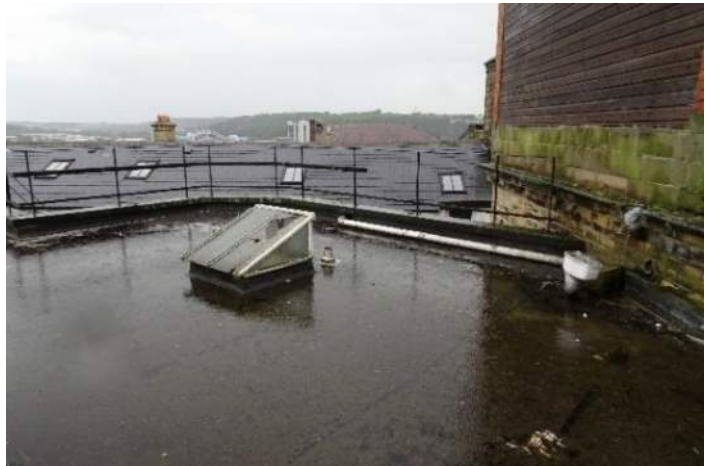
**Ponding Water adjacent to Block A**

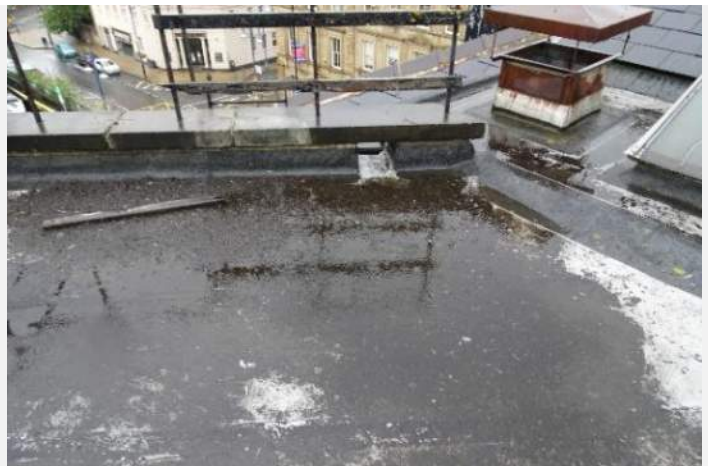
**Ponding water at northern extent of roof**

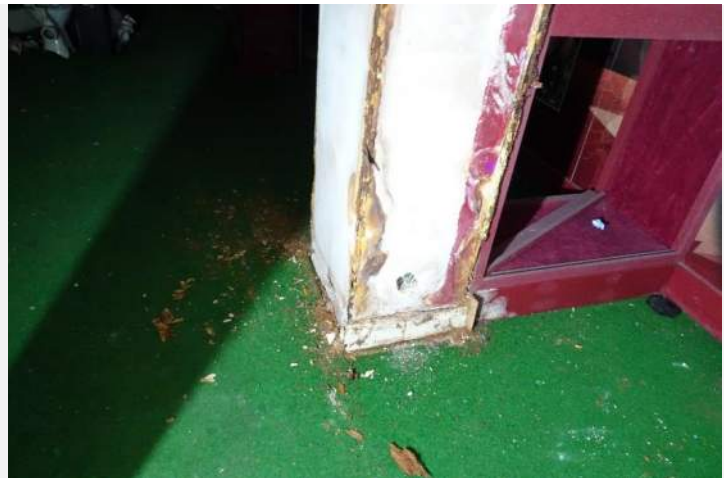
### 99C-01 Rising Damp on columns

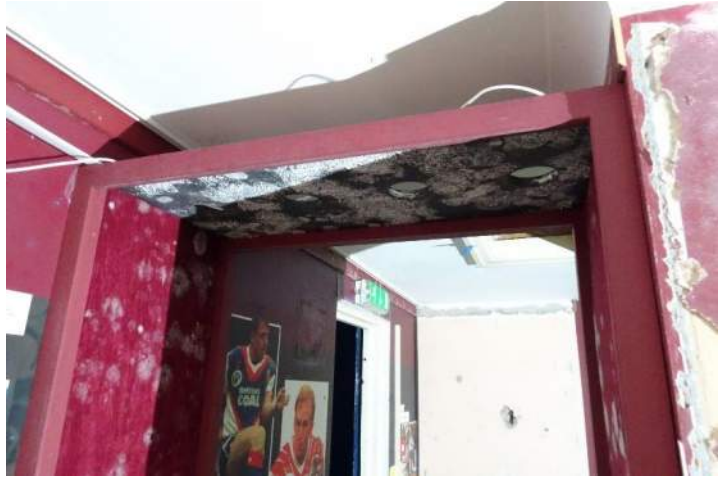
**99C-01**  
**Mould growth**

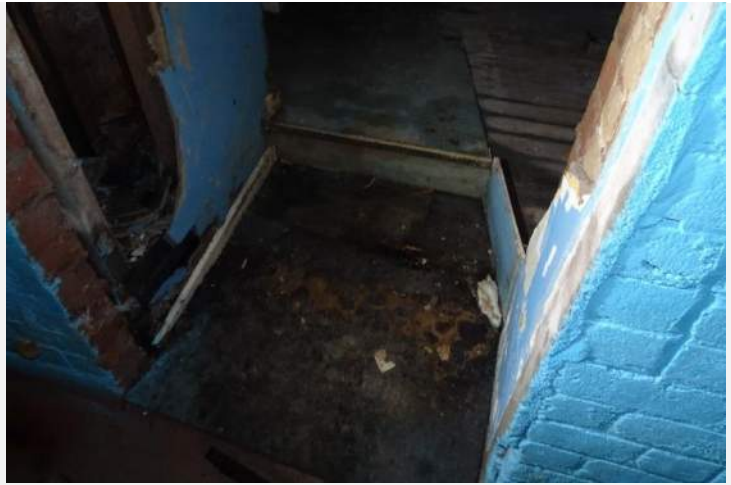
**99C-02**  
**Damp floor**

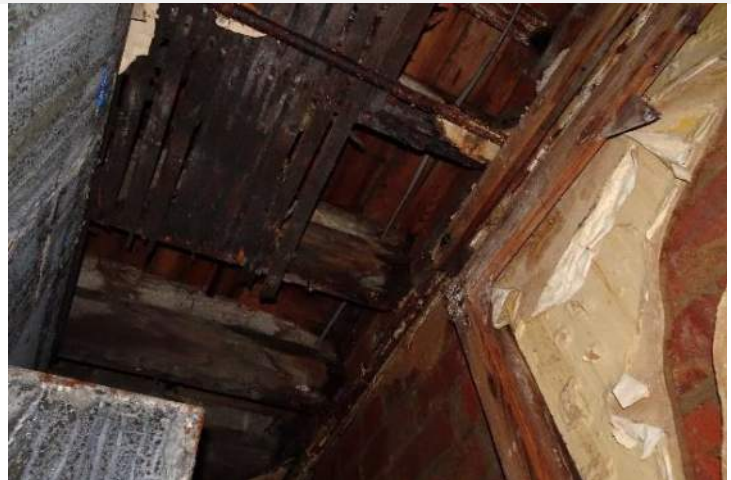
**99C-02**  
**Damp floor structure above and collapsed finishes**

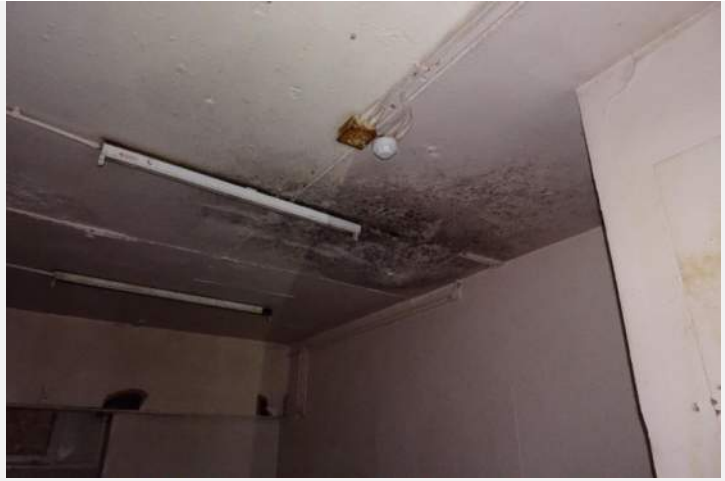
**99C-03**  
**Sagging ceiling finishes**

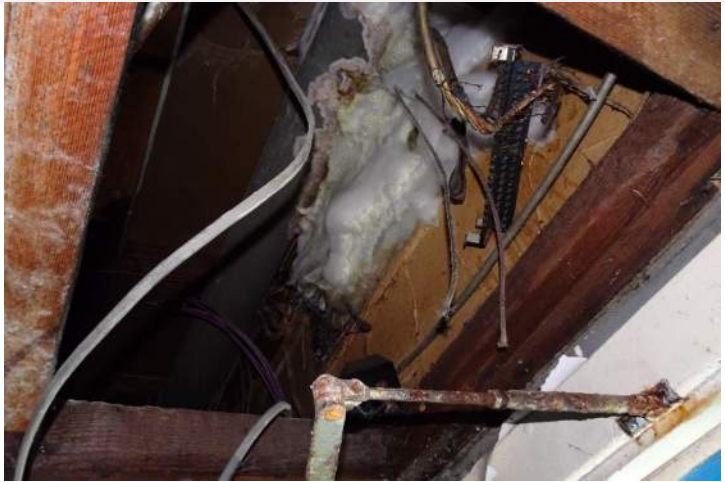
**99C-03**  
**Large mould growth in ceiling cavity**

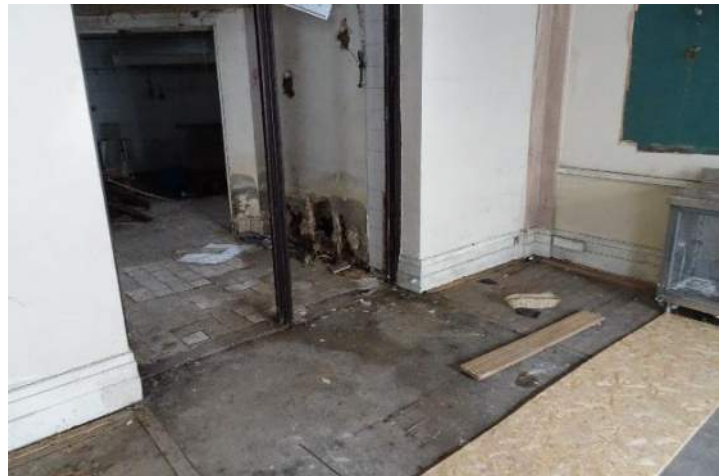
**3.2 Ground Floor**  
**00C-01**  
**Damp area to north of space, adjacent to Block C**

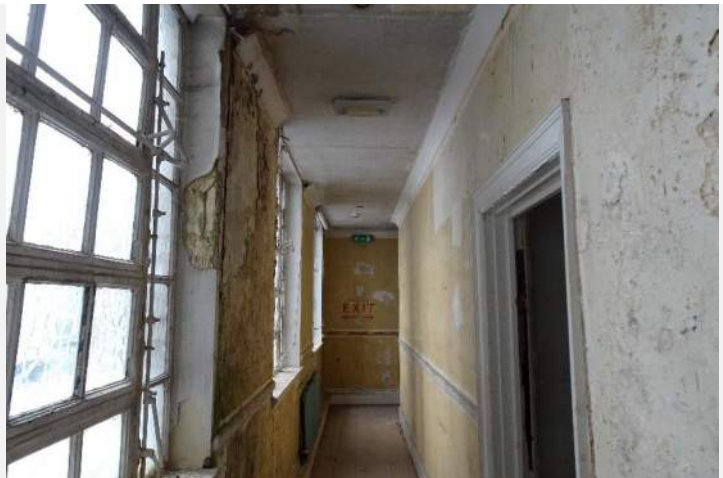
**01C-01**  
**Peeled finishes and staining**

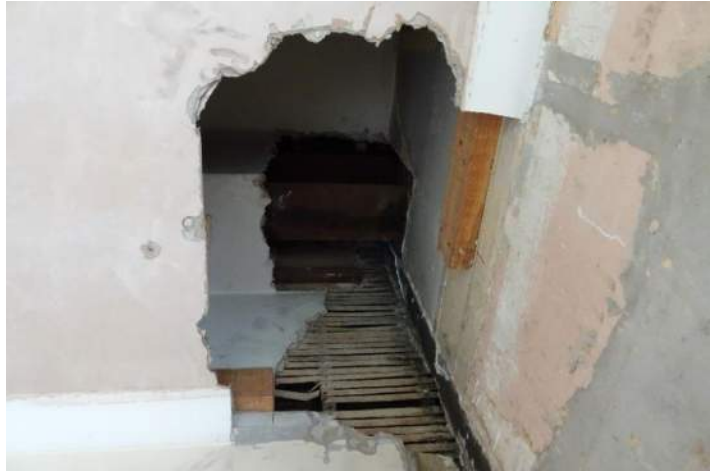
**01C-02**  
**Steel beam in ceiling**  
**above**

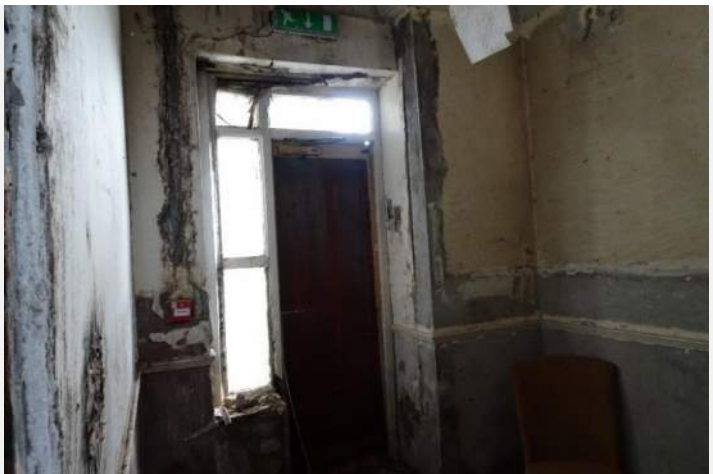
**01C-03**  
**Significant water ingress and cracking of finishes at end of corridor doorway**

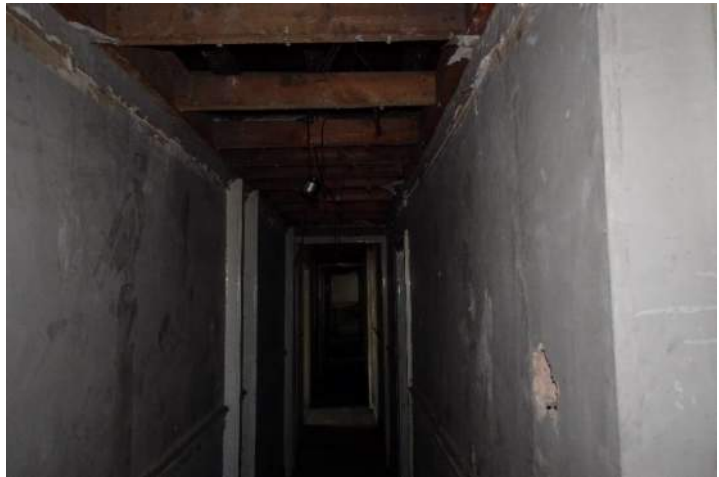
**02C-01**  
Tie rods in corridor  
space

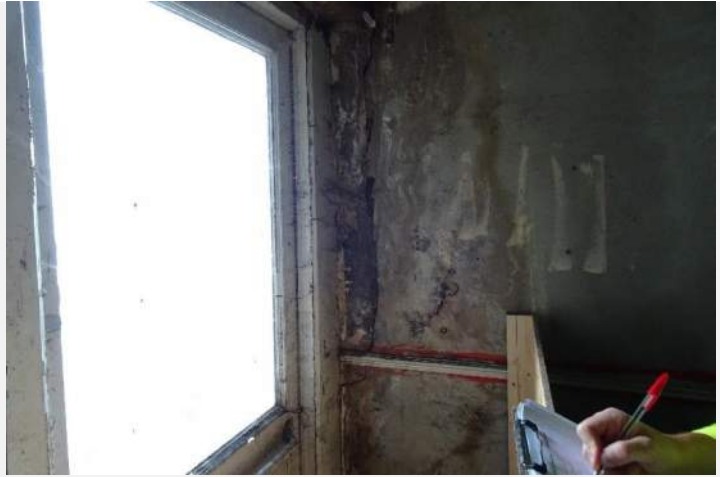
**02C-01**  
**Water ingress, staining and cracks adjacent to internal courtyard door.**

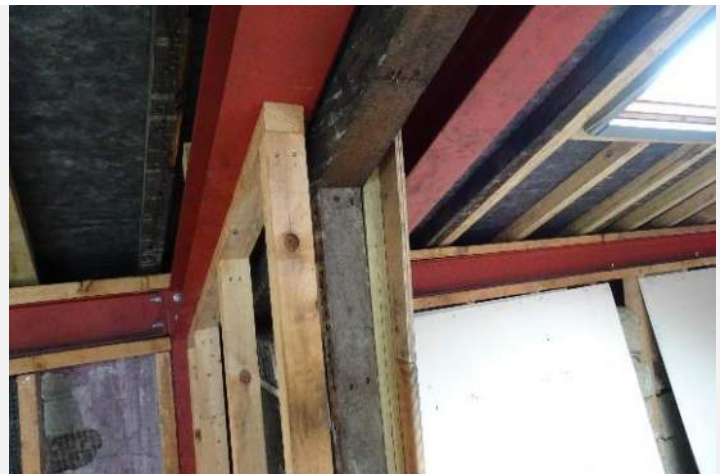
The stability and robustness of the new roof structure in Block C is unknown and suspected to be insufficient due to limited connections between the purlins and the timber joists. It is recommended that a more detailed structural review is completed to identify any required remedial works. It is also recommended to check if the Building Regulation submission for the Block C roof amendments/strengthening is available so the original design intent can be understood.

**03C-01**  
**Internal double structure around existing trusses**

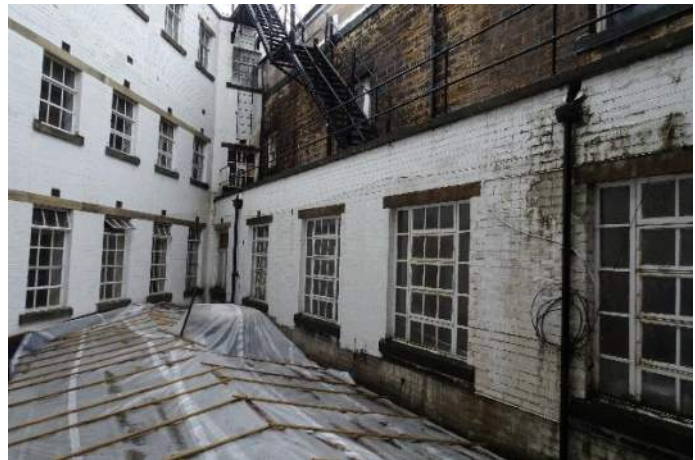
**West and east facade  
General photograph –  
paint finish peeling from  
masonry on eastern  
facade**

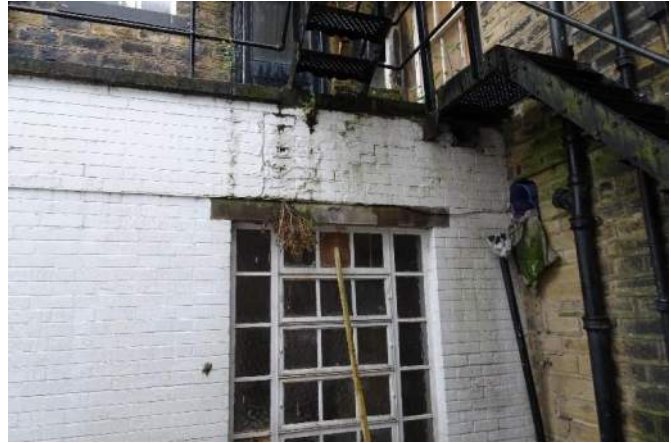
**Eastern Elevation**  
Vegetation and algal growth in damp areas, some cracks forming in masonry mortar joints

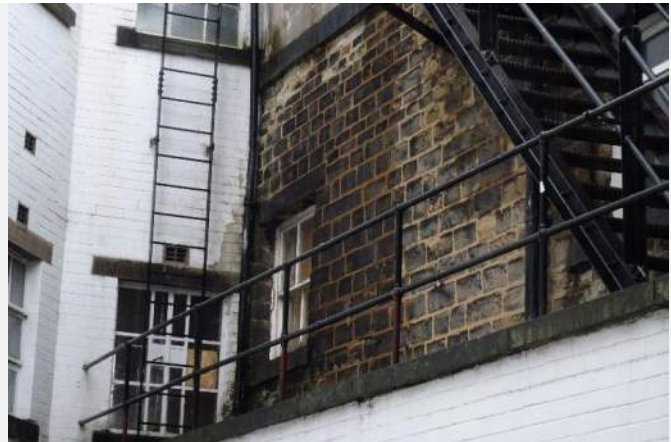
**Eastern Elevation**  
Damp external wall on eastern elevation

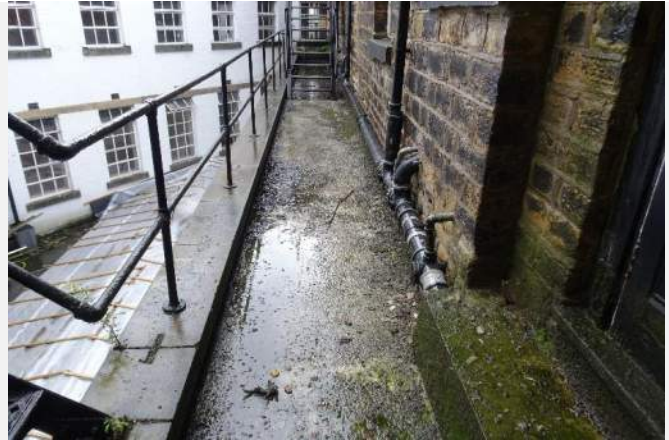
**Eastern Elevation**  
**Water pooling on flat roof**

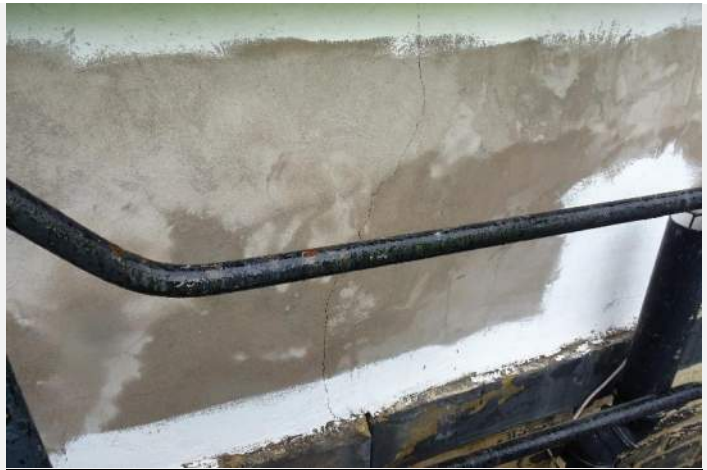
**Eastern Elevation**  
**Hairline crack in plaster finish**
