**FIELD HOUSE 15 WELLINGTON ROAD DEWSBURY WF13 1HF**

- 1.2 The site inspection was carried out on Monday 22 January 2024. The weather was dry, cold and windy.
- 1.3 The survey and report (ref SC/3121) have been carried out for YMG Construction Ltd on instructions from Mr Y Patel.

- 1.4 This schedule of condition of the flagged areas has been produced by a surveyor who has written this report for you to use to assess the current condition of the stone flag paving and identify items of disrepair.

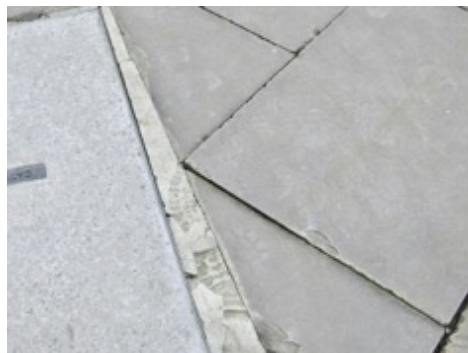
R2 – F3 (lipped and rocks)

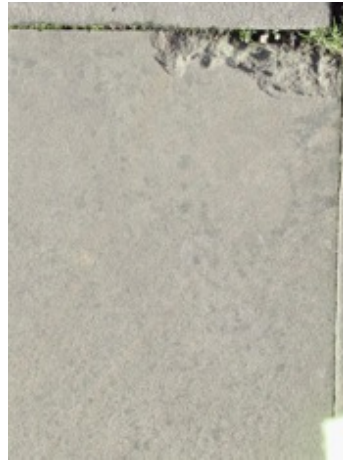
R15 – F2 Dropped

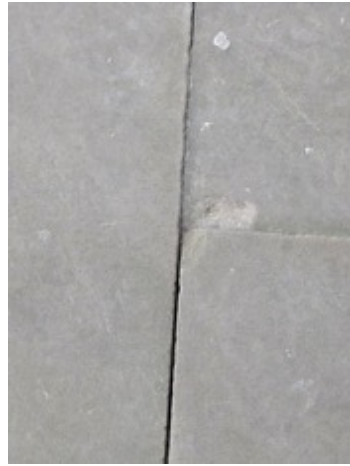
R29 – F4: Lipped
