**Appendix A  
Photograph Schedule**

Original School (1868)

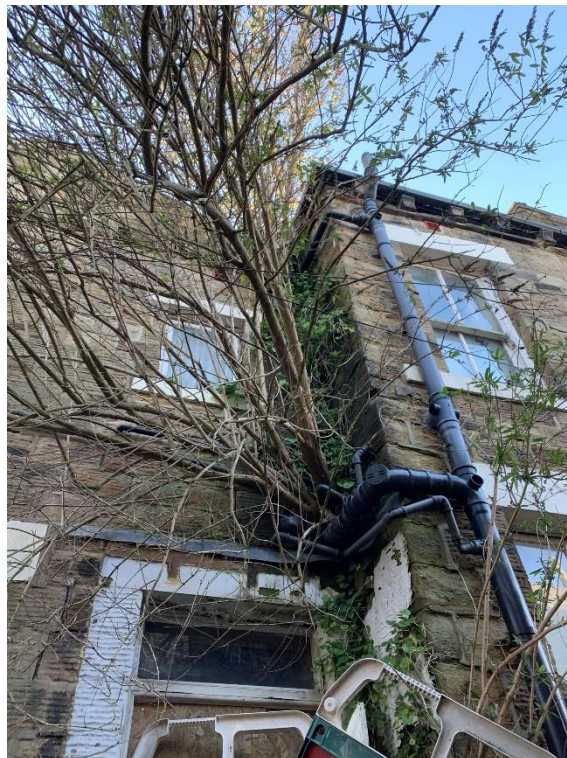
LH Side Elevation general

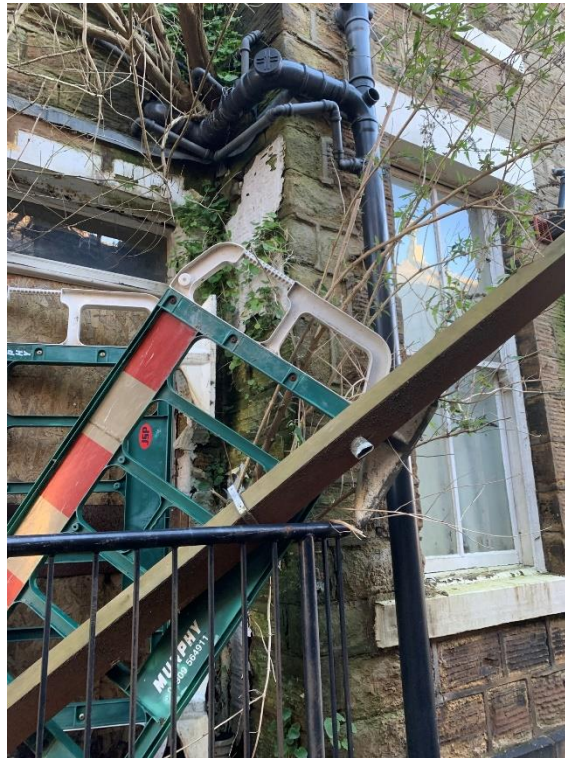
LH Side Elevation general

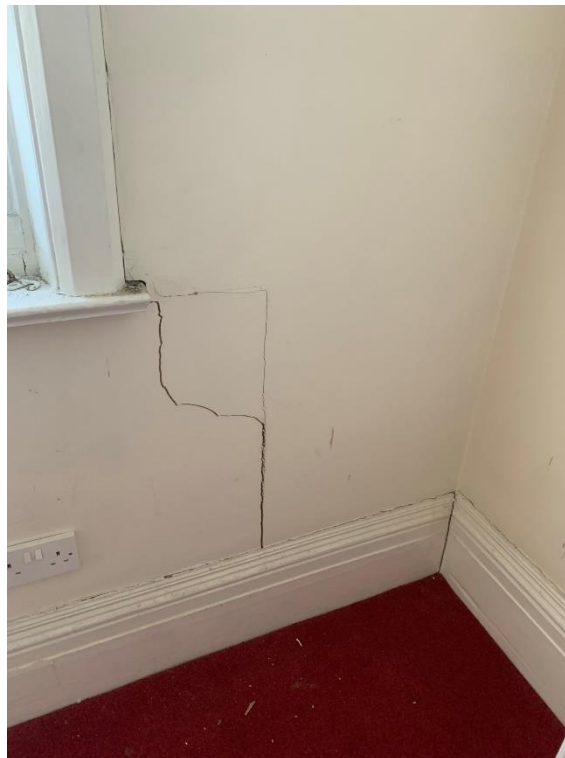
FF movement general

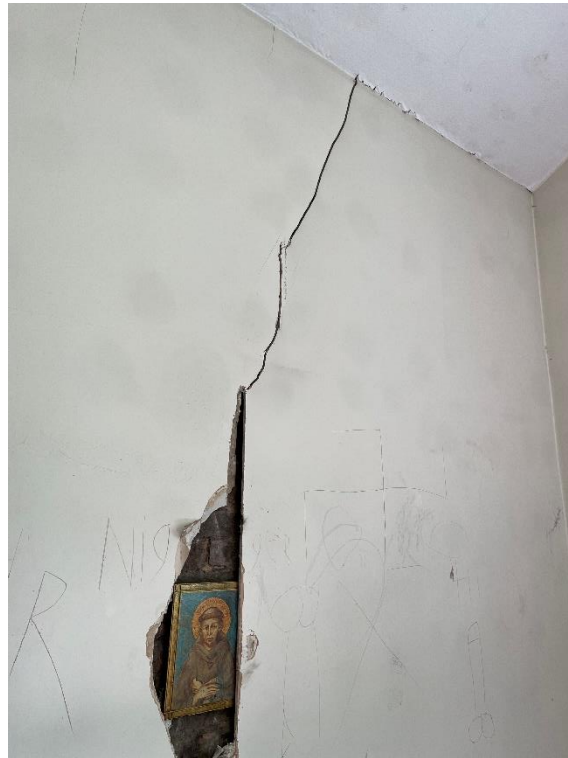
FF movement general
