**Appendix A
Photograph Schedule**

Original School (1868)

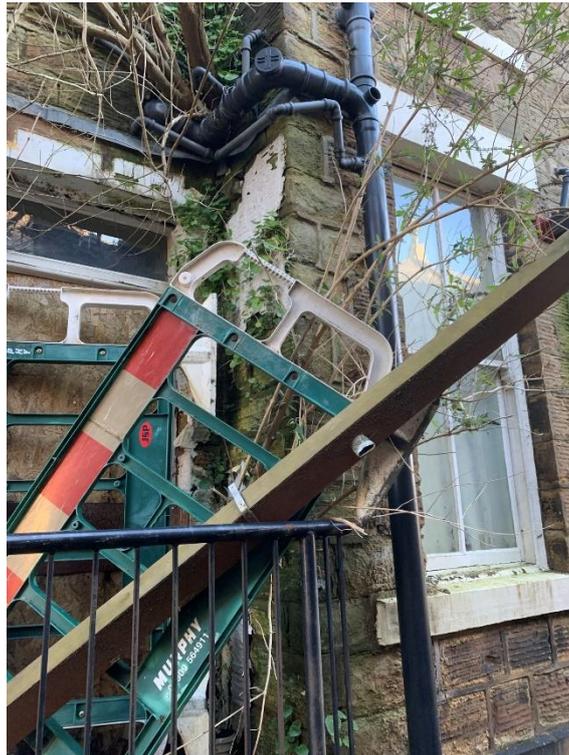
LH Side Elevation general

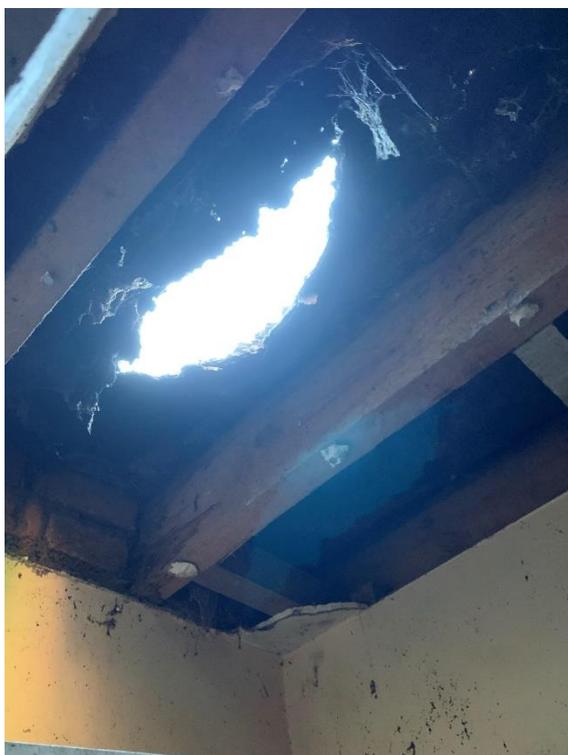
Roof collapse above toilets

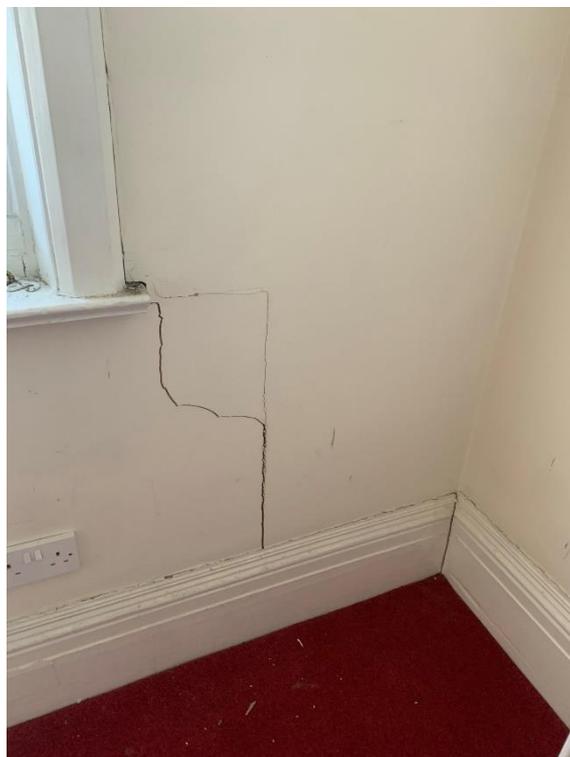
FF movement general

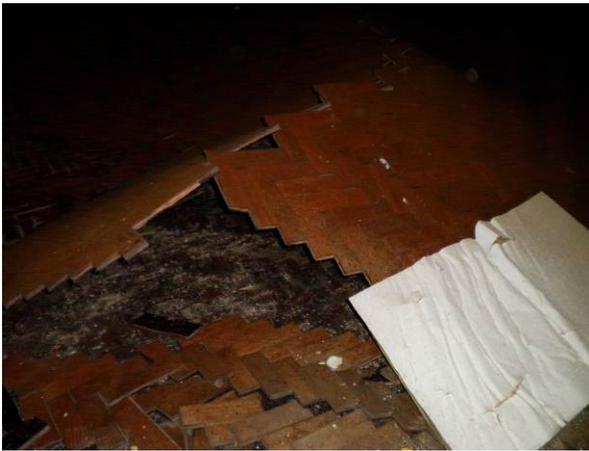
Photo 9
Swollen parquet flooring to main hall

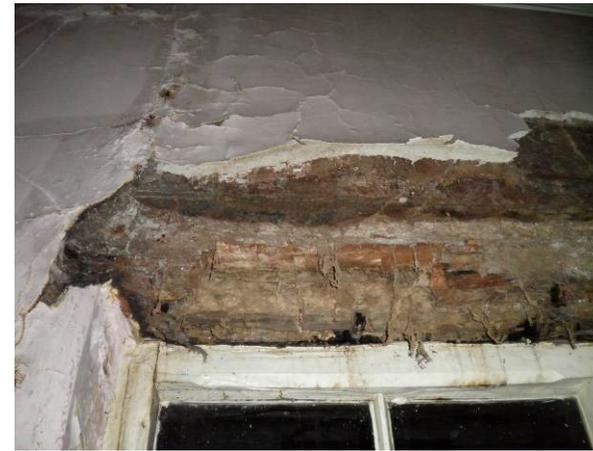
Photo 10
Rotten timber beam

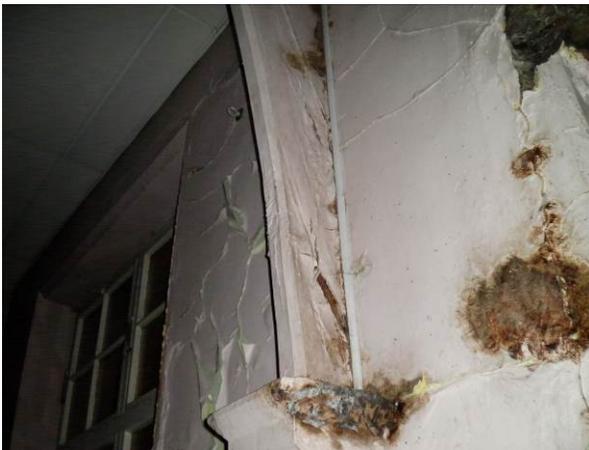
Photo 11
Rotten timber to truss member
