26 May 2023
BC.HUD.2016.00001.005/02

**St Mary's Convent (Nunnery), Batley
Condition Review Update 2023**

Condition Statement in Support of Listed Building and Conservation Area Consent St Mary's (Old) Catholic Primary School, Batley

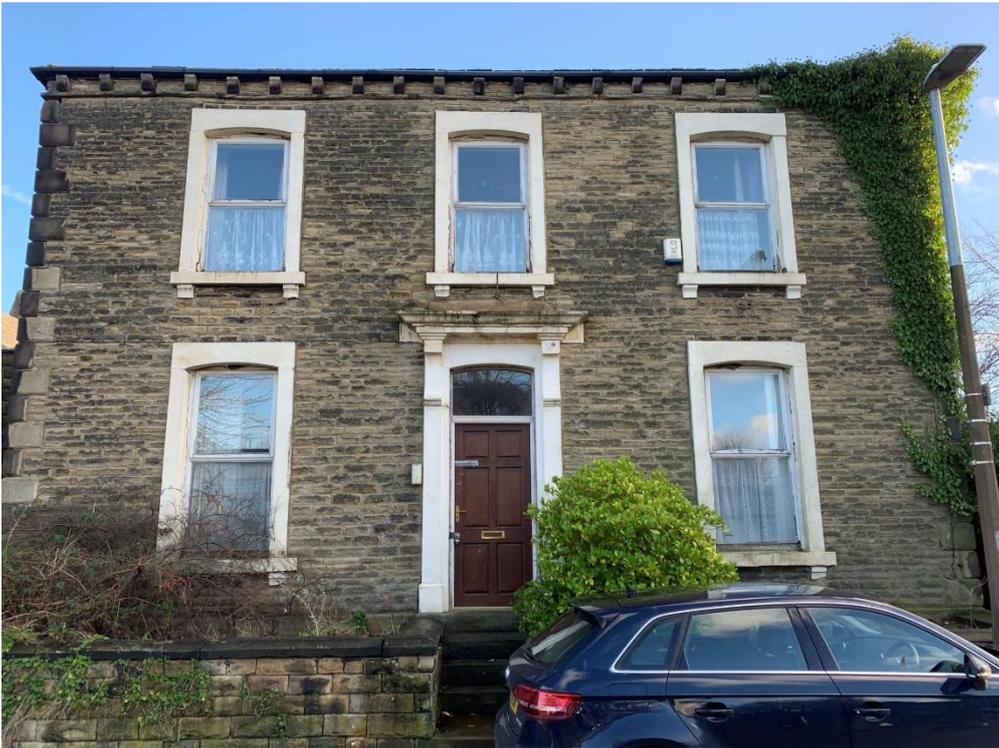
Front Elevation from Upton Street

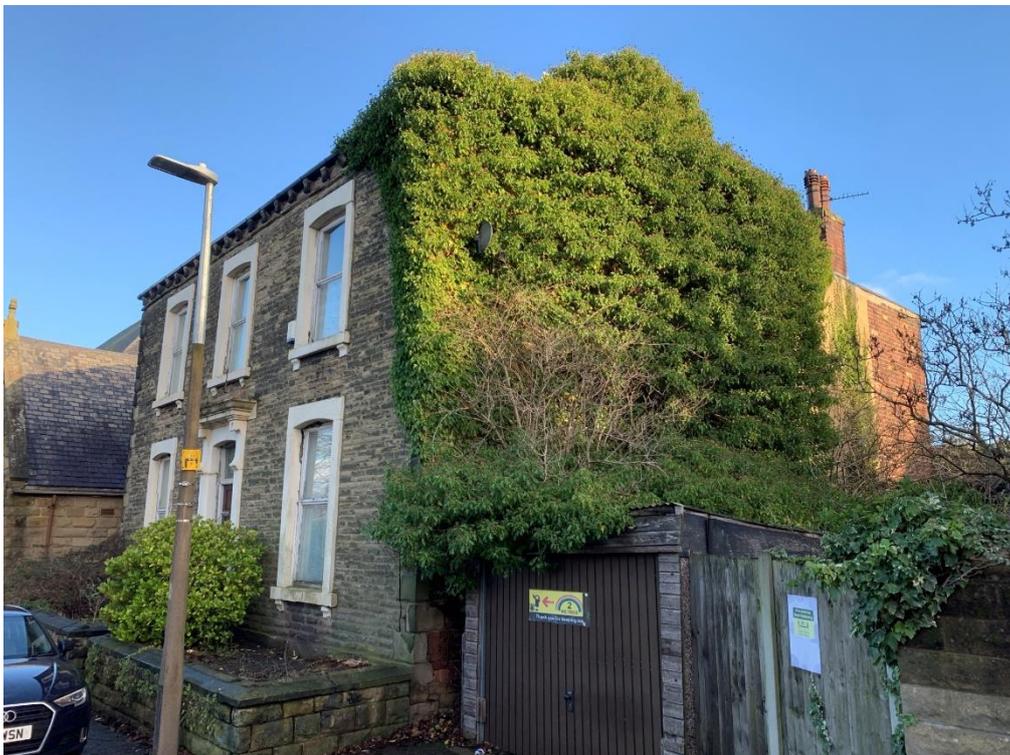
RH Side Elevation from Upton Street

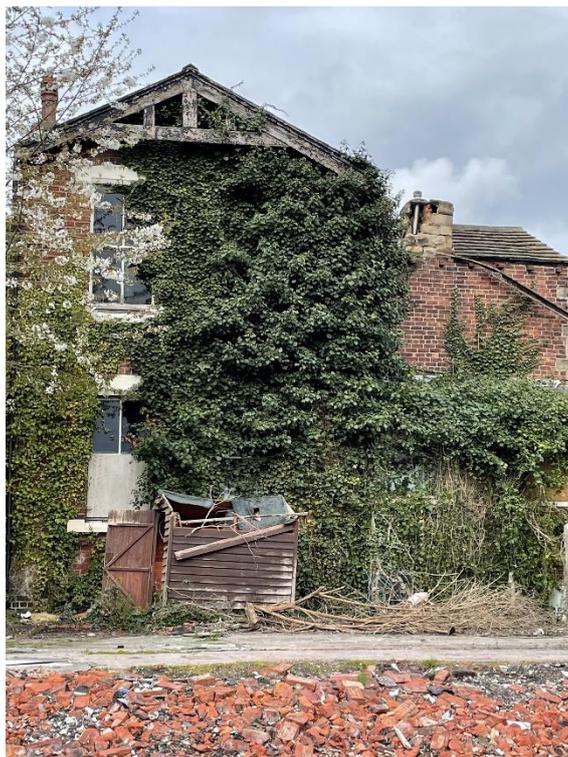
Rear Elevation

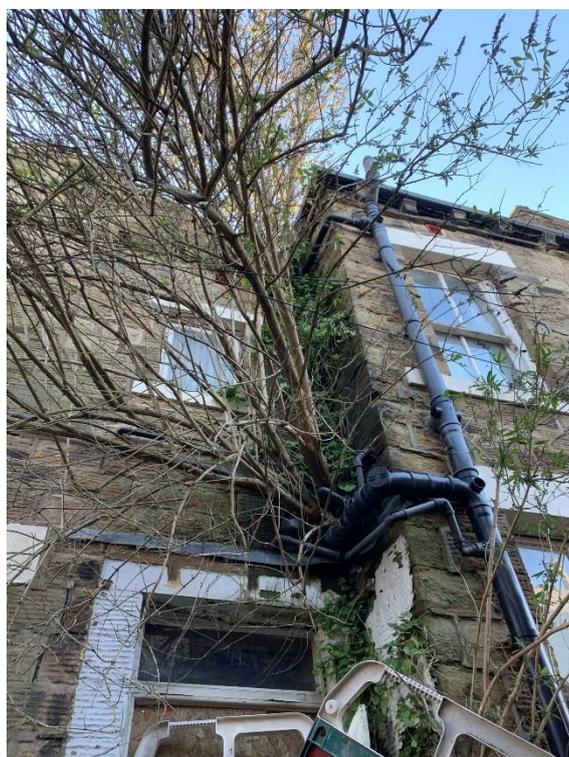
LH Side Elevation general

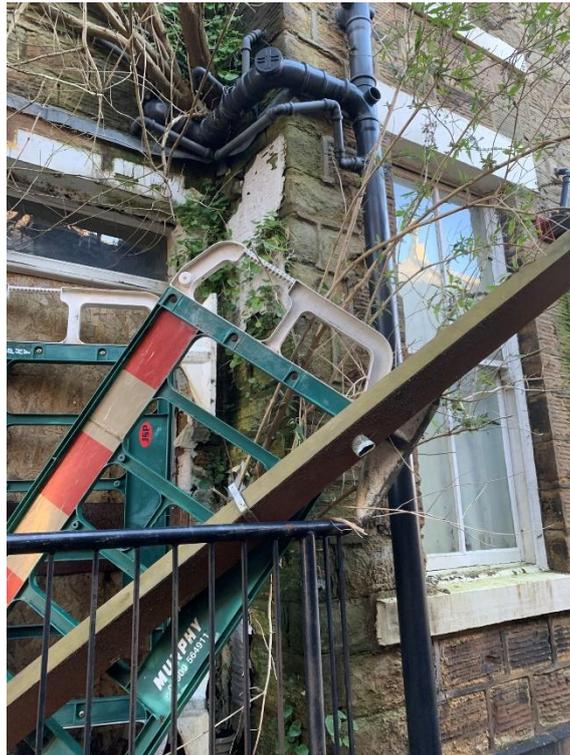
LH Side Elevation general

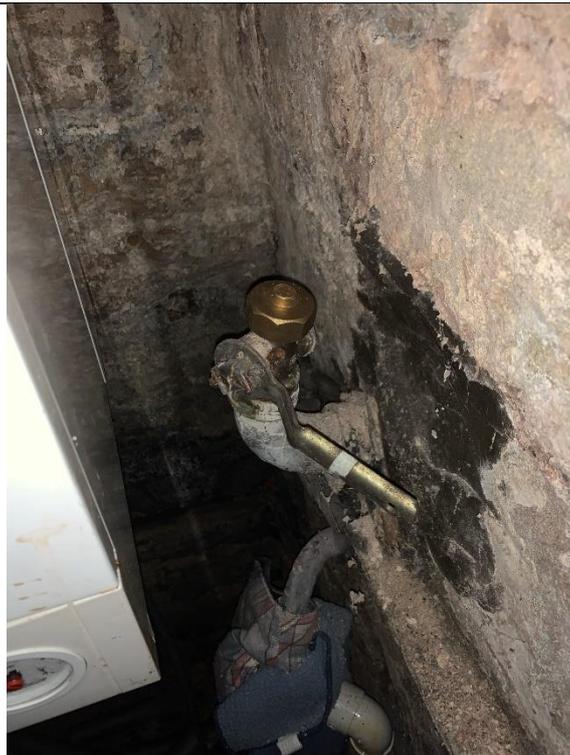
Gas meter removed

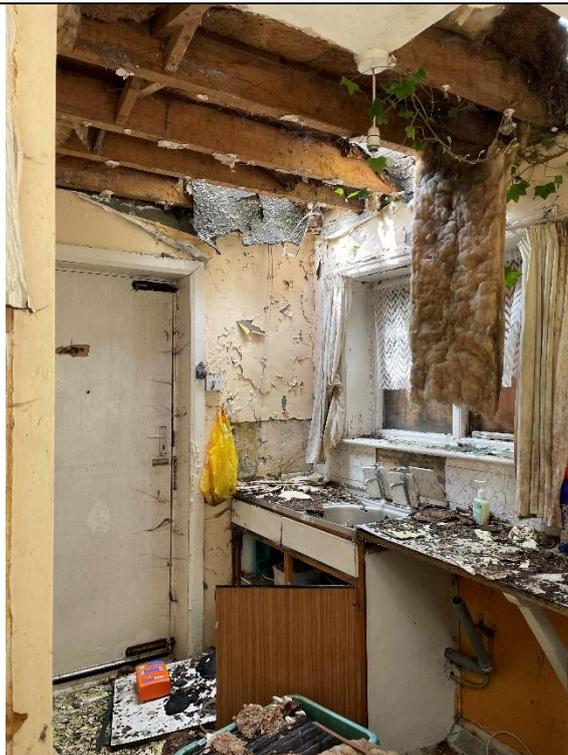
GF side kitchen – roof collapse above

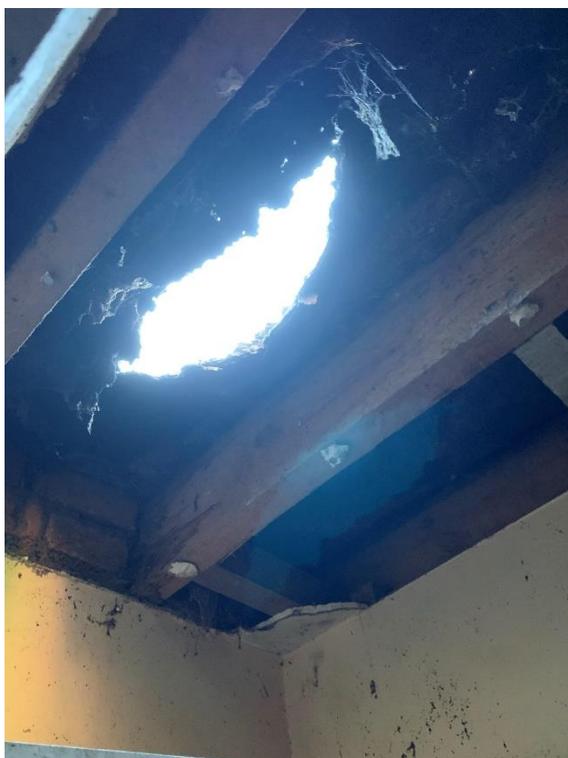
Roof collapse above toilets

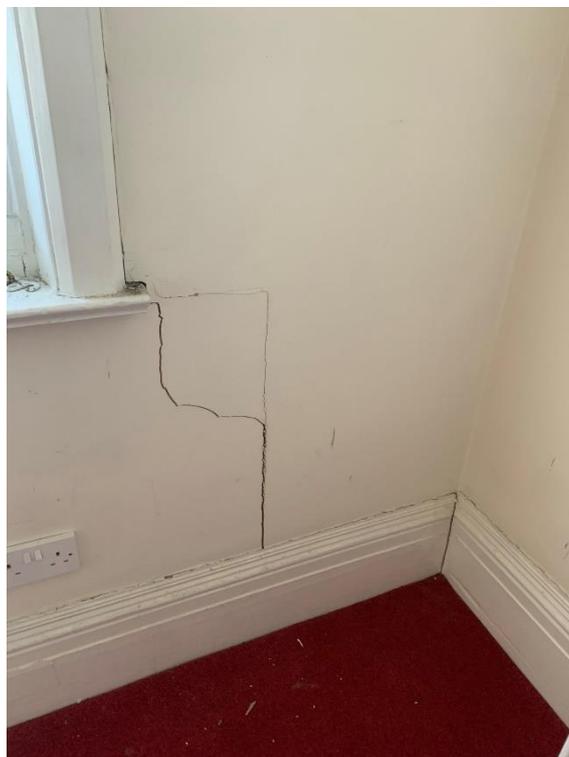
FF movement general

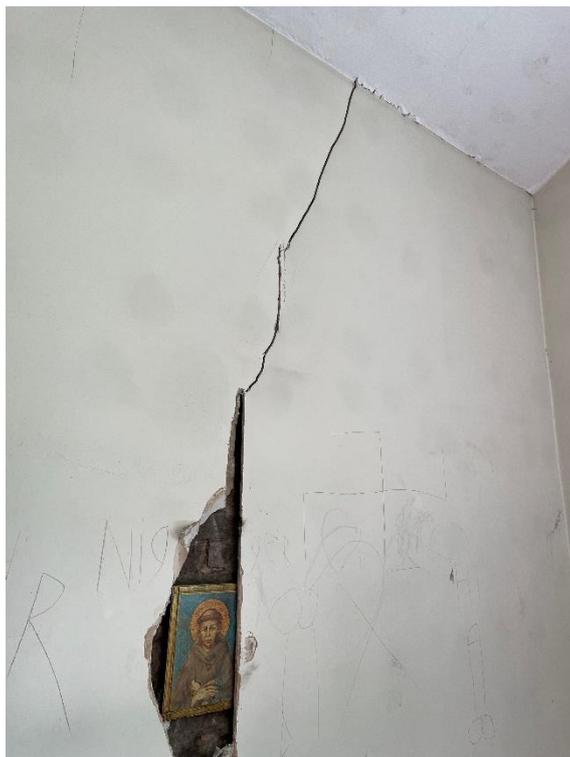
FF movement general

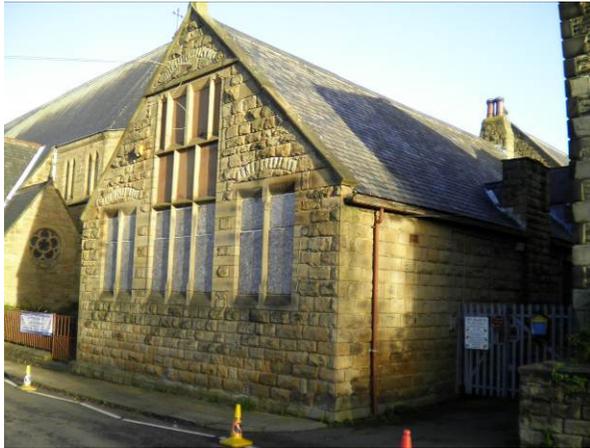
Photo 1
Front elevation

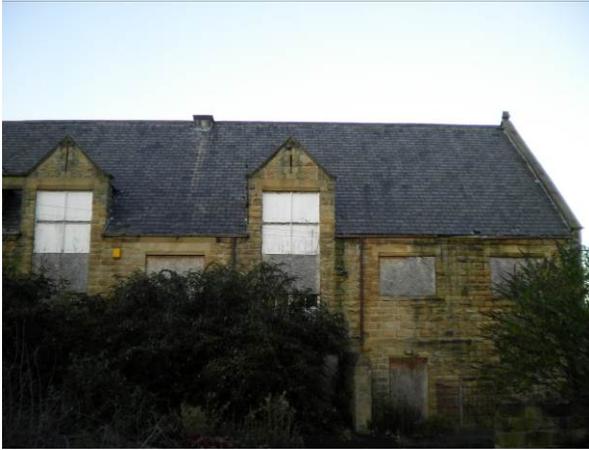
Photo 1
Typical view of side elevation

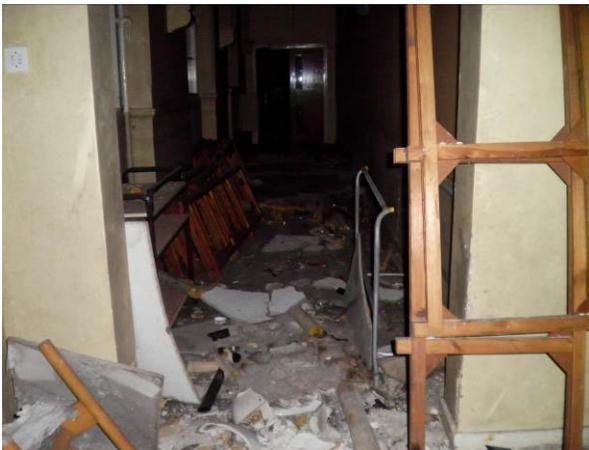
Photo 7
Typical internal view of circulation area

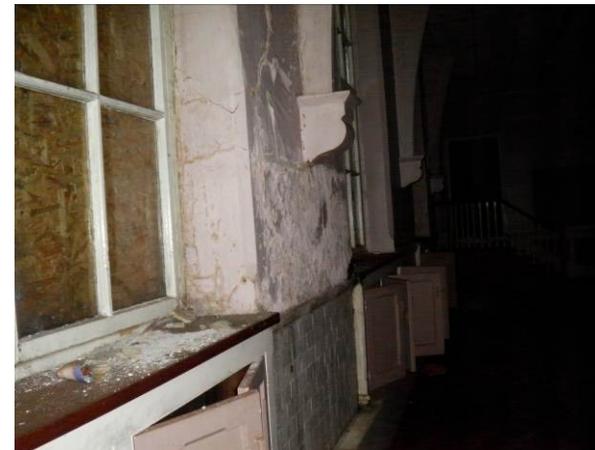
Photo 8
Extent of dampness to external walls

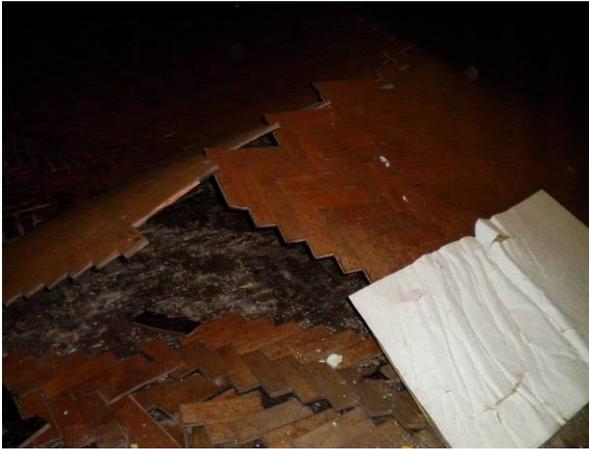
Photo 9
Swollen parquet flooring to main hall

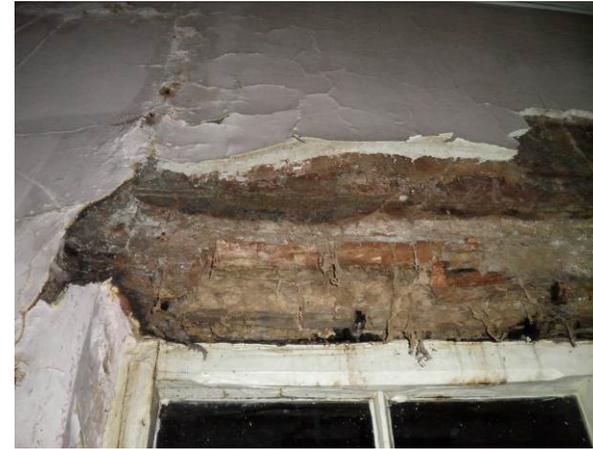
Photo 10
Rotten timber beam

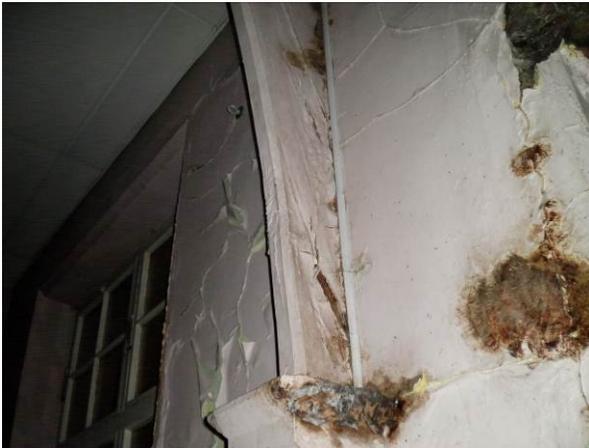
Photo 11
Rotten timber to truss member

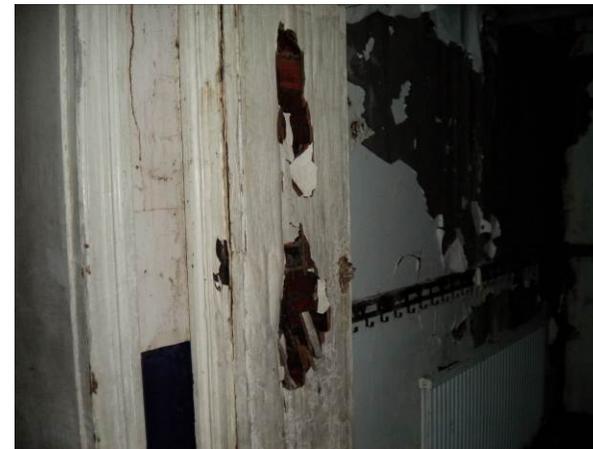
Photo 16
Rotten door frame and water ingress

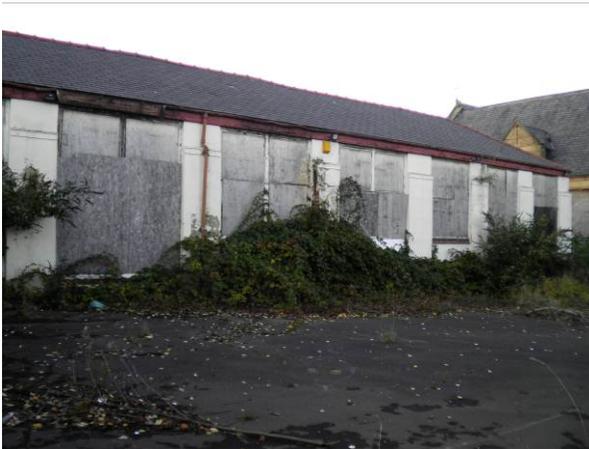
Photo 1
Overall view of eastern elevation

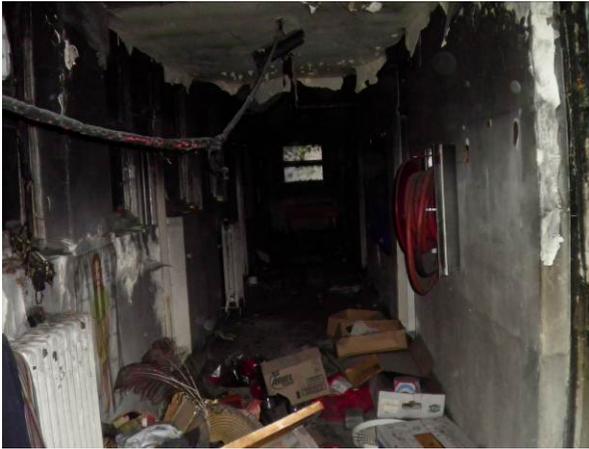
Photo 9
Typical view of circulation areas

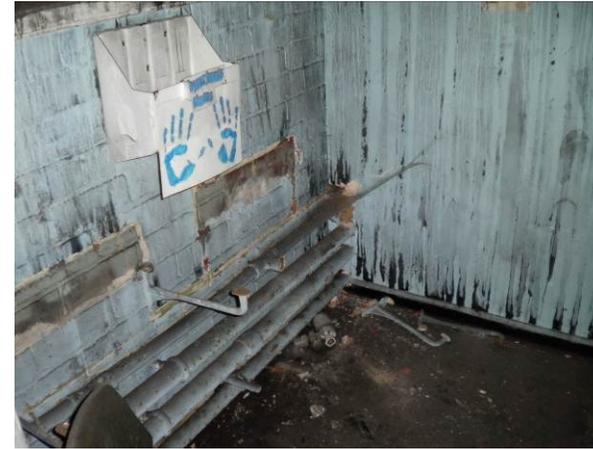
Photo 10
Typical view of toilet accommodation

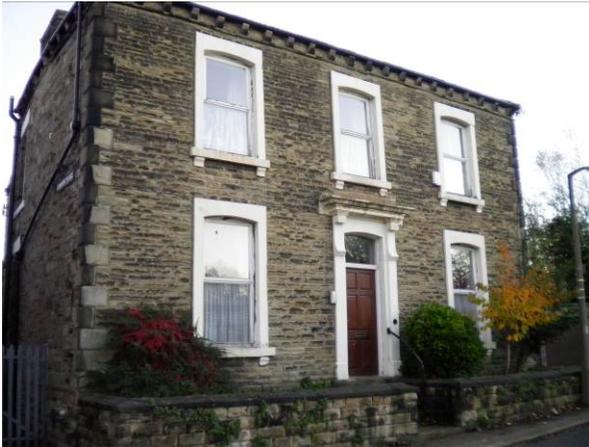
Photo 1
Front elevation

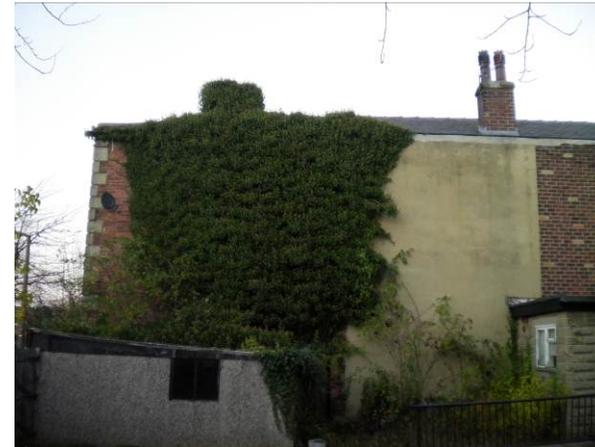
Photo 2
Side elevation (South)

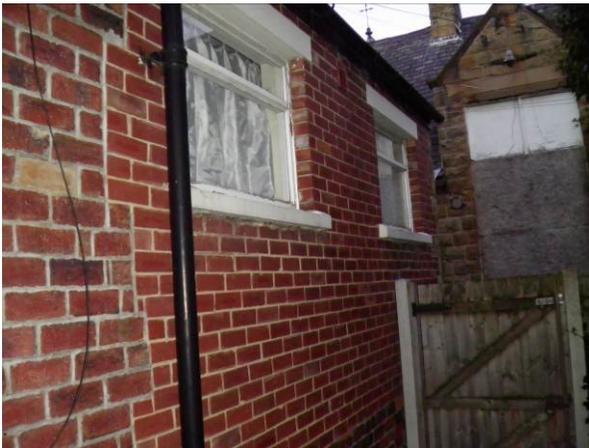
Photo 3
Extensions to rear elevation

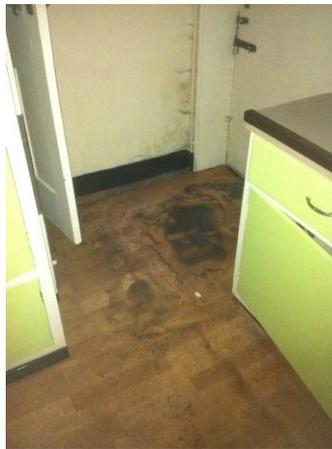
Photo 7
Typical kitchen accommodation

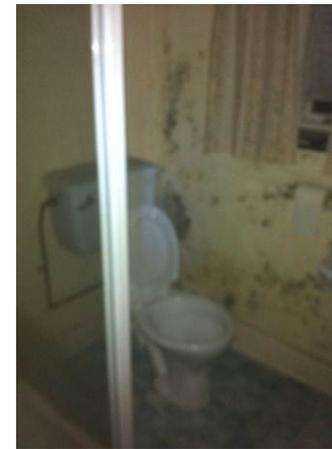
Photo 8
Typical toilet facilities
