GEOSHIELD Verification Report

PROJECT REFERENCE: GEO102848

REPORT NUMBER: 010 REPORT DATE: 22/09/2022

PROJECT: Galiford Try Building

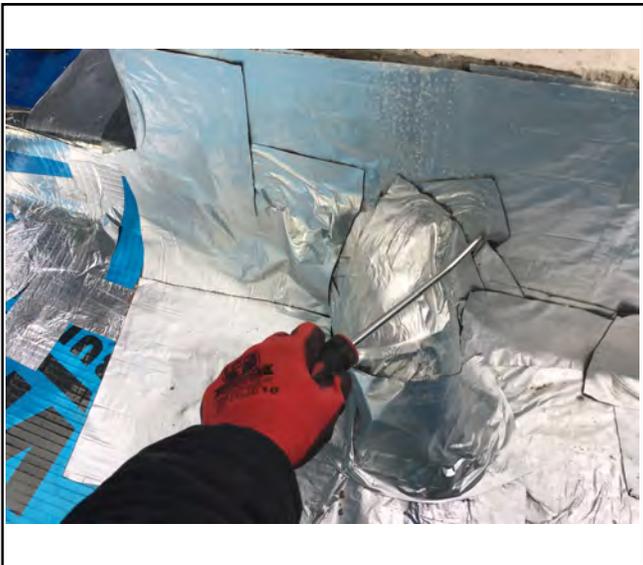
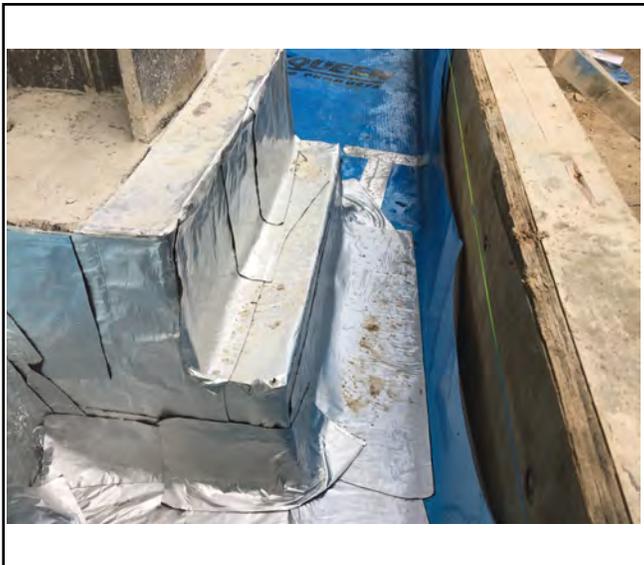
A MSPT, shown in the image above

The above images show the detail of the stanchion bases and the

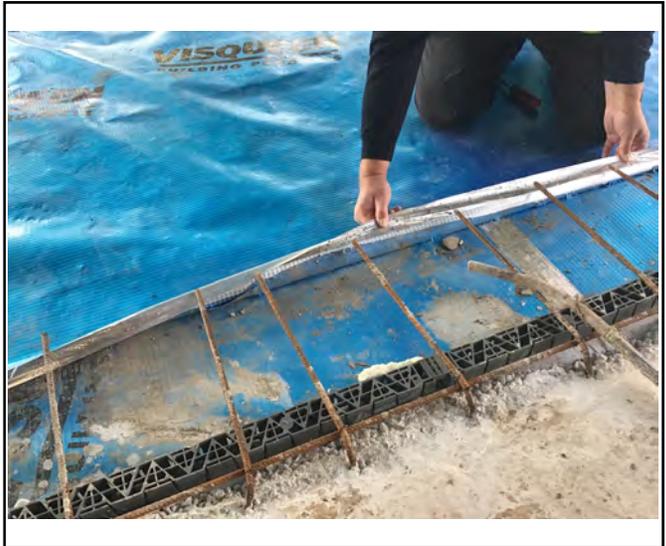
Butyl tape unbonded

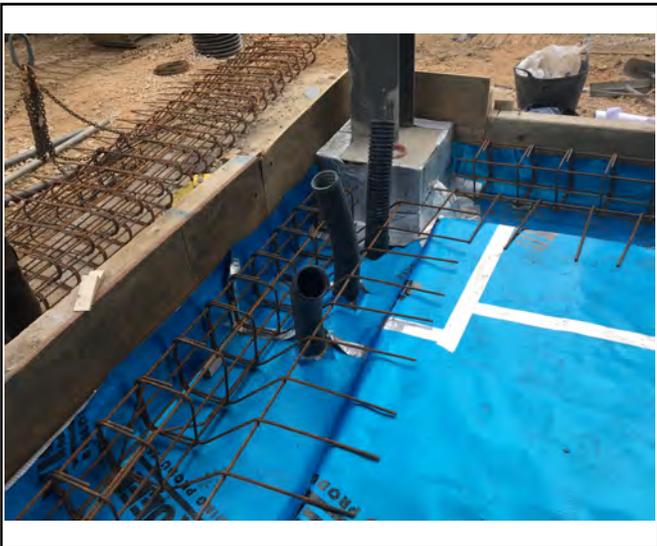
Pipe penetrations unsealed under

Steel reinforcing bar

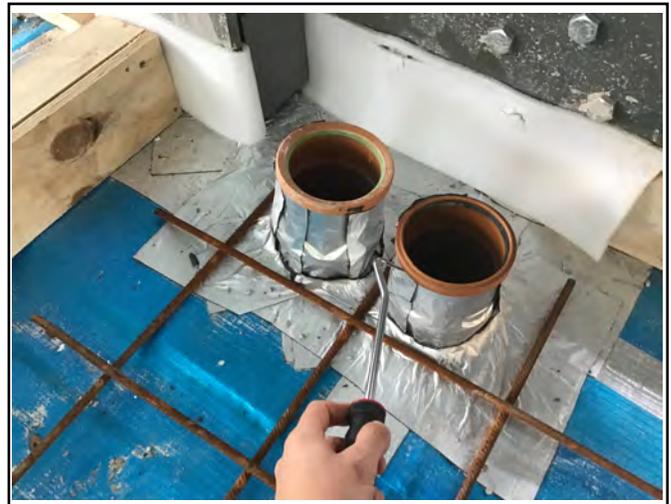
The above images show pipe penetrations being subjected to a MPST,

The double pipe penetration is a good example of treating two close pipes separately

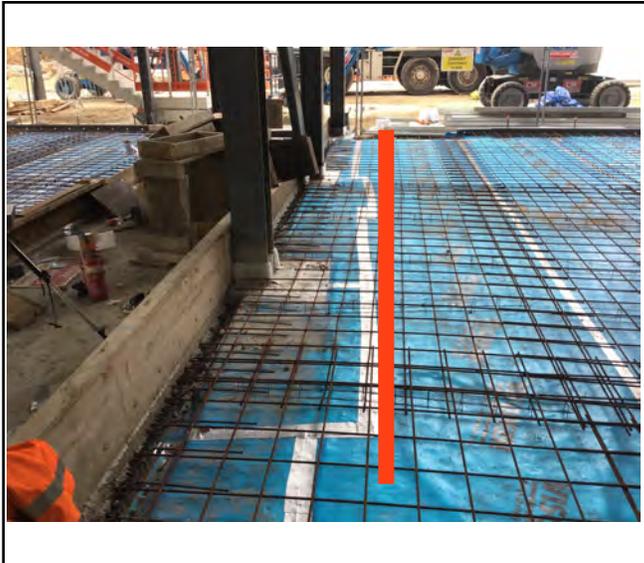
NOTES: In the previous report it was noted that there was an

Insufficient bond formed round the two previously poured concrete areas

The above right image show a MPST being carried out on the GRSAM

Bonded seam

It was agreed that GRSAM would be used in these areas to complete the bond

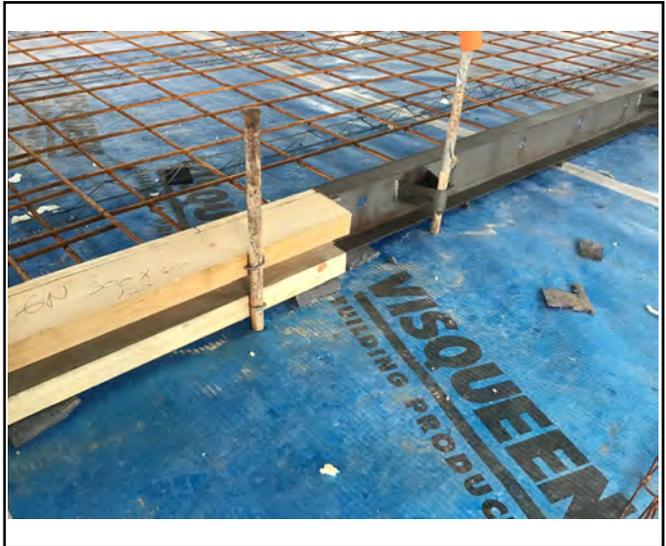
Closer view of shuttering pins

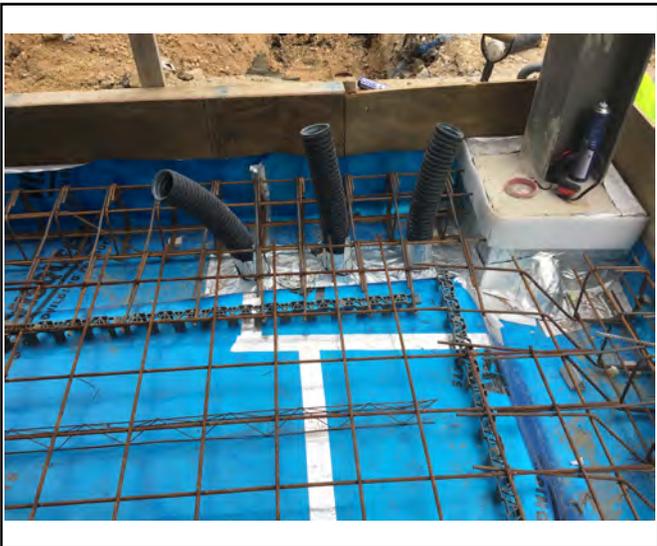
Pipes from previous report

Remediated

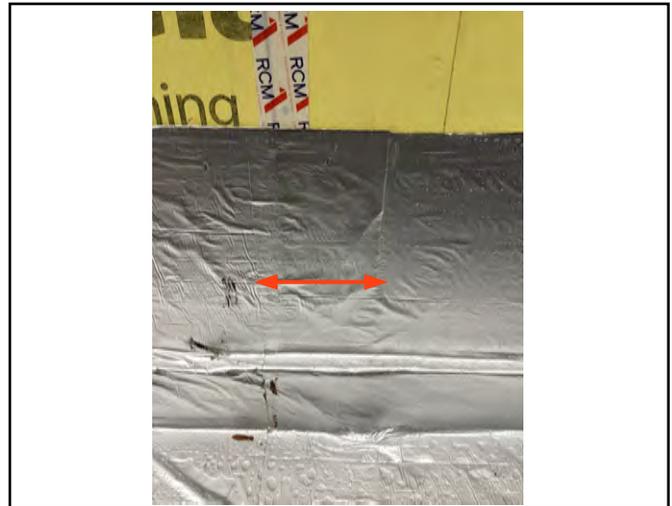
The first photograph below shows an overview of where the Visqueen GRSAM has been applied to the perimeter, overlaying the Visqueen gas barrier to achieve a strong seal. The installers used a hot air leister and silicone roller to apply the GRSAM ...

.. to adhere and seal the GRSAM properly. Also, the installers have applied Visqueen HP tanking primer before applying the GRSAM to ensure for a secure seal. The

second photograph above shows where the installers have lapped the GRSAM by

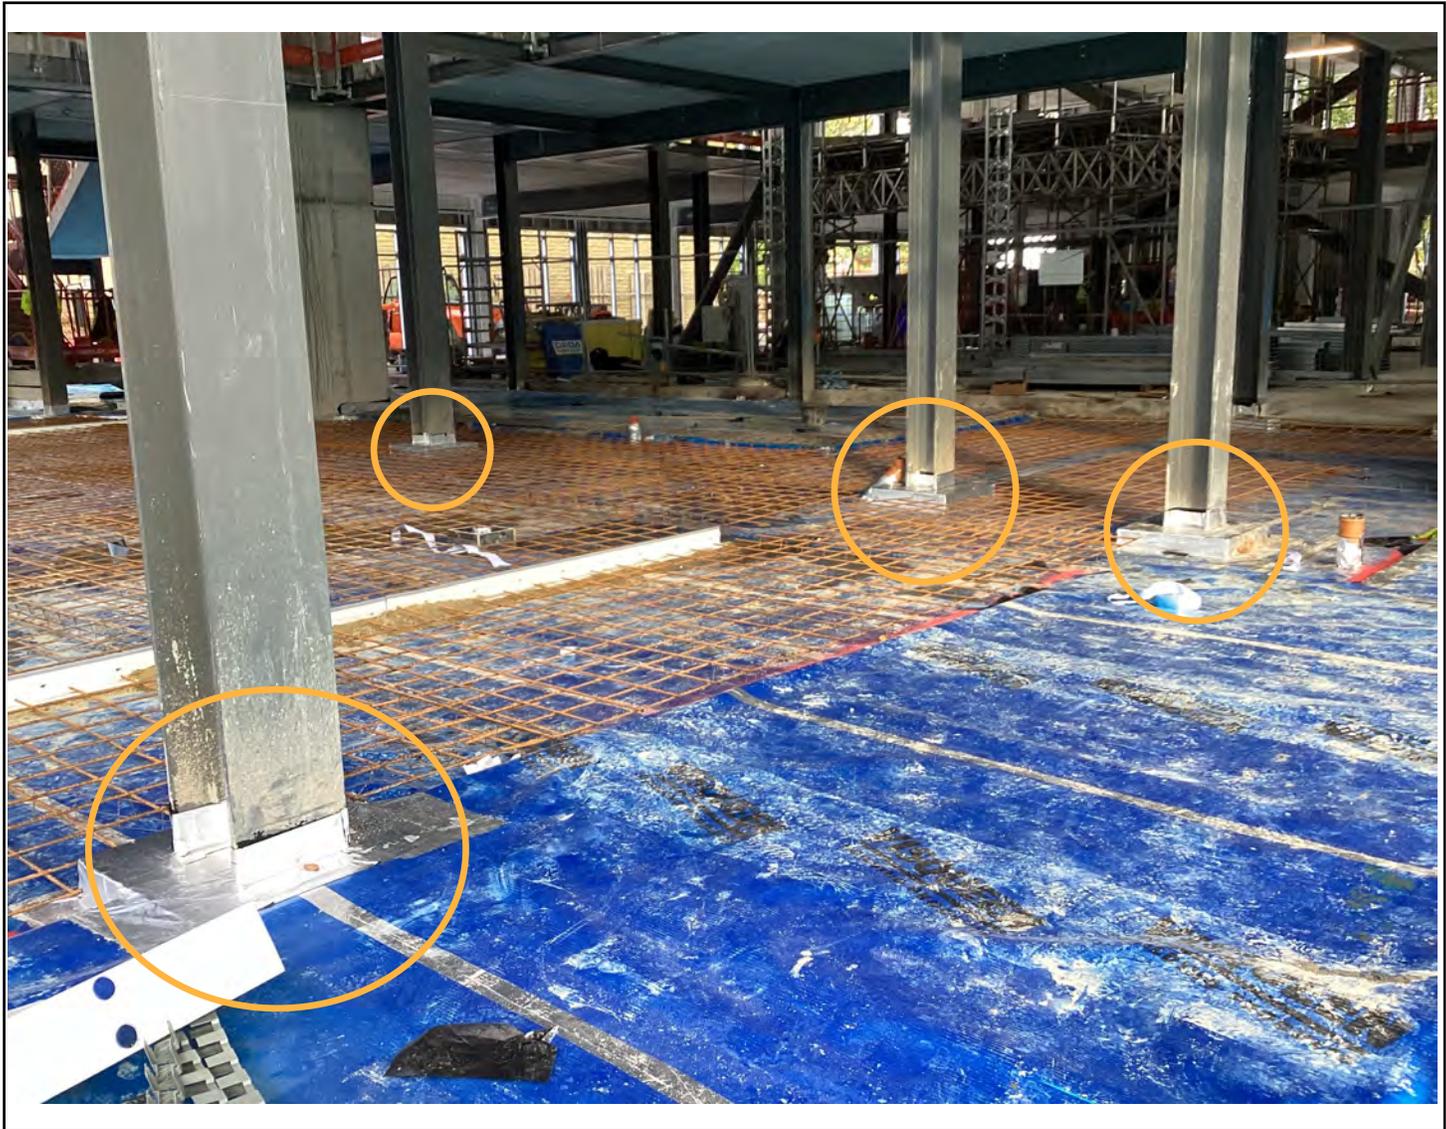
VERIFICATION ITEM TWO

The image on the right shows the Mechanical Point Stress Test being undertaken along the edges of the Visqueen GRSAM so as to ensure there was a complete seal with the Visqueen Gas Barrier. There were no issues identified throughout the verification and noted that the application of heat helped improve adhesion.

The overview image shows some of the stanchions which were subjected to

the Mechanical Point Stress Test.

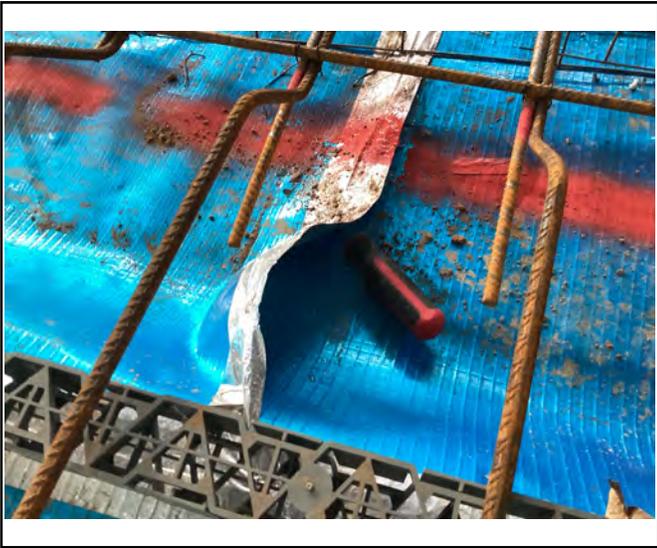
View of third sampled Lap Joint

as per verification this report

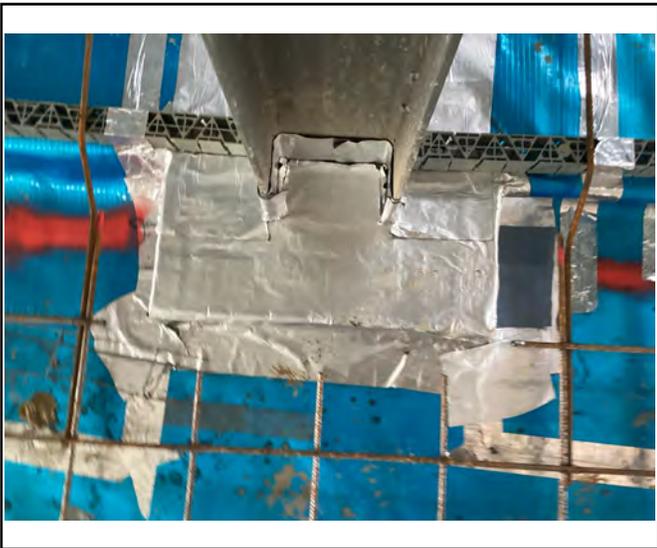
View of steel reinforcement which

has been placed clear of GRSAM

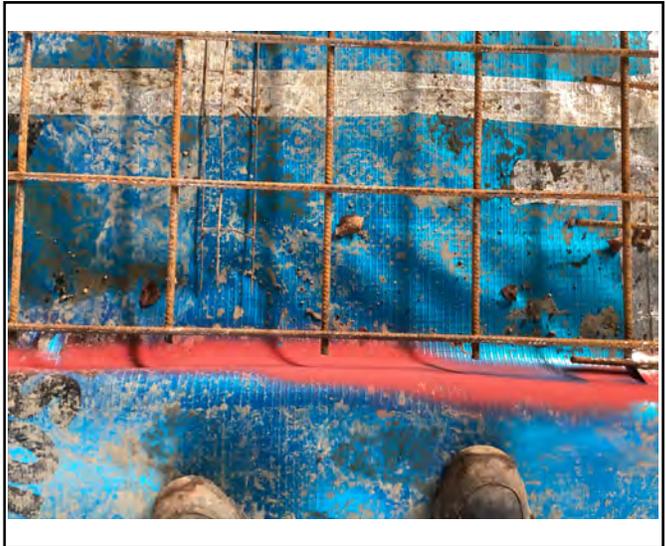
View of steel reinforcement which has

been placed clear of Gas Barrier

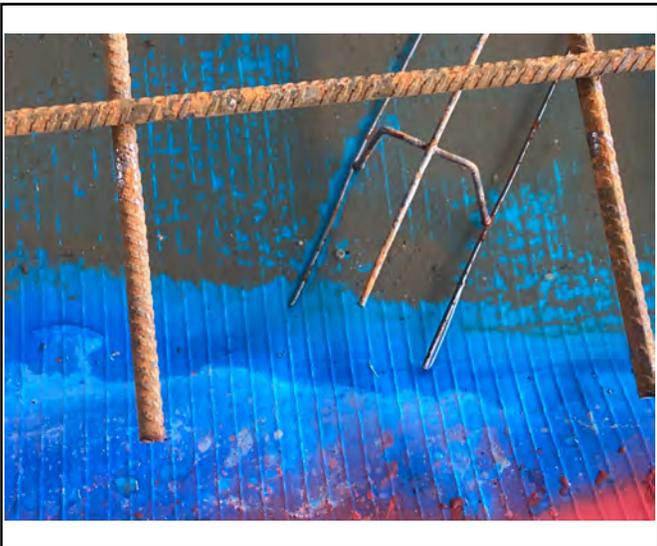
View of steel high chair where the end

is a potential puncture concern

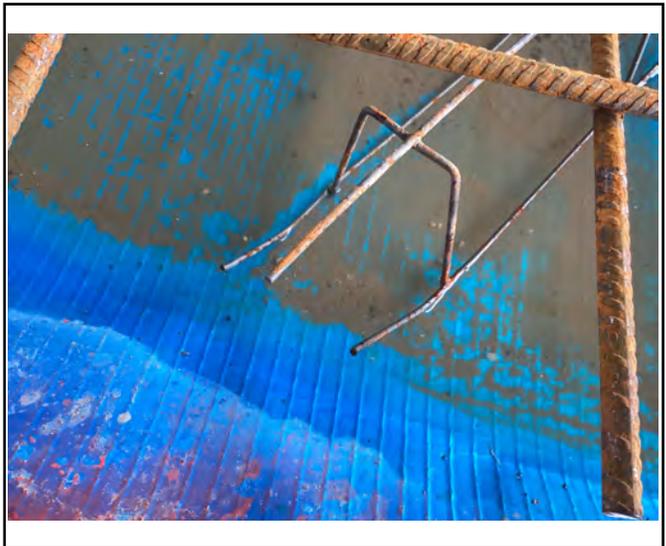
View of steel high chair where the ends

have been bent away from Gas Barrier

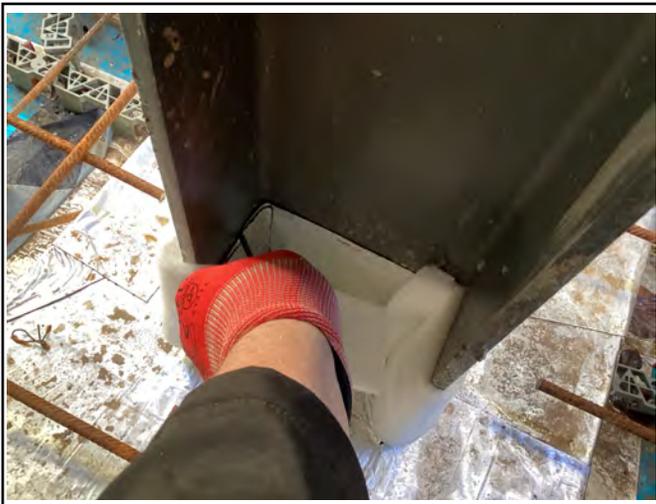
aid adhesion. The image on the left shows the Mechanical Point Stress Test being

undertaken once the 'miothene expansion strip' was carefully removed exposing the

detailing and checking that a full bond had been completed with the stanchion.

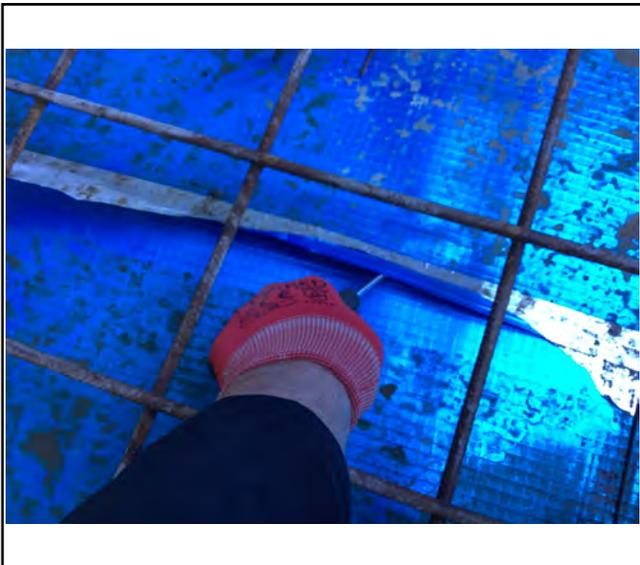
The Visqueen Gas Barrier had been installed upon a layer of insulation and effectively providing a suitable substrate. The lap joints were dual sealed combining the

Visqueen Double Sided Butyl Tape (main seal) and the Visqueen Foil Lap Tape which

protects the lap. A Visqueen lap joint was sampled where as seen in the first image,

the Visqueen Foil Lap Tape was peeled back before completing the Mechanical

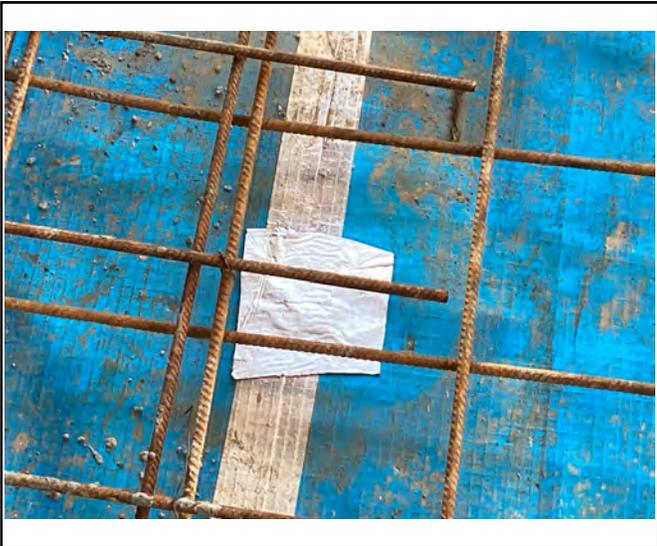
Puncture to Visqueen Gas Barrier

identified as Verification Item Two

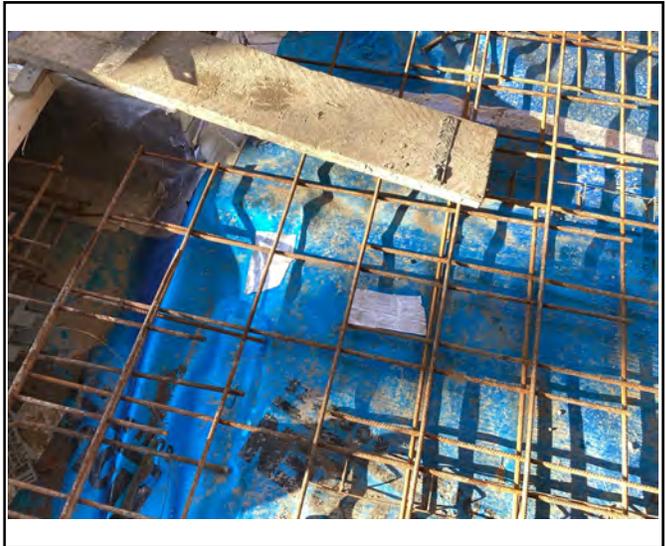
Puncture to Visqueen Gas Barrier

identified as Verification Item Two
