## **Condition Survey, Blue Hills Farm – Planning Application 2022/91047 - Condition 10**

# BLUE HILLS FARM

Highway Dilapidation Survey

Thursday, 10 August 2023

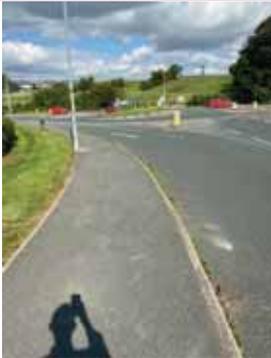
**ISSUE 1**

Patch to wearing course

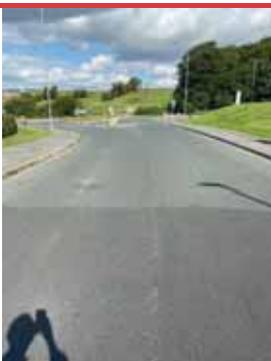
**ISSUE 3**

Patch to wearing course

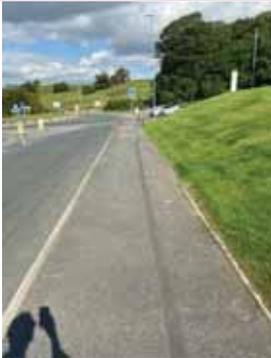
**ISSUE 5**

Wearing course friable

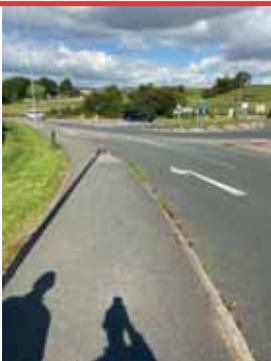
**ISSUE 6**

Wearing course intact

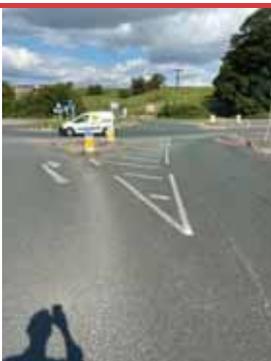
**ISSUE 7**

Wearing course intact

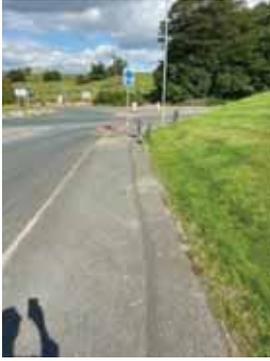
**ISSUE 8**

Wearing course intact

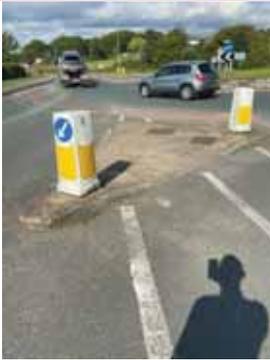
**ISSUE 9**

Wearing course intact

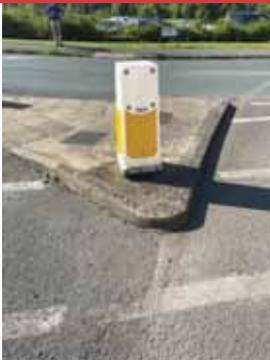
**ISSUE 10**

Traffic Island intact

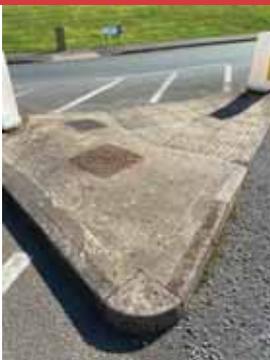
**ISSUE 11**

Traffic island intact

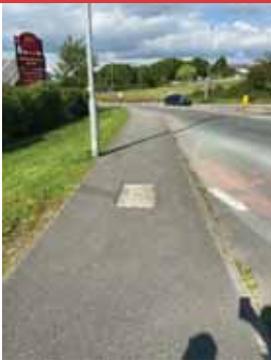
**ISSUE 14**

Wearing course intact

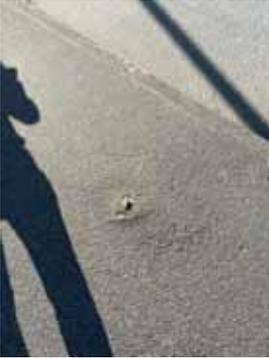
**ISSUE 17**

Wearing course intact

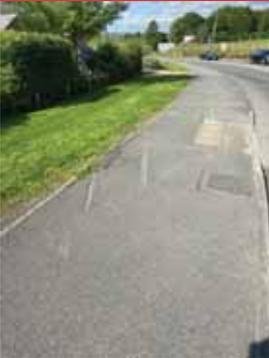
**ISSUE 18**

Remains of post remain

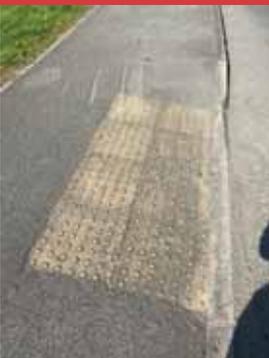
**ISSUE 19**

Scars / patches to wearing course

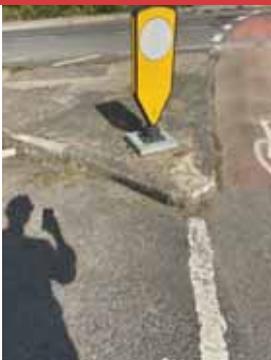
**ISSUE 27**

Wearing course friable / patchy

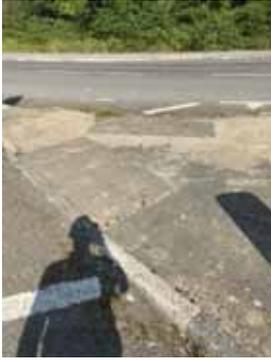
**ISSUE 28**

Traffic island intact

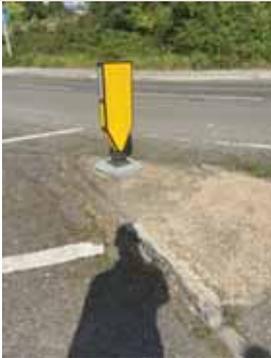
**ISSUE 29**

Traffic island intact

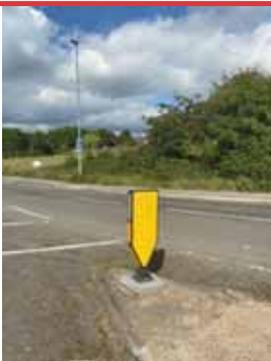
**ISSUE 30**

Traffic island intact

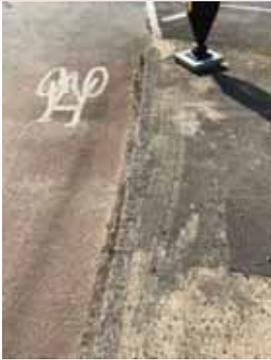
**ISSUE 33**

Wearing course friable

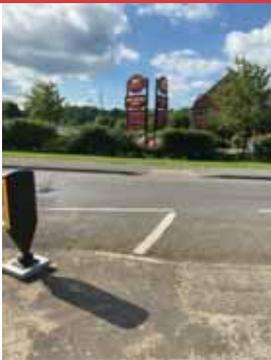
**ISSUE 34**

Wearing course intact

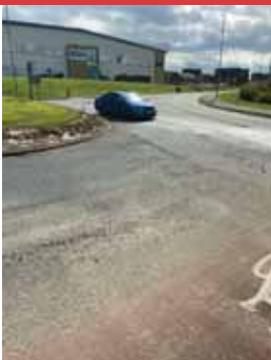
**ISSUE 35**

Wearing course intact

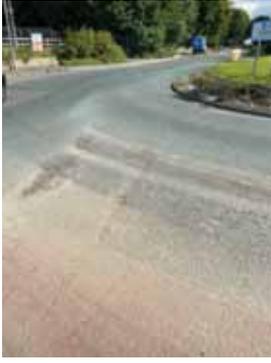
**ISSUE 36**

Wearing course friable

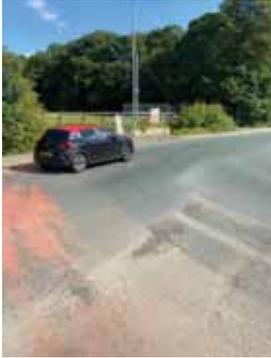
**ISSUE 37**

Wearing course friable

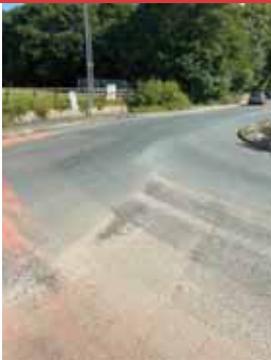
**ISSUE 38**

Wearing course friable

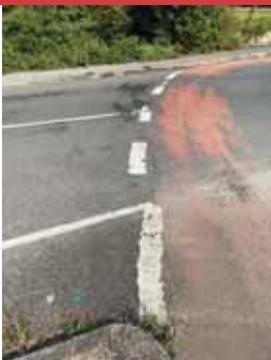
**ISSUE 39**

Wearing course friable

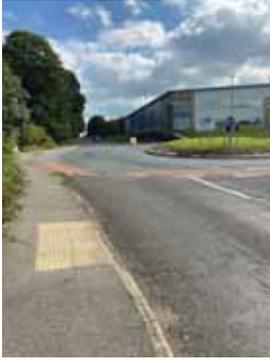
**ISSUE 40**

Wearing course friable

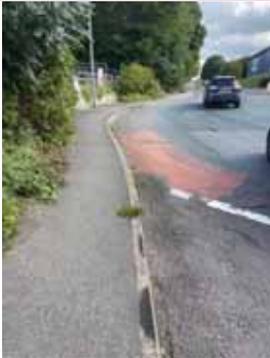
**ISSUE 41**

Wearing course friable

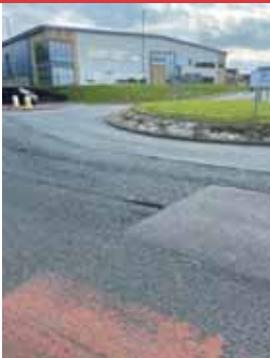
**ISSUE 42**

Wearing course friable

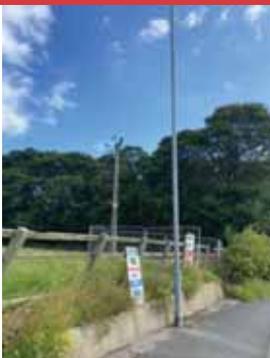
**ISSUE 43**

Wearing course friable / pothole

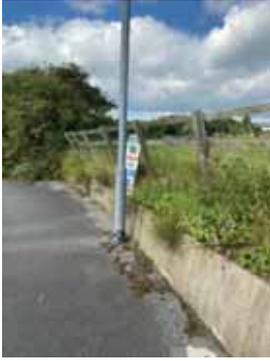
**ISSUE 44**

Patch to wearing course

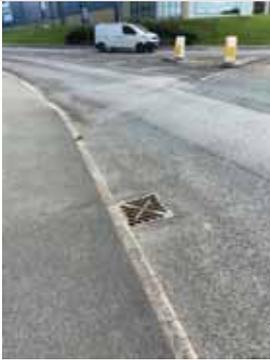
**ISSUE 45**

Patch to wearing course

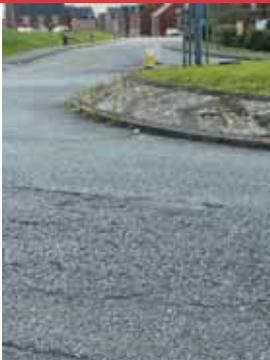
**ISSUE 46**

Wearing course friable

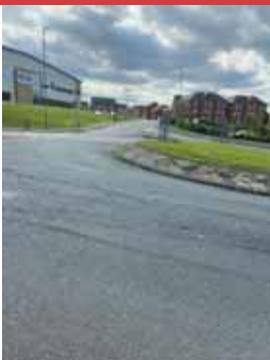
**ISSUE 47**

Wearing course friable

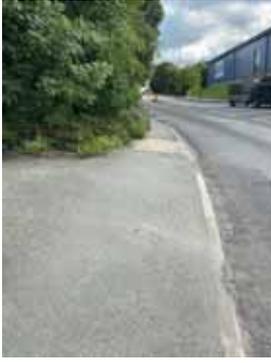
**ISSUE 48**

Wearing course friable

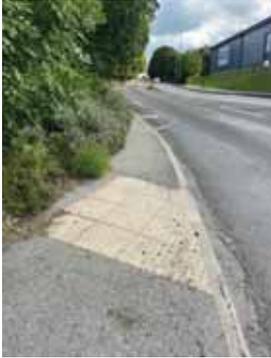
**ISSUE 49**

Wearing course intact

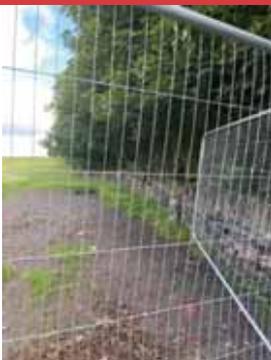
**ISSUE 51**

Drystone wall

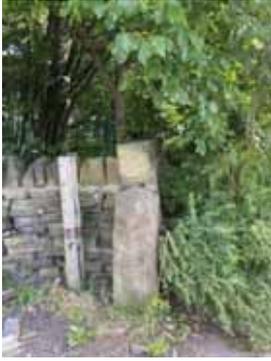
**ISSUE 52**

Drystone Wall

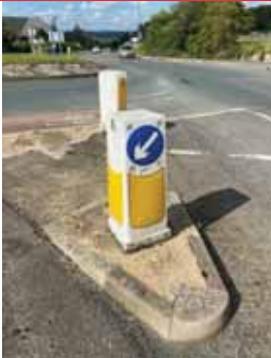
**ISSUE 54**  
Wearing course friable

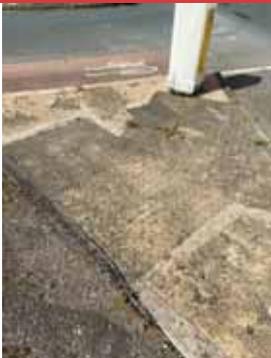
**ISSUE 55**  
Traffic island intact

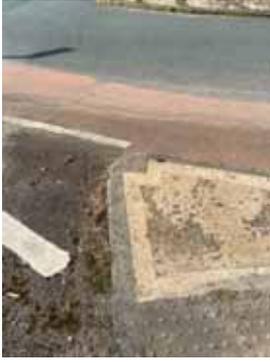
**ISSUE 56**  
Traffic island intact

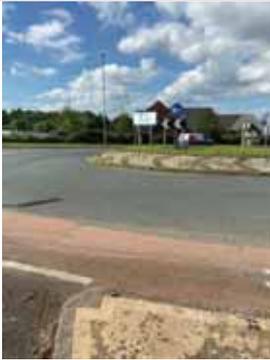
**ISSUE 57**

Wearing course friable

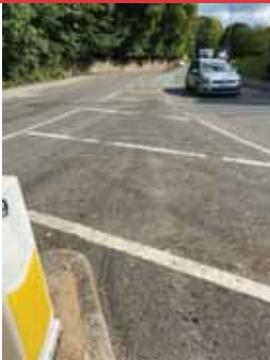
**ISSUE 58**

Wearing course scarred

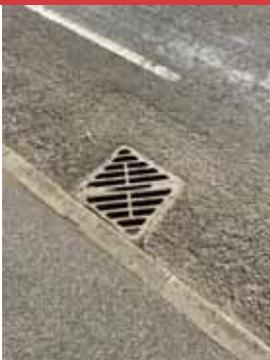
**ISSUE 59**

Wearing course intact

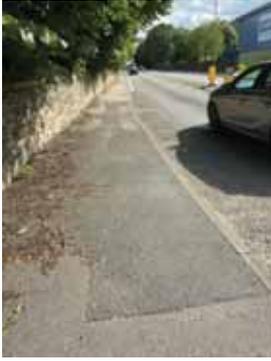
**ISSUE 60**

Wearing course patchy / friable

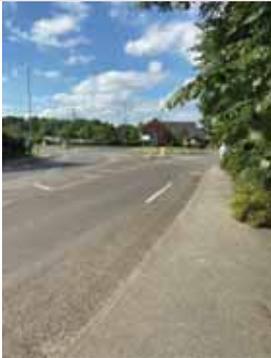
**ISSUE 61**

Wearing course patchy

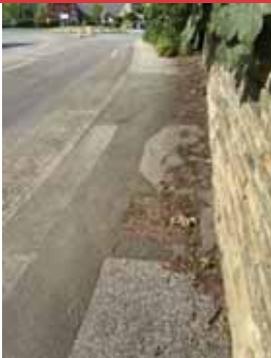
**ISSUE 62**

Wearing course friable

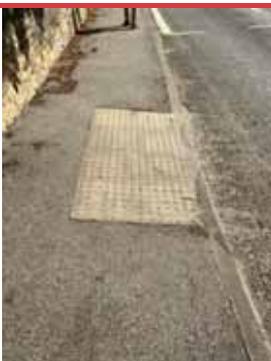
**ISSUE 63**

Wearing course patchy

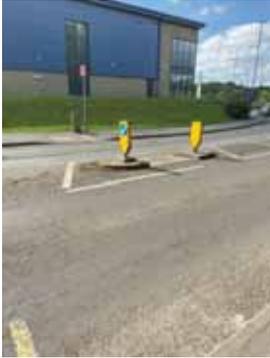
**ISSUE 65**

Wearing course friable

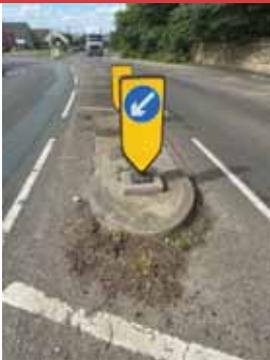
**ISSUE 66**

Wearing course friable

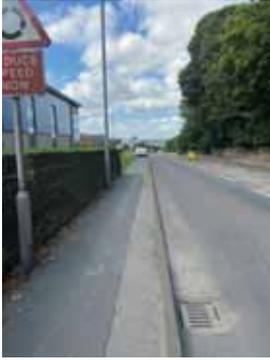
**ISSUE 68**

Wearing course friable / ironworks sunk

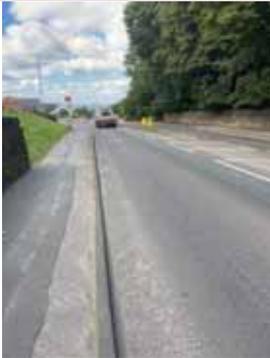
**ISSUE 69**

Wearing course intact

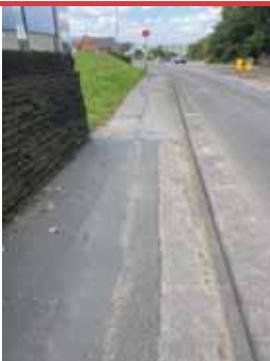
**ISSUE 70**

Patches in wearing course

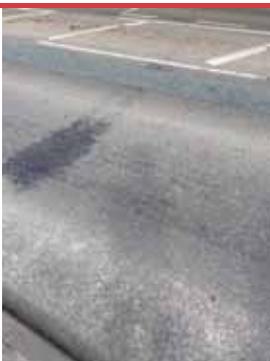
**ISSUE 71**

Patches to wearing course

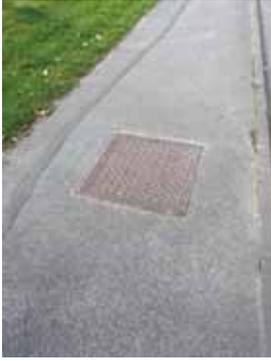
**ISSUE 72**

Wearing course intact

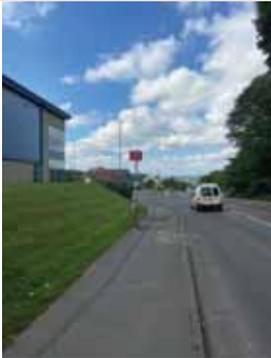
**ISSUE 73**

Wearing course intact

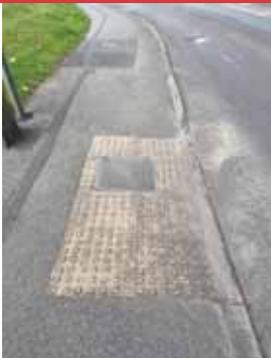
**ISSUE 74**

Wearing course intact

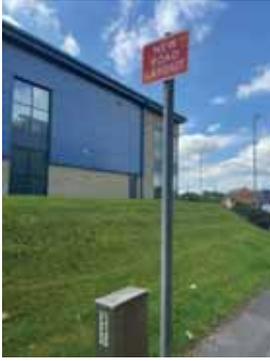
**ISSUE 76**

Wearing course intact

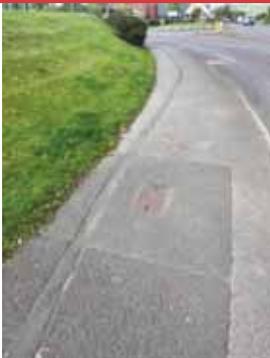
**ISSUE 78**  
Wearing course intact

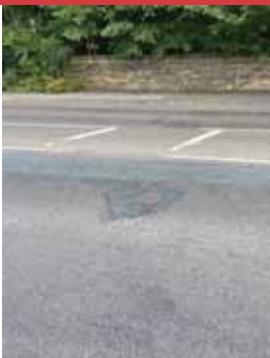
**ISSUE 79**  
Patches in wearing course

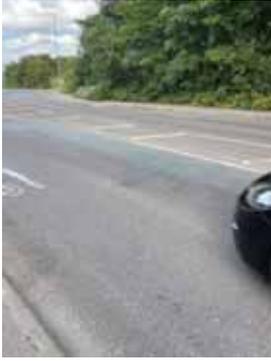
**ISSUE 80**  
Wearing course friable

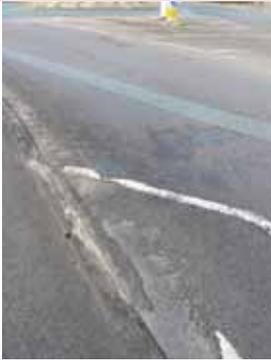
**ISSUE 81**

Wearing course intact

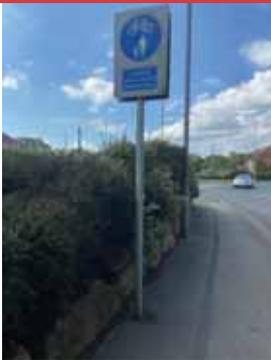
**ISSUE 82**

Wearing course intact

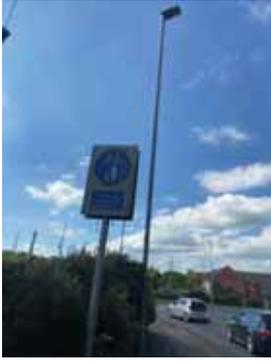
**ISSUE 84**

Wearing course intact

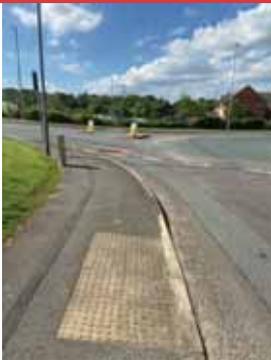
**ISSUE 86**  
Tactile paving intact

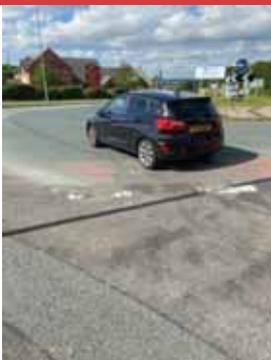
**ISSUE 87**  
Wearing course friable

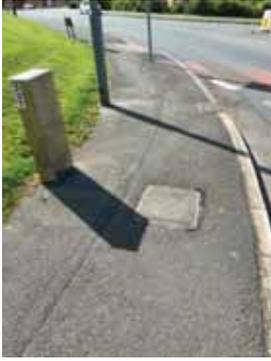
**ISSUE 88**  
Wearing course friable / patchy

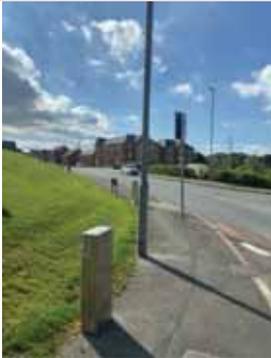
**ISSUE 89**

Wearing course intact

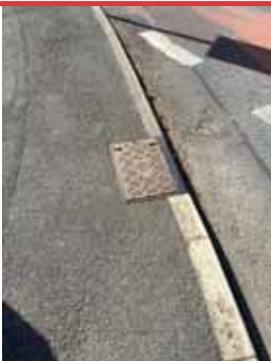
**ISSUE 90**

Wearing course intact

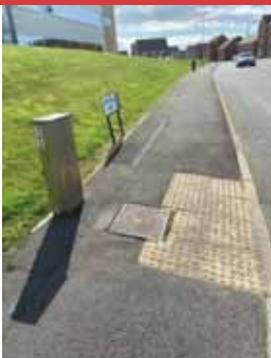
**ISSUE 91**

Wearing course intact

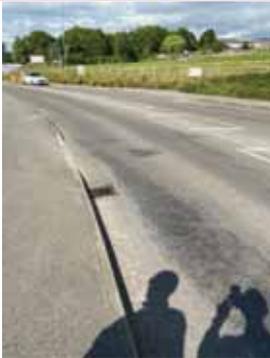
**ISSUE 93**

Wearing course intact

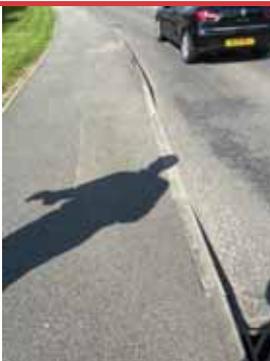
**ISSUE 94**

Wearing course intact

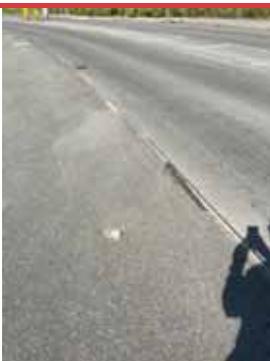
**ISSUE 95**

Wearing course intact

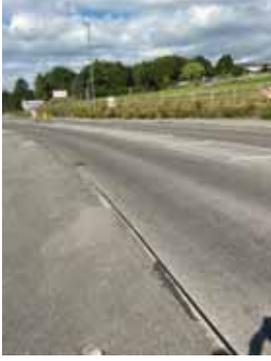
**ISSUE 96**

Wearing course intact

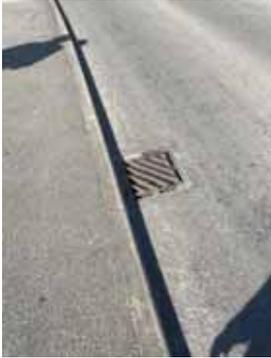
**ISSUE 97**

Wearing course intact

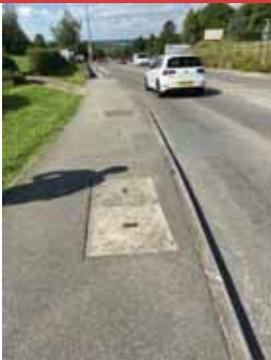
**ISSUE 98**

Wearing course intact

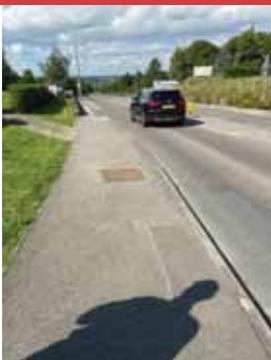
**ISSUE 99**

Wearing course / telecoms lid intact

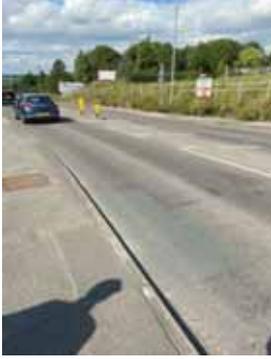
**ISSUE 100**

Wearing course intact

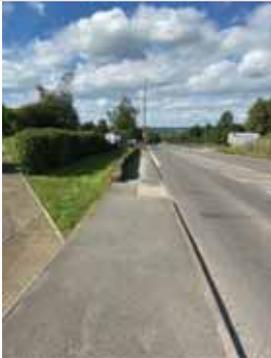
**ISSUE 101**

Wearing course intact

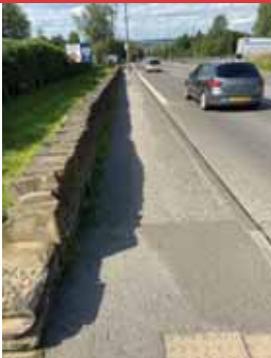
**ISSUE 102**

Wearing course intact

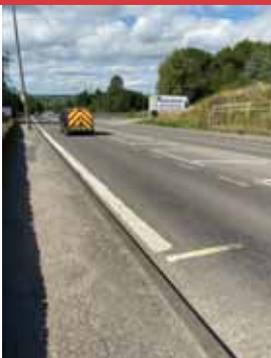
**ISSUE 103**

Wearing course intact

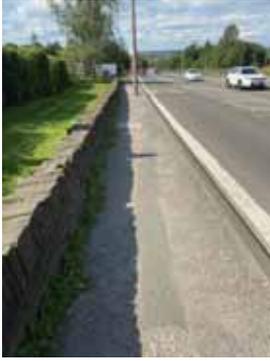
**ISSUE 104**

Wearing course friable

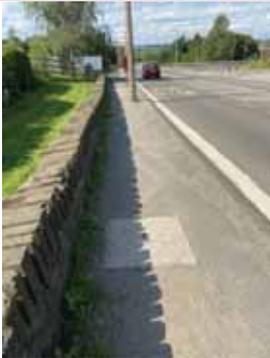
**ISSUE 105**

Wearing course friable

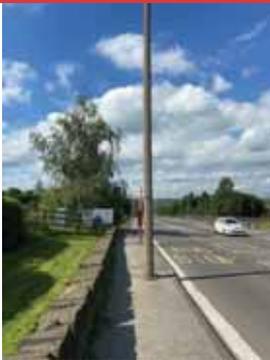
**ISSUE 106**

Wearing course friable

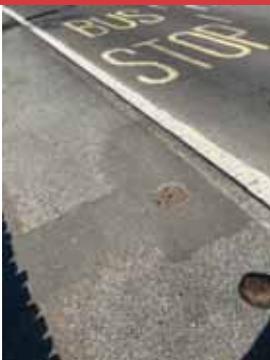
**ISSUE 107**

Post intact

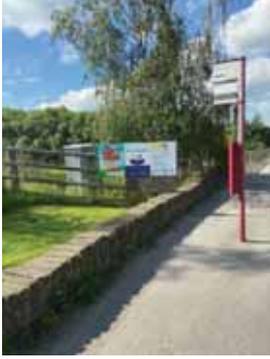
**ISSUE 108**

Patch in wearing course

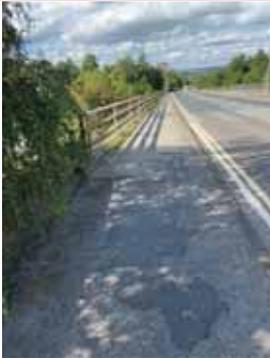
**ISSUE 109**

Wearing course intact

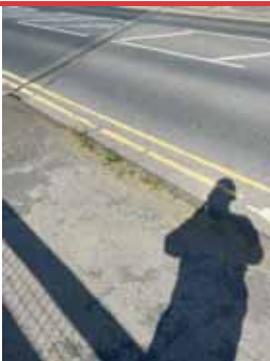
**ISSUE 110**

Wearing course friable

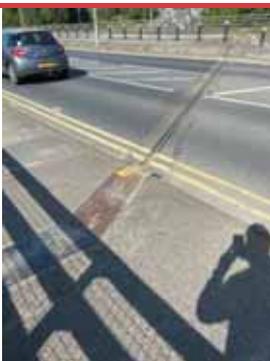
**ISSUE 111**

Wearing course patchy

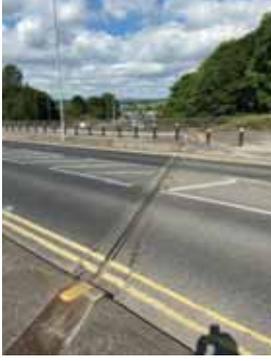
**ISSUE 112**

Wearing course friable

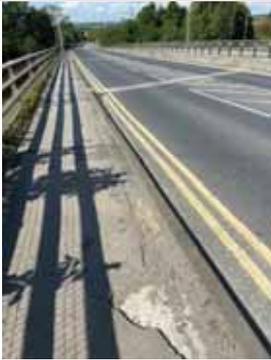
**ISSUE 113**

Patch in wearing course

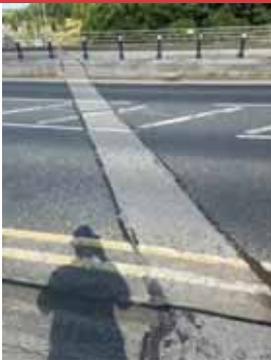
**ISSUE 114**

Wearing course friable

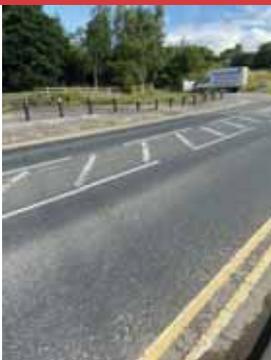
**ISSUE 115**

Scar in wearing course

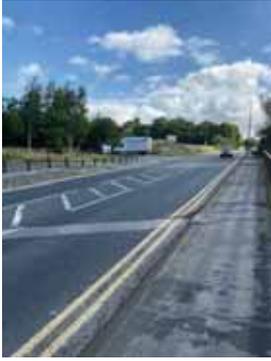
**ISSUE 116**

Wearing course intact

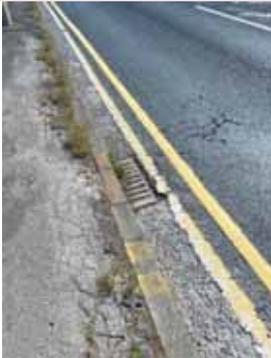
**ISSUE 117**

Wearing course friable / scarred

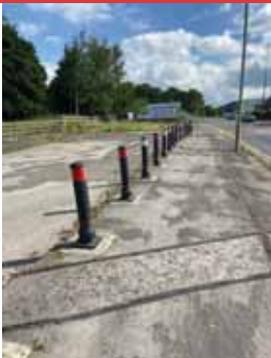
**ISSUE 118**

Wearing course friable

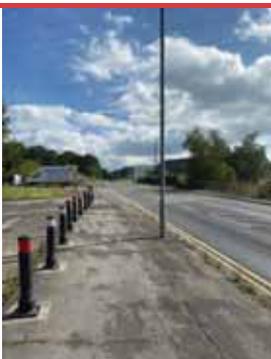
**ISSUE 119**

Wearing course friable

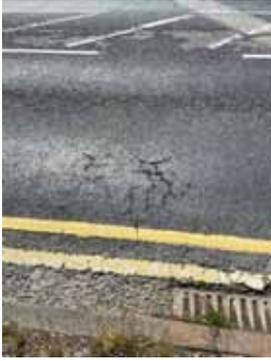
**ISSUE 120**

Wearing course friable

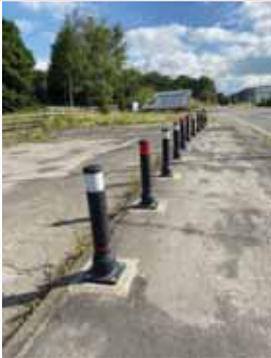
**ISSUE 121**

Wearing course friable

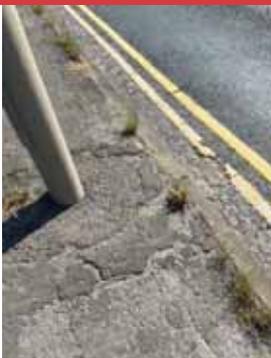
**ISSUE 123**

Wearing course intact

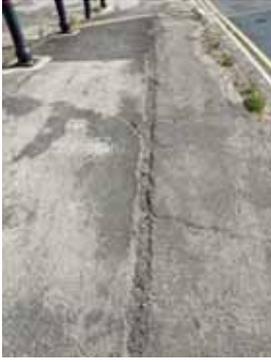
**ISSUE 124**

Wearing course intact

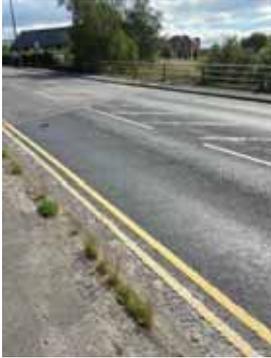
**ISSUE 125**

Wearing course intact

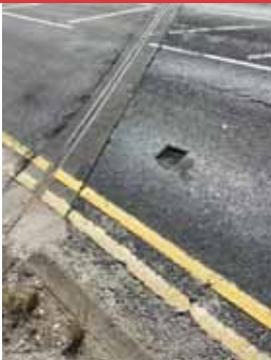
**ISSUE 126**

Wearing course intact

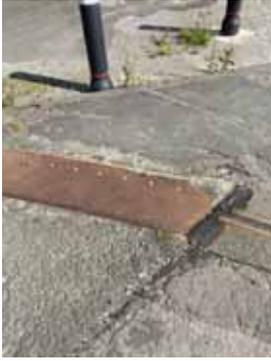
**ISSUE 128**

Wearing course friable

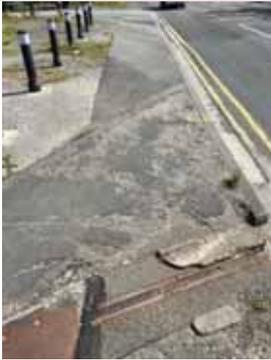
**ISSUE 129**

Wearing course scarred

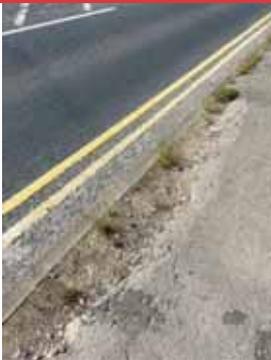
**ISSUE 130**

Wearing course friable / patchy

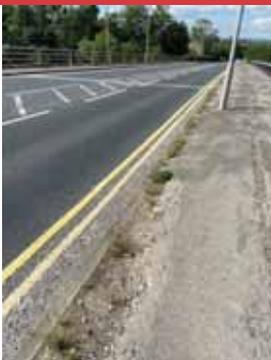
**ISSUE 131**

Wearing course friable

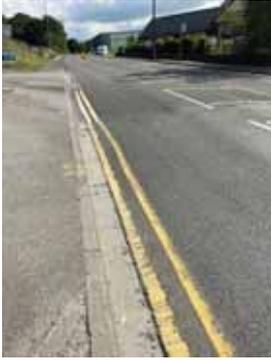
**ISSUE 132**

Wearing course friable

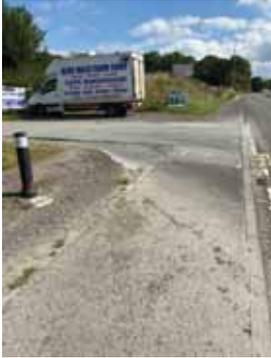
**ISSUE 133**

Wearing course intact

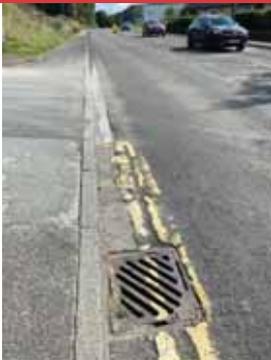
**ISSUE 134**

Wearing course intact

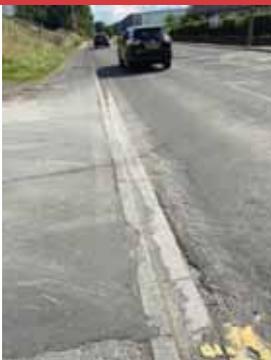
**ISSUE 135**

Wearing course friable

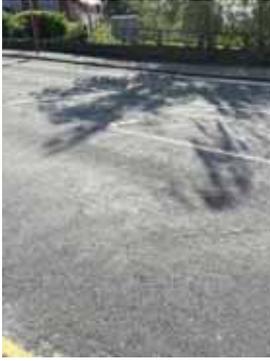
**ISSUE 136**

Wearing course friable

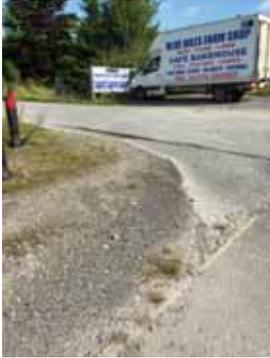
**ISSUE 137**

Wearing course intact

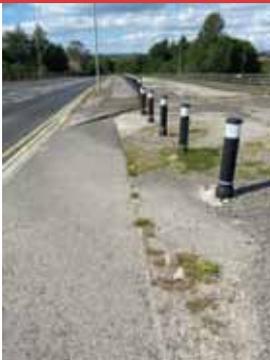
**ISSUE 138**

Wearing course friable

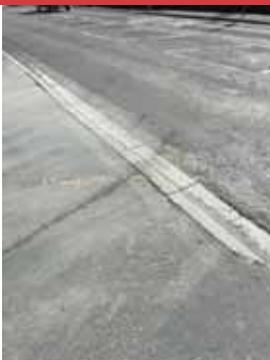
**ISSUE 139**

Wearing course friable

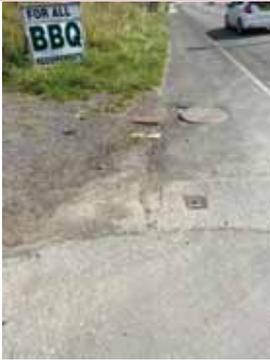
**ISSUE 140**

Wearing course intact

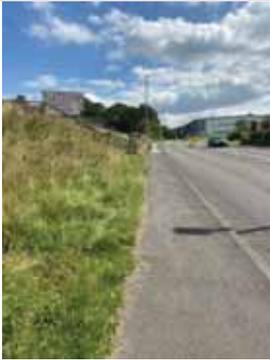
**ISSUE 141**

Wearing course patchy

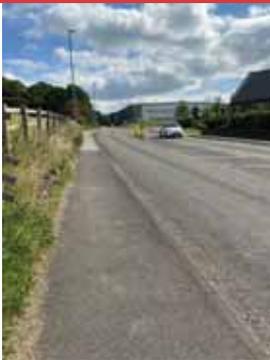
**ISSUE 142**

Wearing course intact

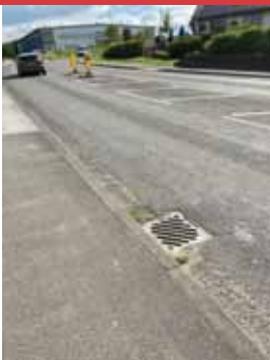
**ISSUE 143**

Wearing course intact

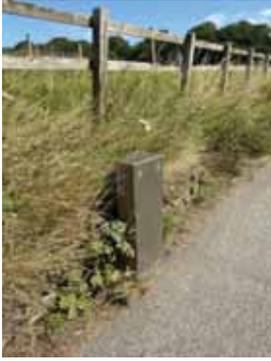
**ISSUE 144**

Wearing course intact

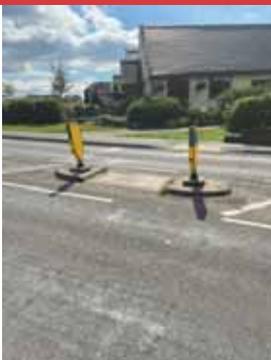
**ISSUE 147**

Post intact

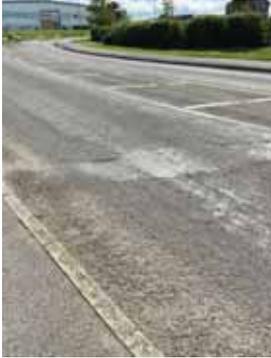
**ISSUE 149**

Wearing course scarred

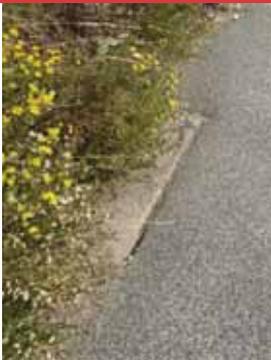
**ISSUE 150**

Wearing course friable

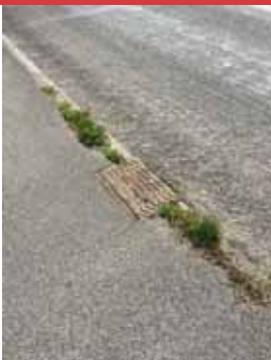
**ISSUE 151**

Wearing course intact

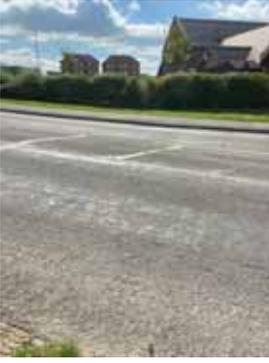
**ISSUE 152**

Wearing course friable

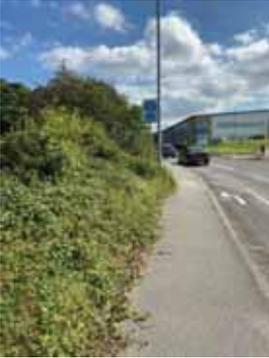
**ISSUE 153**

Wearing course friable

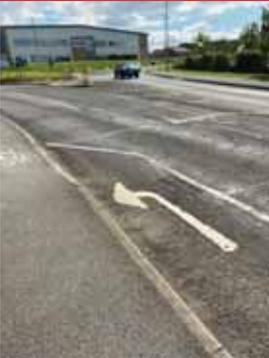
**ISSUE 154**

Wearing course intact

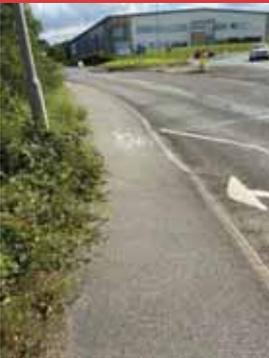
**ISSUE 155**

Wearing course friable

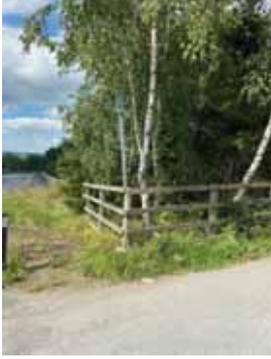
**ISSUE 1**

Entrance to PROW

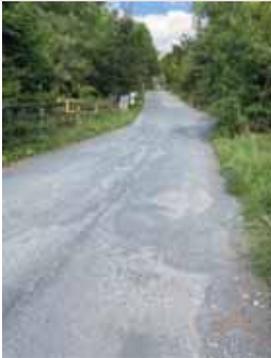
**ISSUE 2**

Wearing course friable

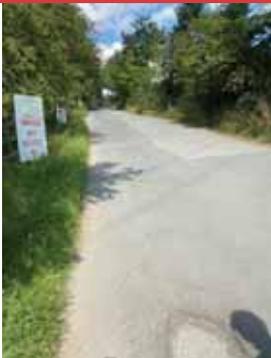
**ISSUE 3**

Wearing course patchy

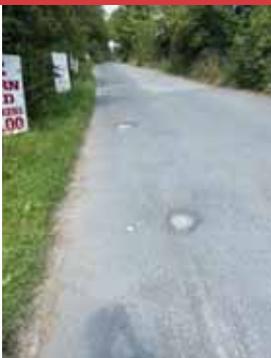
**ISSUE 4**

Wearing course patchy

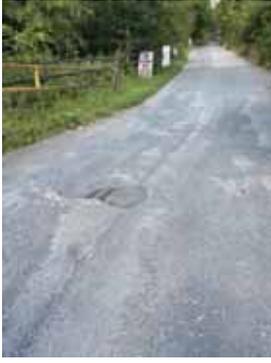
**ISSUE 5**

Wearing course patchy

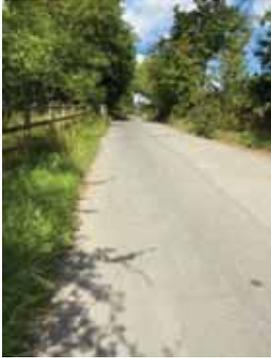
**ISSUE 6**

Wearing course patchy

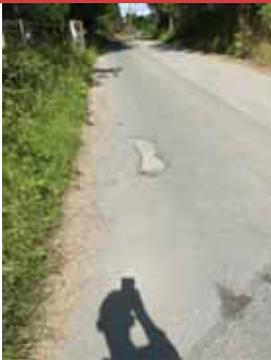
**ISSUE 7**

Wearing course patchy

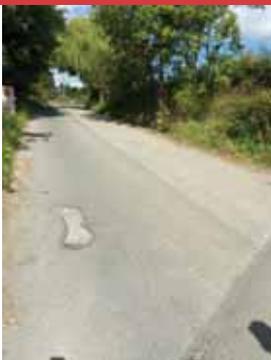
**ISSUE 8**

Weather course patchy

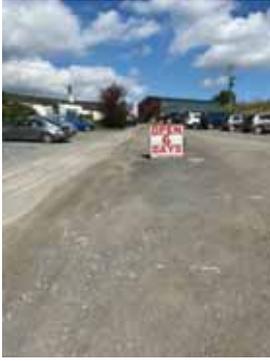
**ISSUE 9**

Wearing course friable

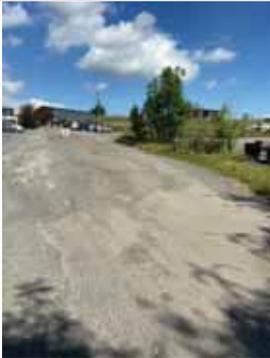
**ISSUE 10**

Weather course friable

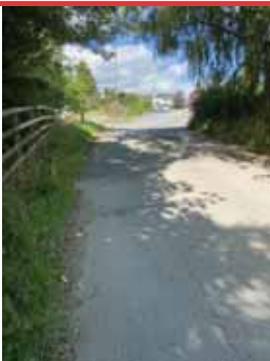
**ISSUE 11**

Wearing course patchy

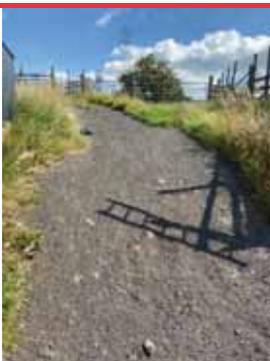
**ISSUE 12**

Pathway broken up / friable

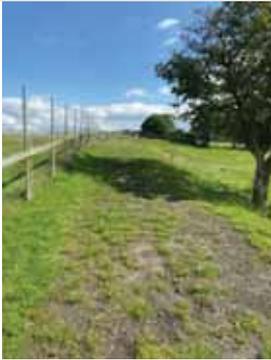
**ISSUE 14**

PROW - fence intact

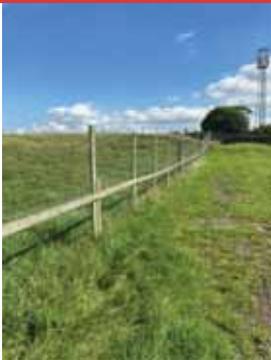
**ISSUE 15**

PROW - fence intact

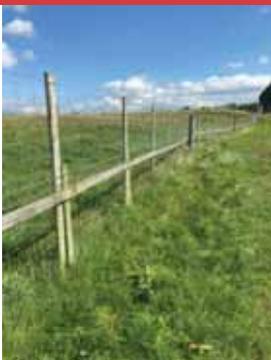
**ISSUE 16**

PROW - fence intact

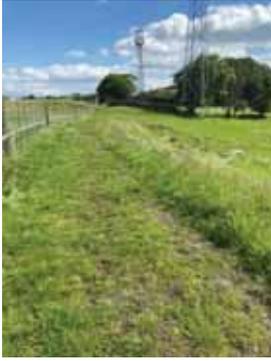
**ISSUE 17**

PROW - fence intact

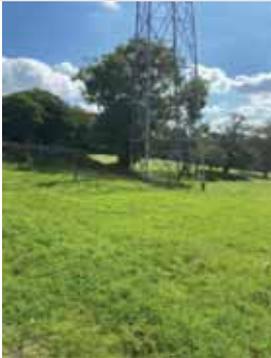
**ISSUE 18**

Pylon intact

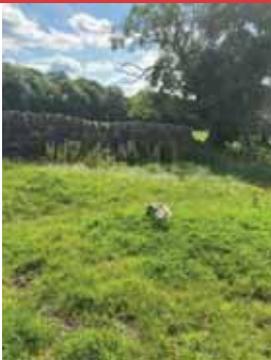
**ISSUE 19**

Drystone wall intact

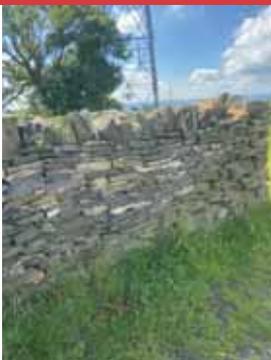
**ISSUE 20**

Drystone wall intact
