## STRUCTURAL CONDITION REPORT The George Hotel, Huddersfield

Client: GMI Construction  
Project Name: The George Hotel, Huddersfield  
Report Title: Block A – Condition Report  
Report Author: James Hendry  
Document ref: 00.24363 -ACE-ZZ-ZZ-T-S-0003  
Date: Apr'25

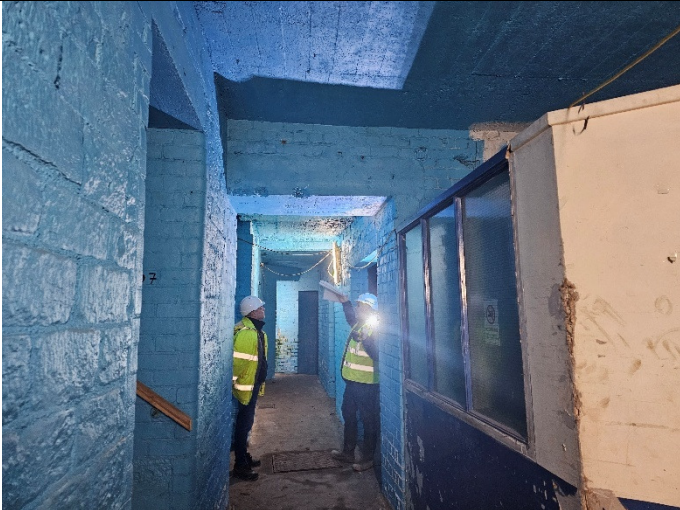
Location	Notes	Photo	
B.06	Signs of damp and lack of cover to concrete reinforcement.

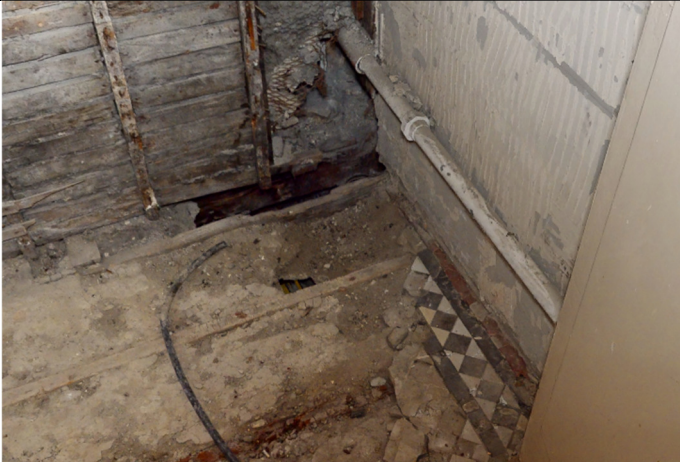
1.03	Hole in floor as per photo G.13.  Pugging visible between 275mm deep timber joists.

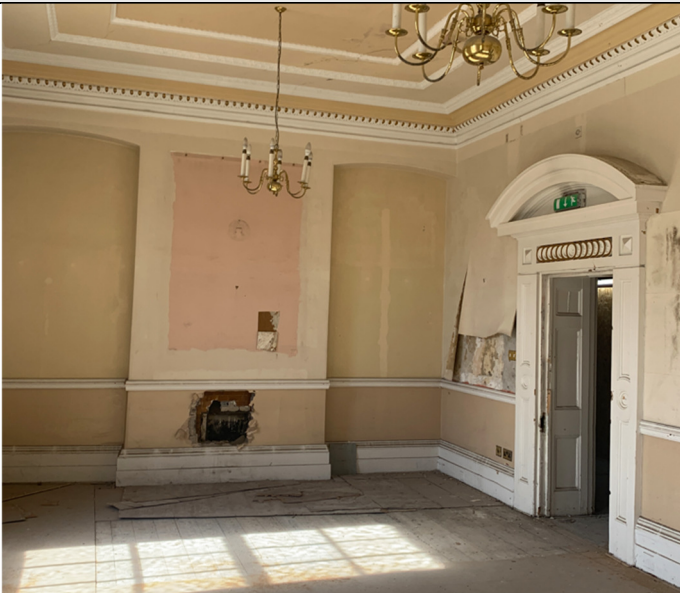
Location	Notes	Photo	
1.06	Photo of the 'signing room' at first floor.

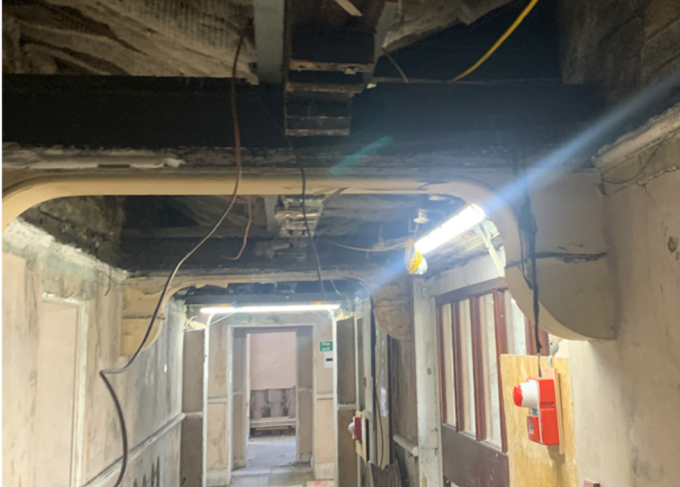
4.05	View of fourth floor corridor space and existing roof structure which is outside the scope of this report.

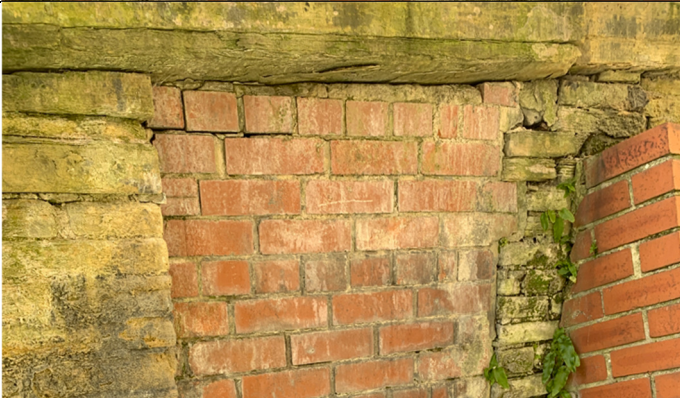
Location	Notes	Photo
<p>Car Park Historic Wall Adjacent to St George's Square.</p>	<p>External retaining wall observed to be in generally poor condition, with a noticeable lean towards Block A.</p> <p>Brickwork piers appear to have been retrospectively added to provide some degree of stabilisation.</p> <p>Foundation details are currently unknown.</p> <p>Vegetation growth noted at the base of the wall, which may be contributing to ongoing deterioration.</p>

As Above.	As above.
