Grange Moor Roundabout S278
Works

Pre-Commencement Condition
Survey (Condition 34)

CLIENT: PCS Property Solutions Ltd
PROJECT TITLE: Grange Moor Roundabout
Section 278 Works
REPORT TITLE: Pre-Commencement Condition Survey (Condition 34)
PROJECT NUMBER: 165875
DOCUMENT NUMBER: 165875-SAN-GMR-XX-RP-C-01
ISSUE NUMBER: P04
DATE: June 2025

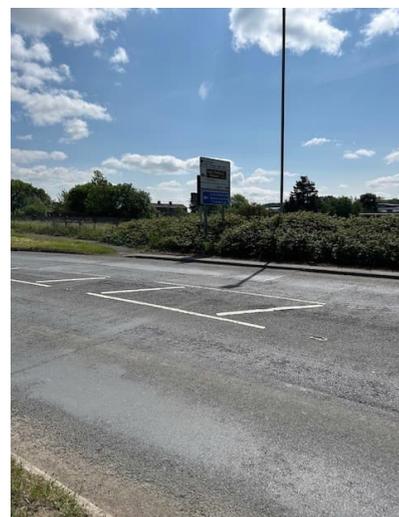
4. Liley Lane looking SW on the approach to the existing roundabout

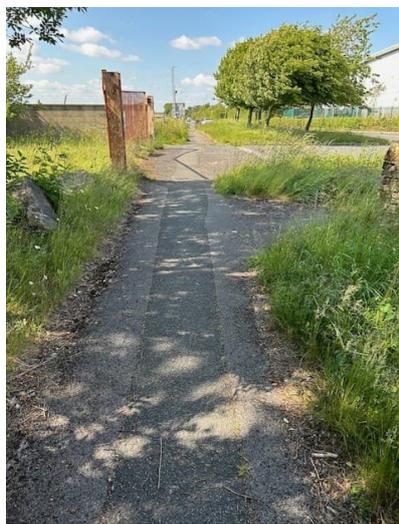
41. Liley Lane, western footpath looking north.
