Condition Survey Report

Whitehall Road West, Birkenshaw.

May 2025

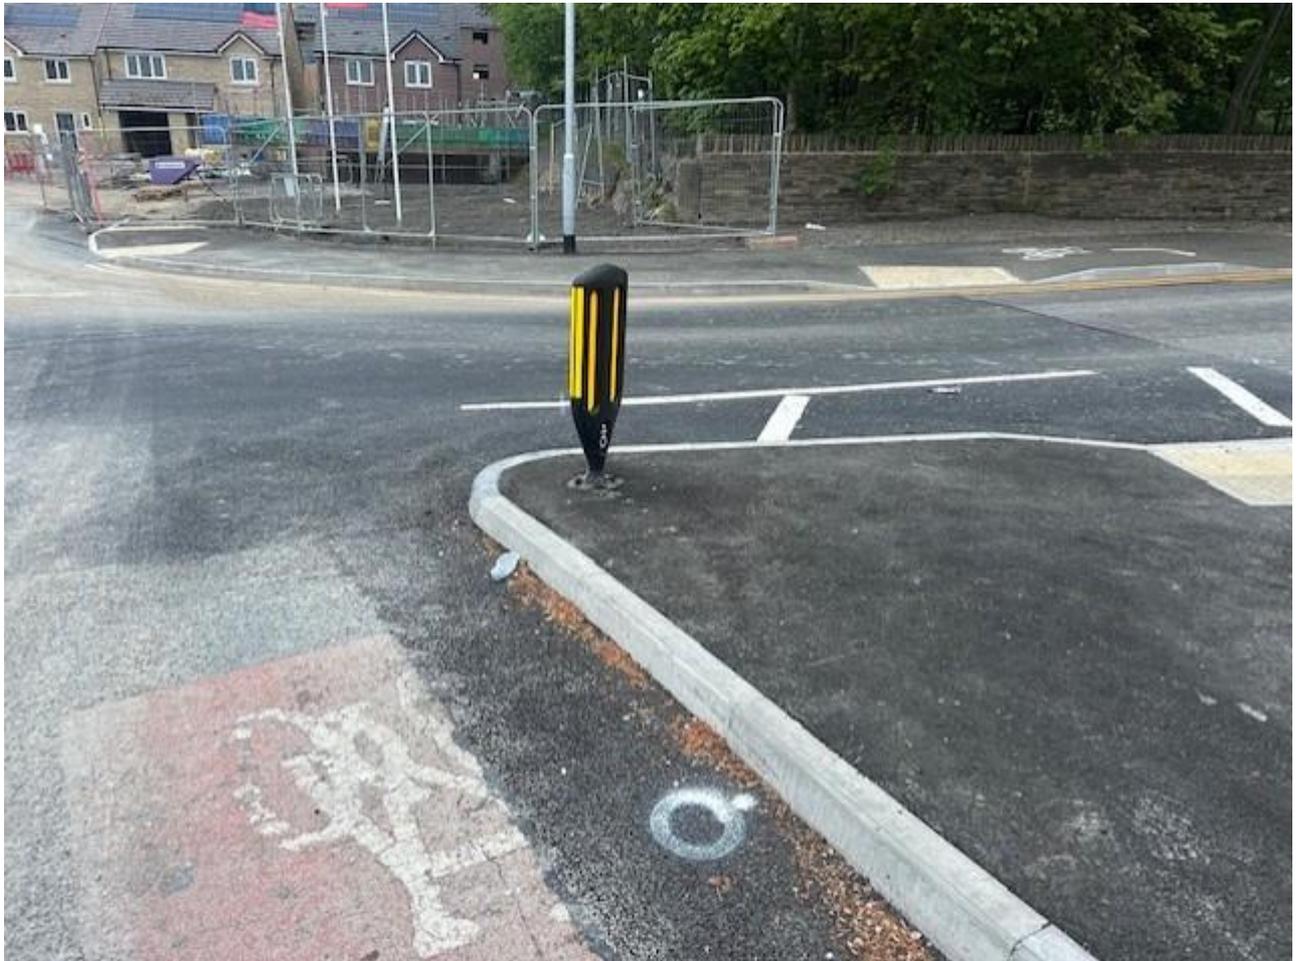
Comments – previous cycle lane / brindle surface dressing heavily worn. No details of whether this will be reinstated as part of the latest works.

Comments – see previous.

Recommendation – Highway Authority to monitor.

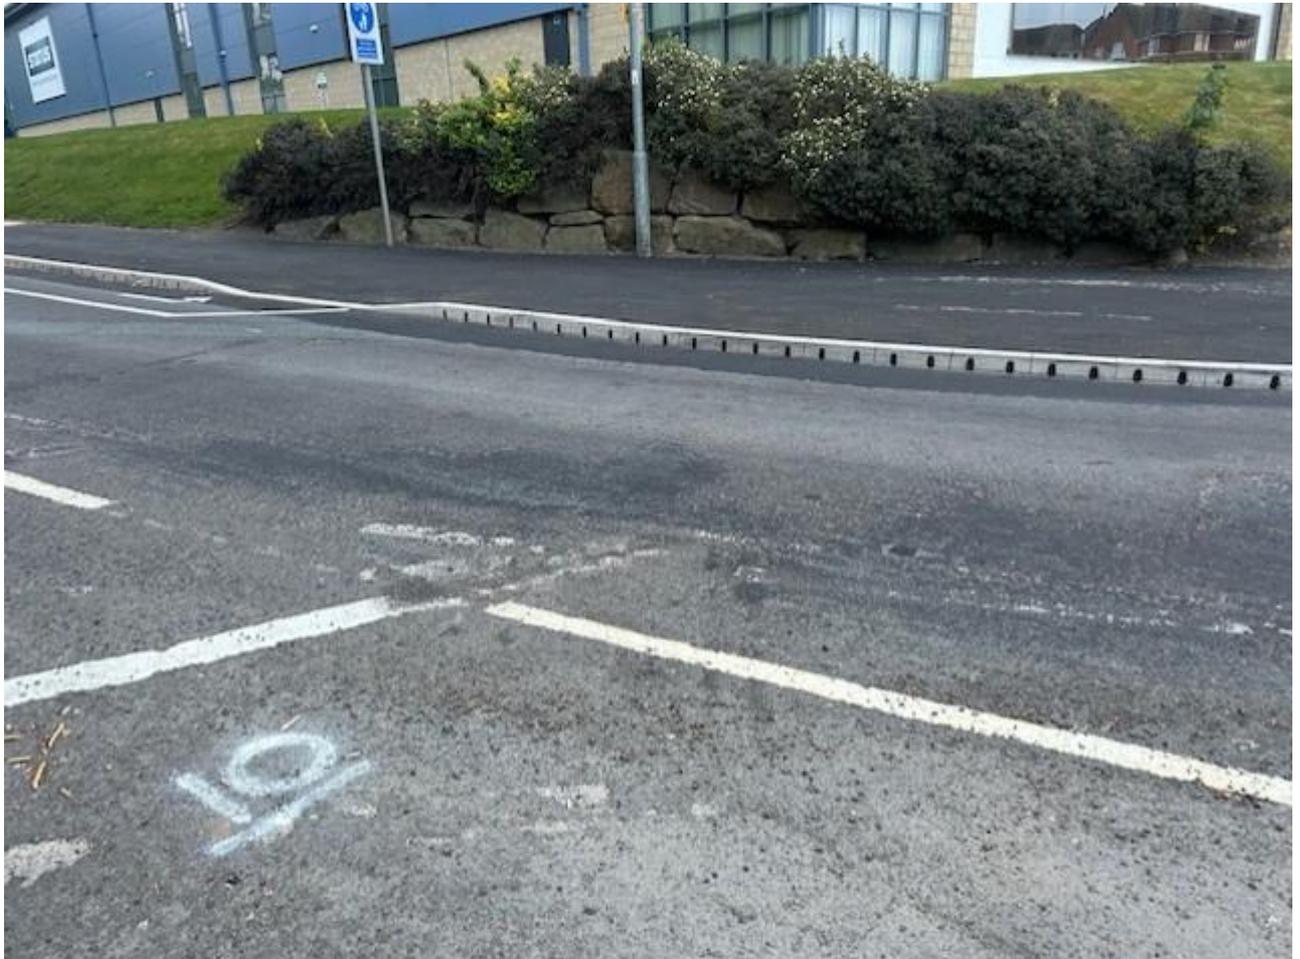
Comments – surface course requires a road sweep. Some evidence of previous road marking may require addressing as part of Road Safety Stage 3 for recent highway works.

Comments – see previous.

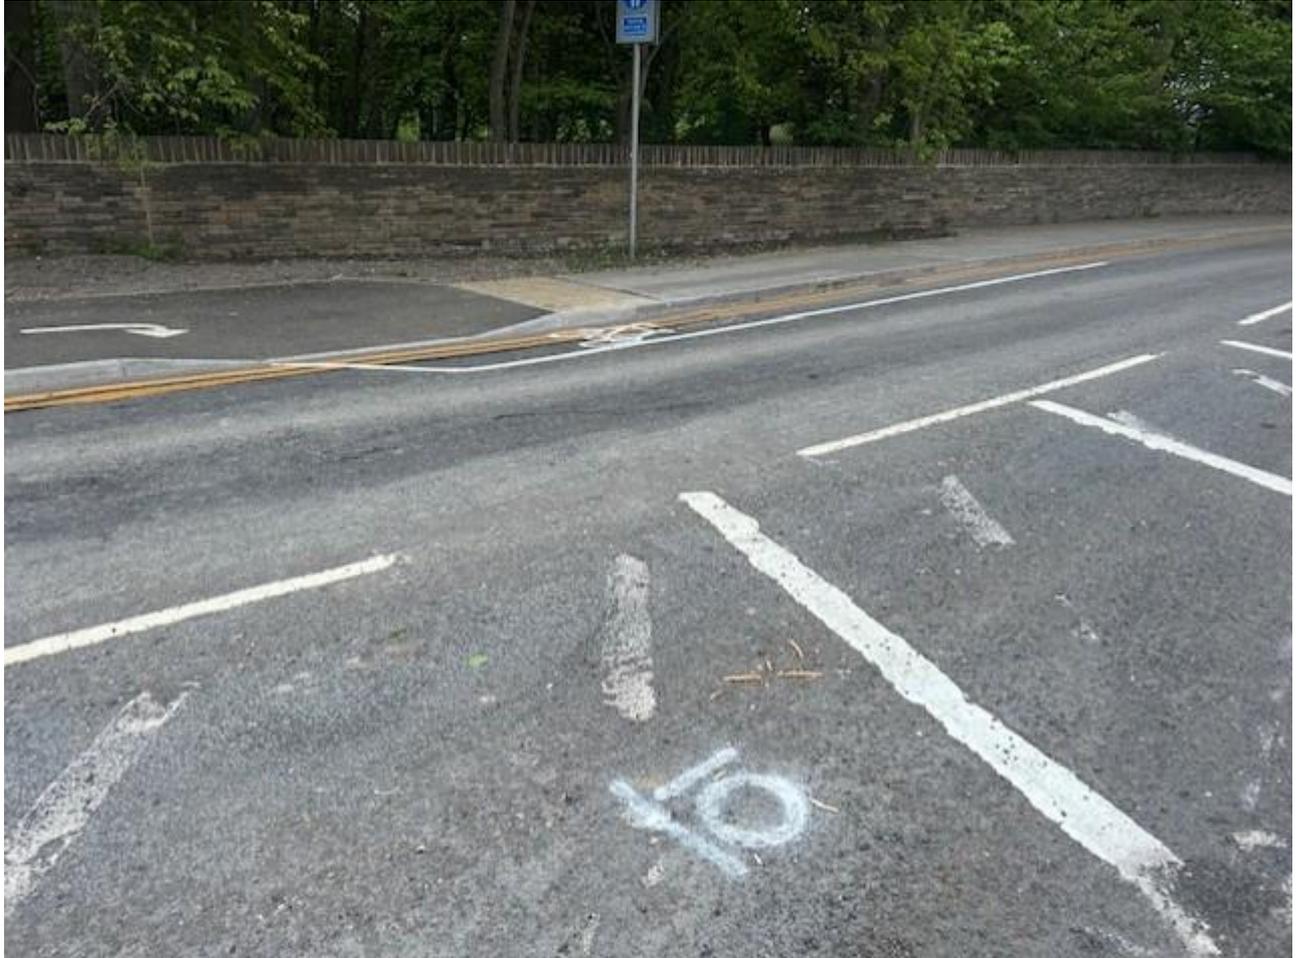
Comments – see previous.

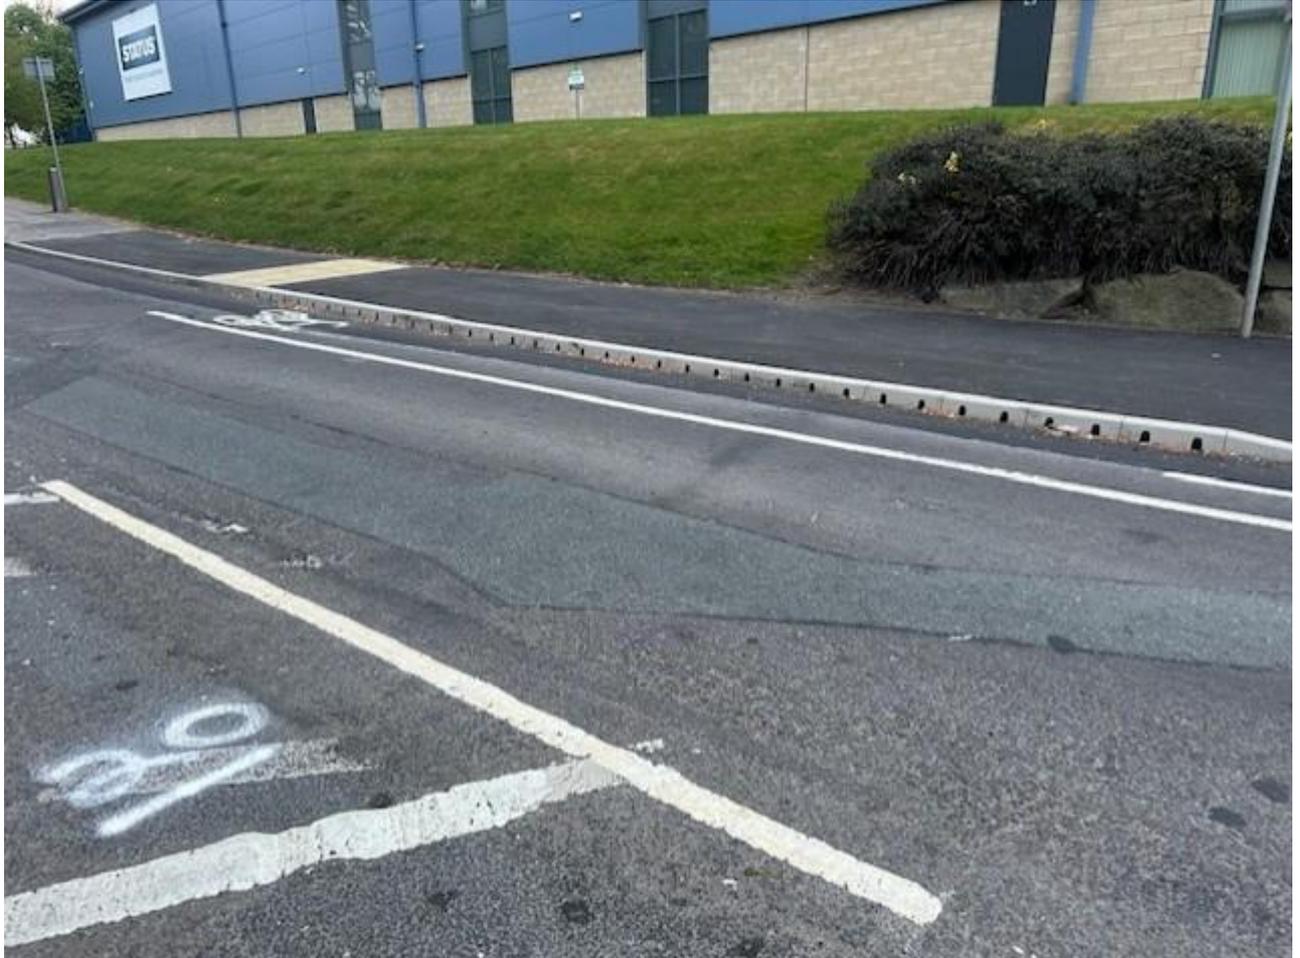
Comments – several trench reinstatements particularly at Ch 25m and also along the southern side of the carriageway where trenches cross over each other. Potential for accelerated settlement.

Comments – see previous.

Recommendation – Highway Authority to monitor.

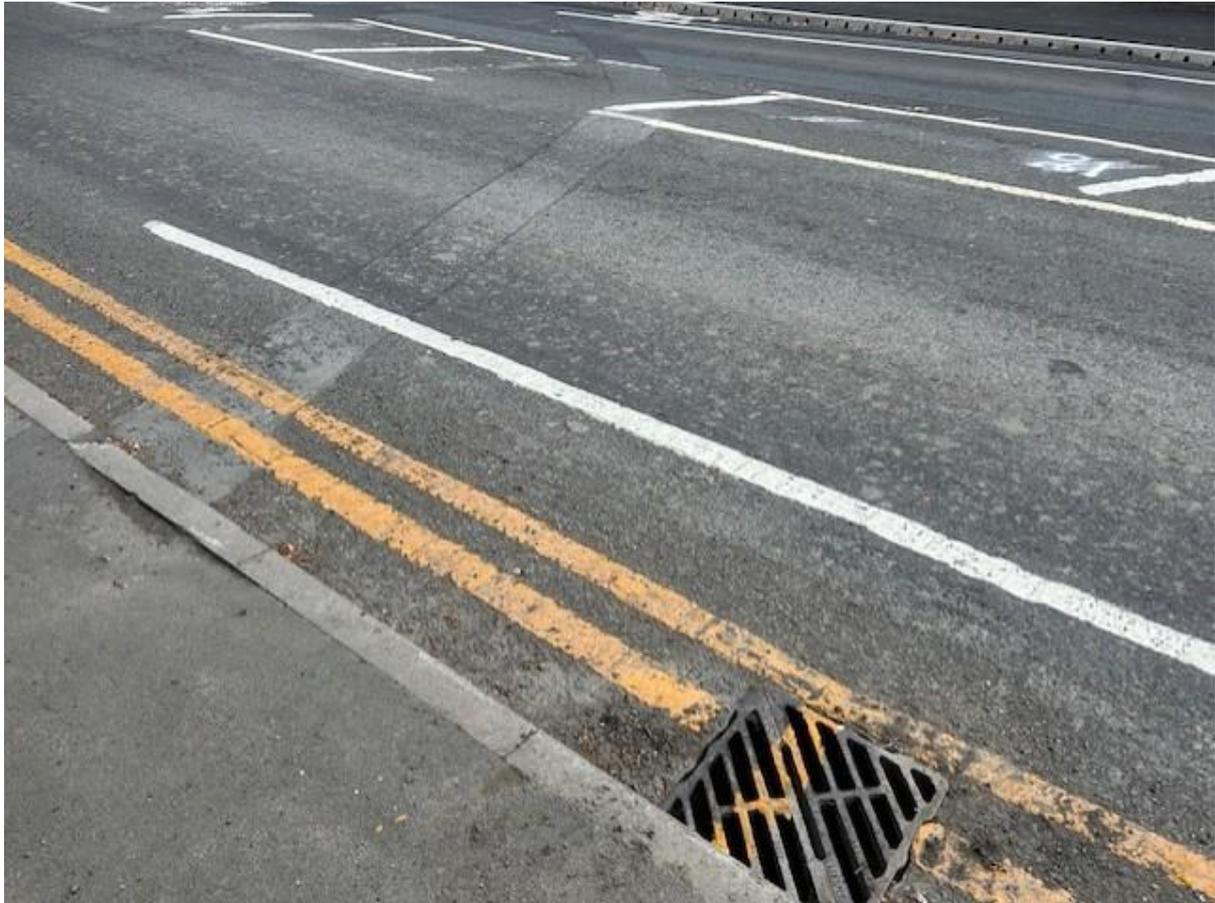
Comments – trench reinstatement running perpendicular across carriageway.

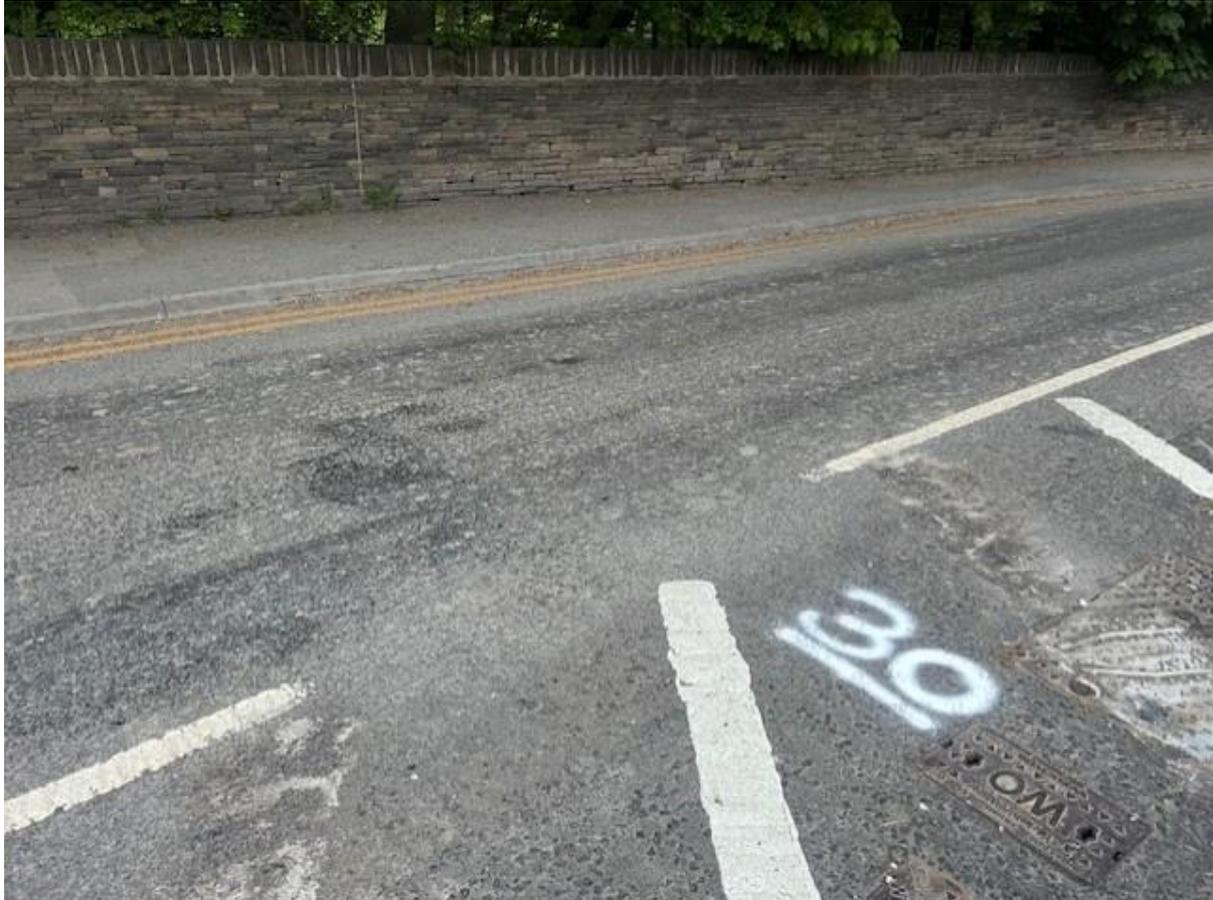
Comment – patchwork of trench reinstatements.

Comment – see previous.

Recommendation – Highway Authority to monitor.

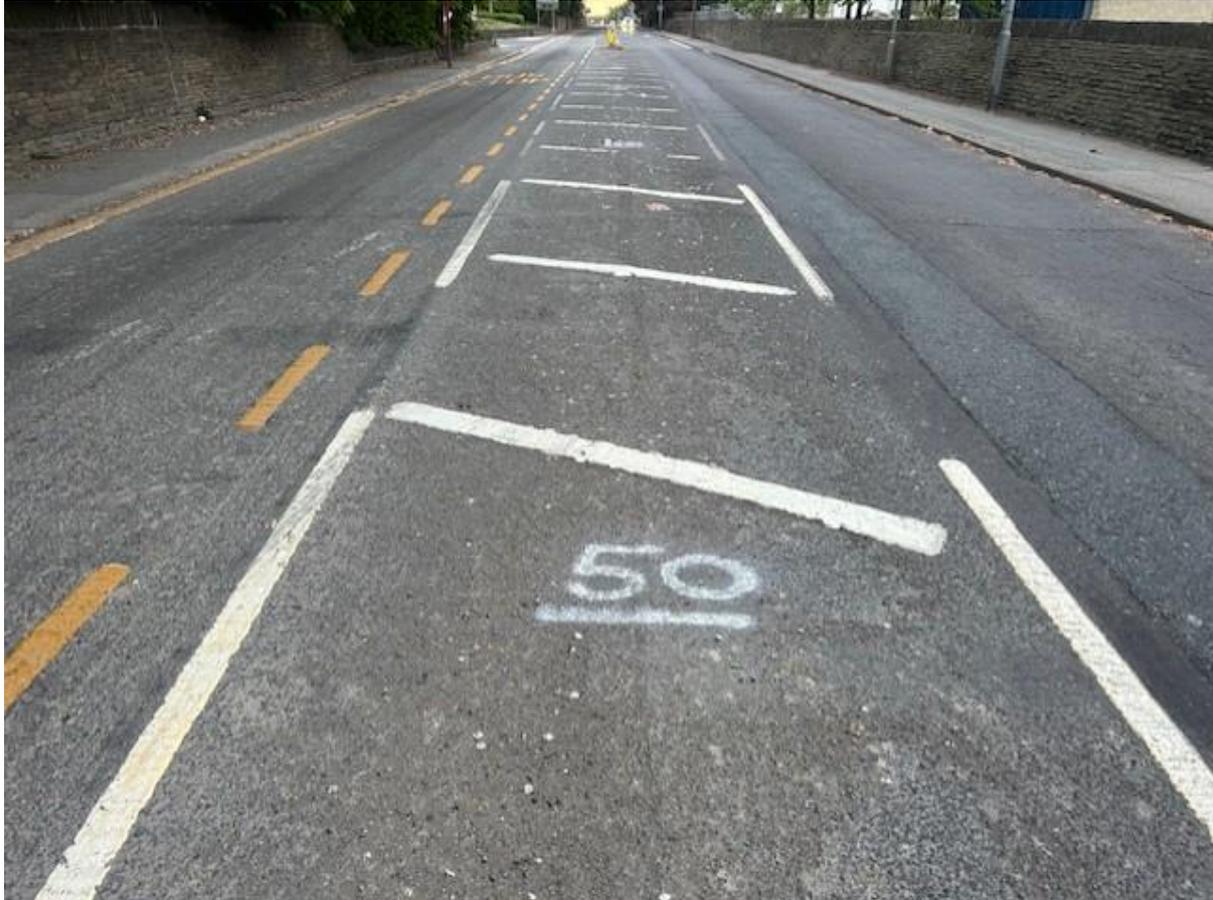
Comments - Surface course of northern side of carriageway showing signs of becoming polished.
Note trench reinstatement on southern side of carriageway.

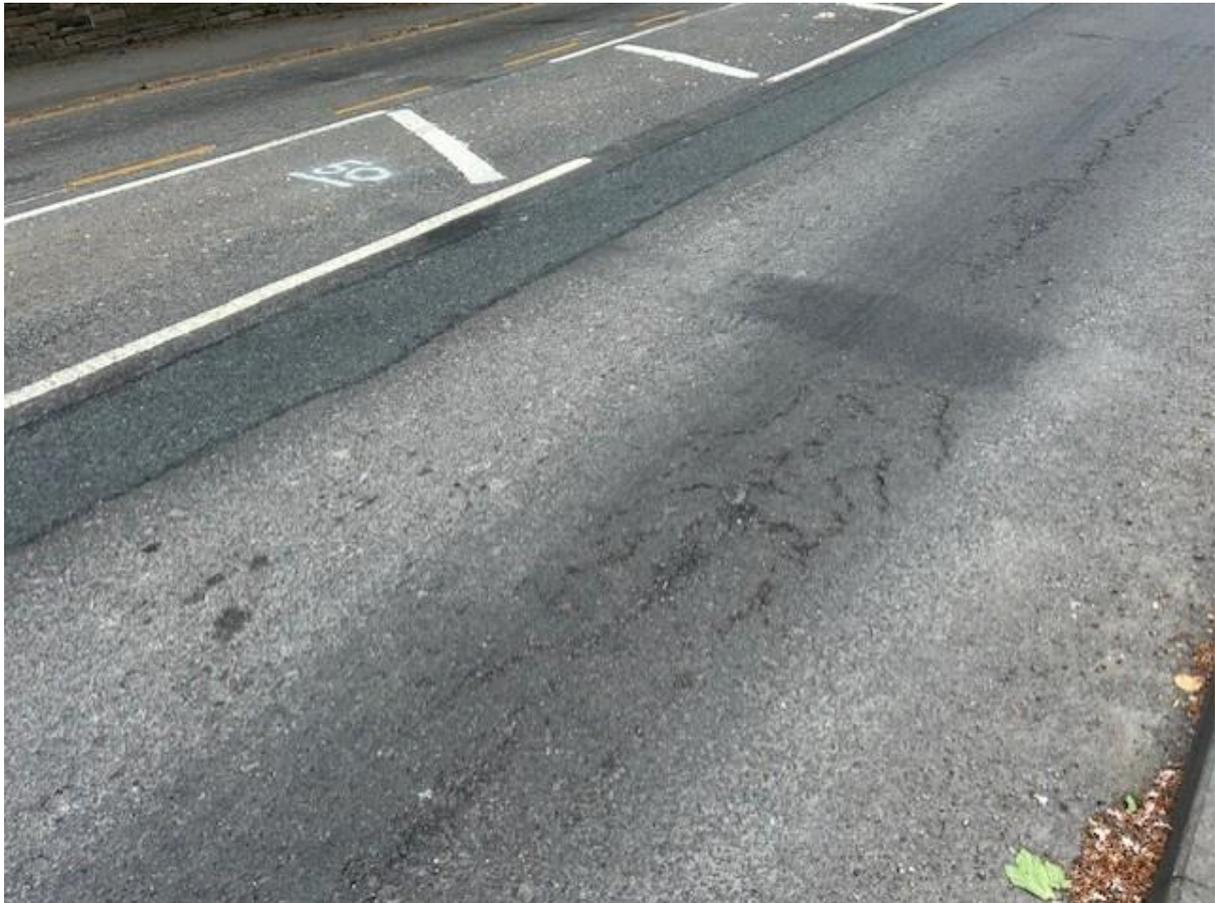
Comments – Surface course showing signs of tensile cracking along near side wheel track on south side of carriageway.

Comments – see previous.

Recommendation – Highway Authority to monitor.

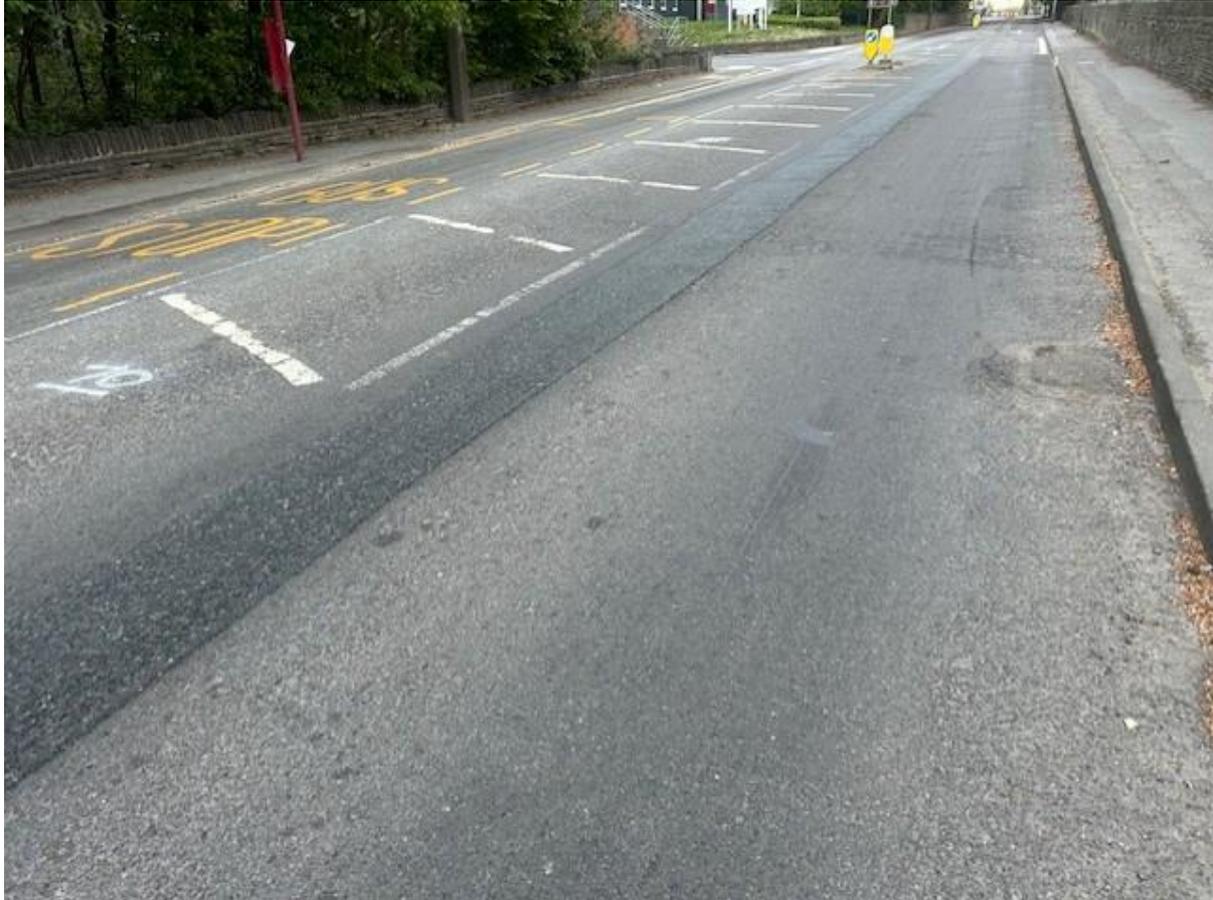
Comments – Surface course adjacent to existing kerb at Ch 71m uneven.

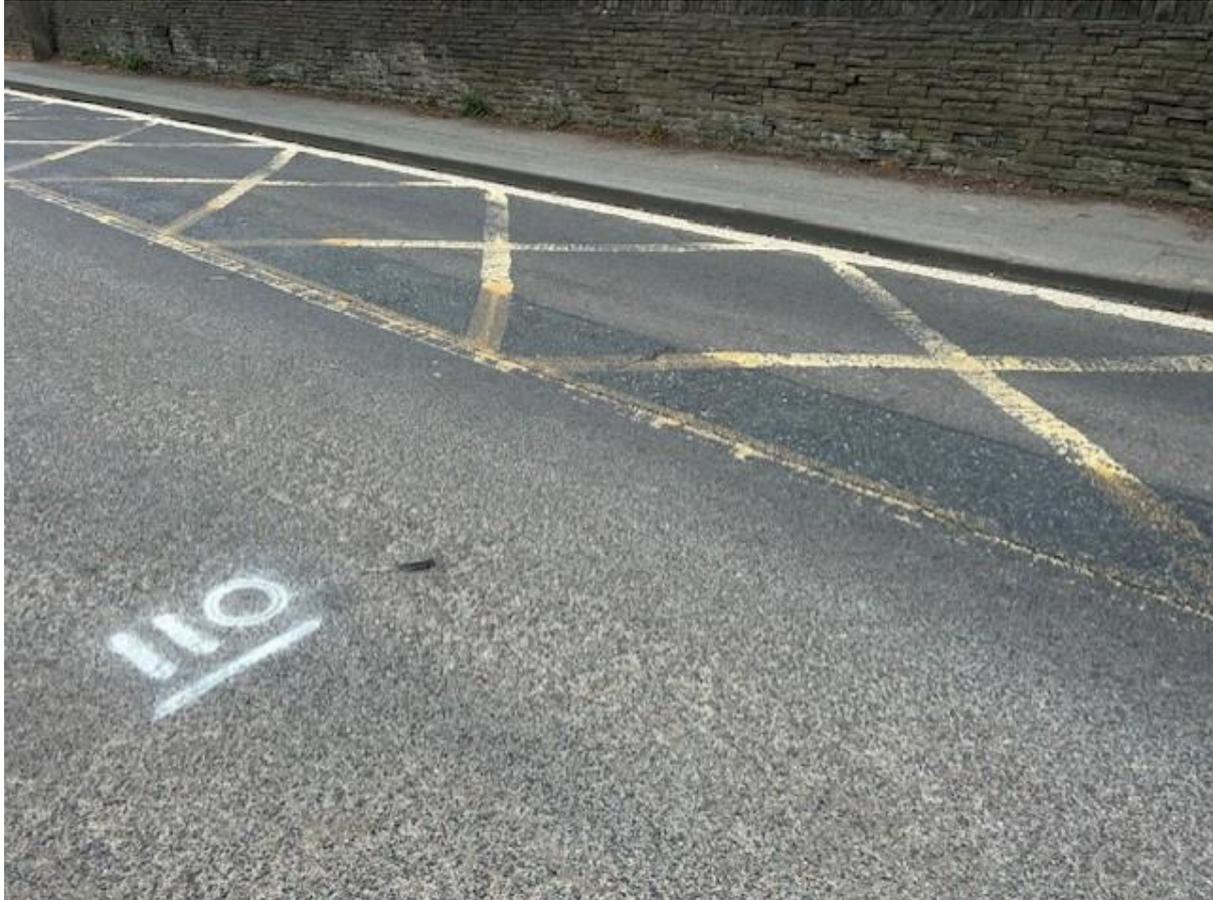
Comments – All carriageway markings suffering from premature wear because of heavy goods vehicles turning in and out of the Fire Service Headquarters.

Comments – As above.

Recommendation – Highway Authority to monitor.

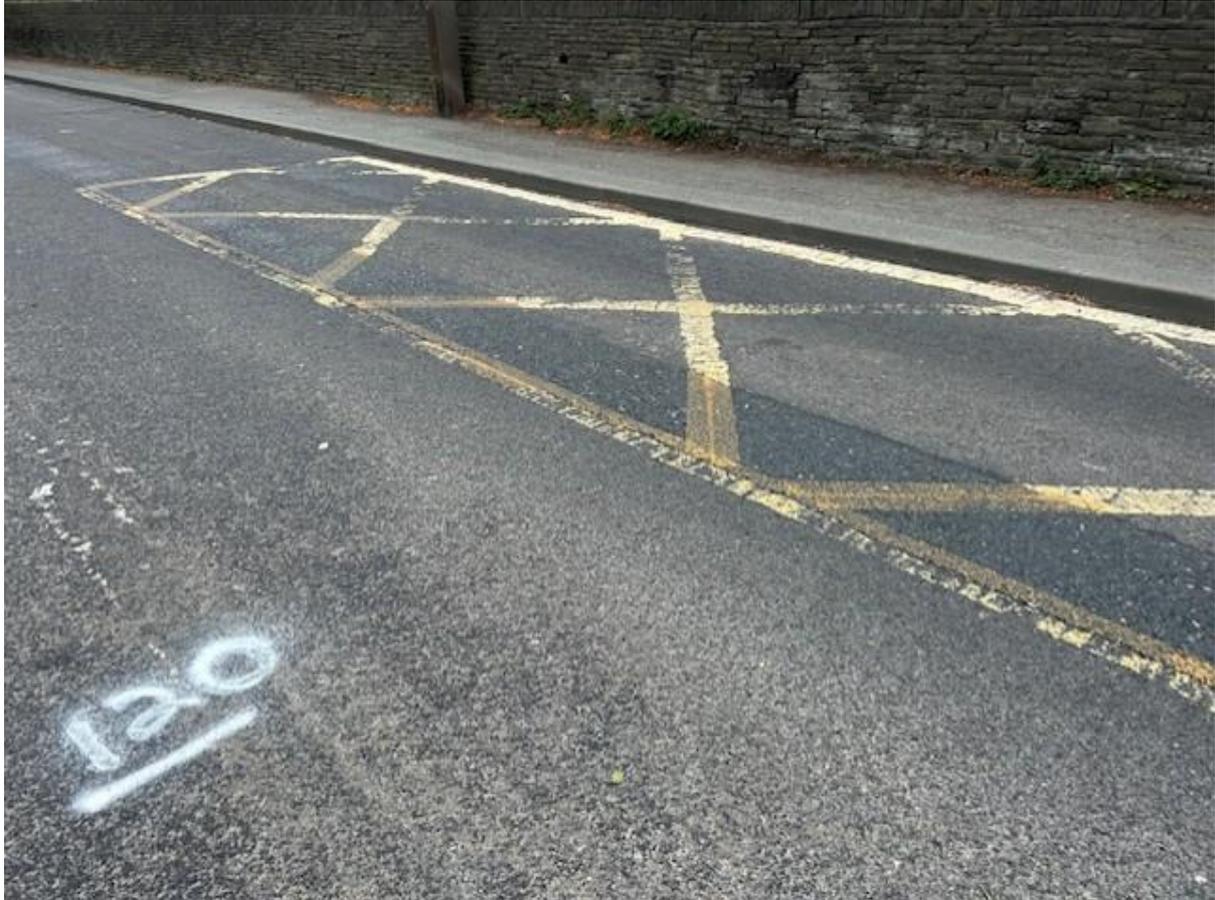
Comments – Surface course and road markings worn.

Comments – see previous.

Recommendation – To be monitored by the Highway Authority.

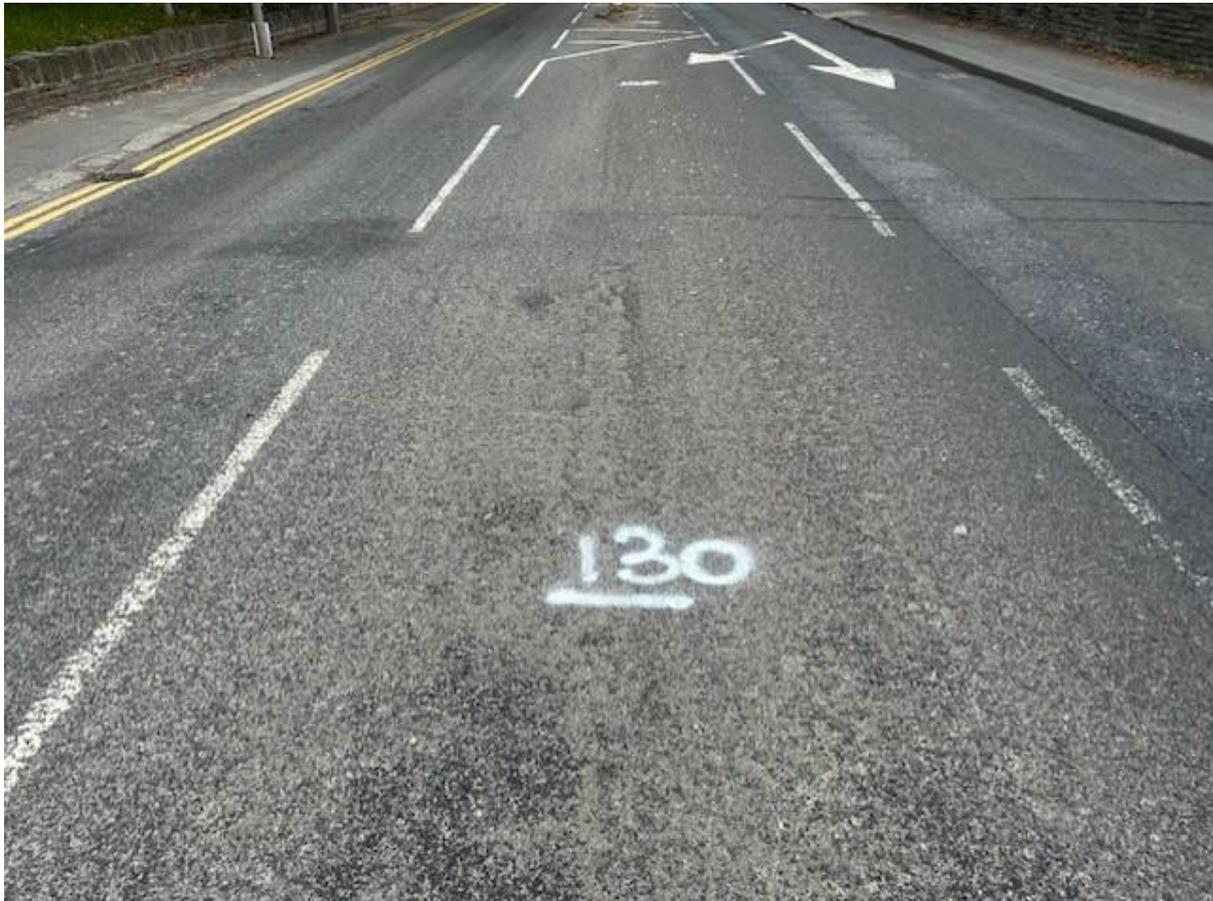
Comments – Trench reinstatement across carriageway at Ch 134m.

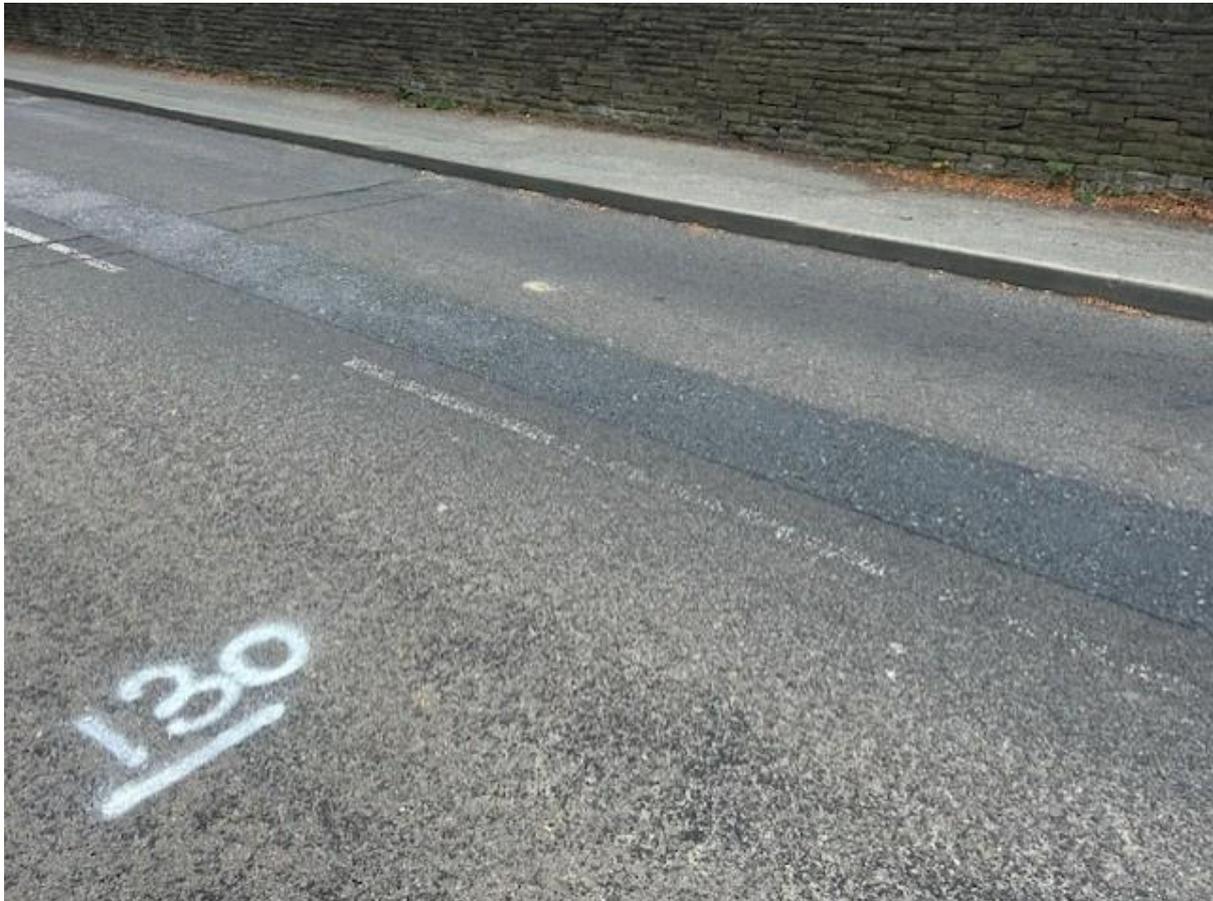
Comments – Trench reinstatement crossing parallel trench running along length of Whitehall Road
West Ch 134m.

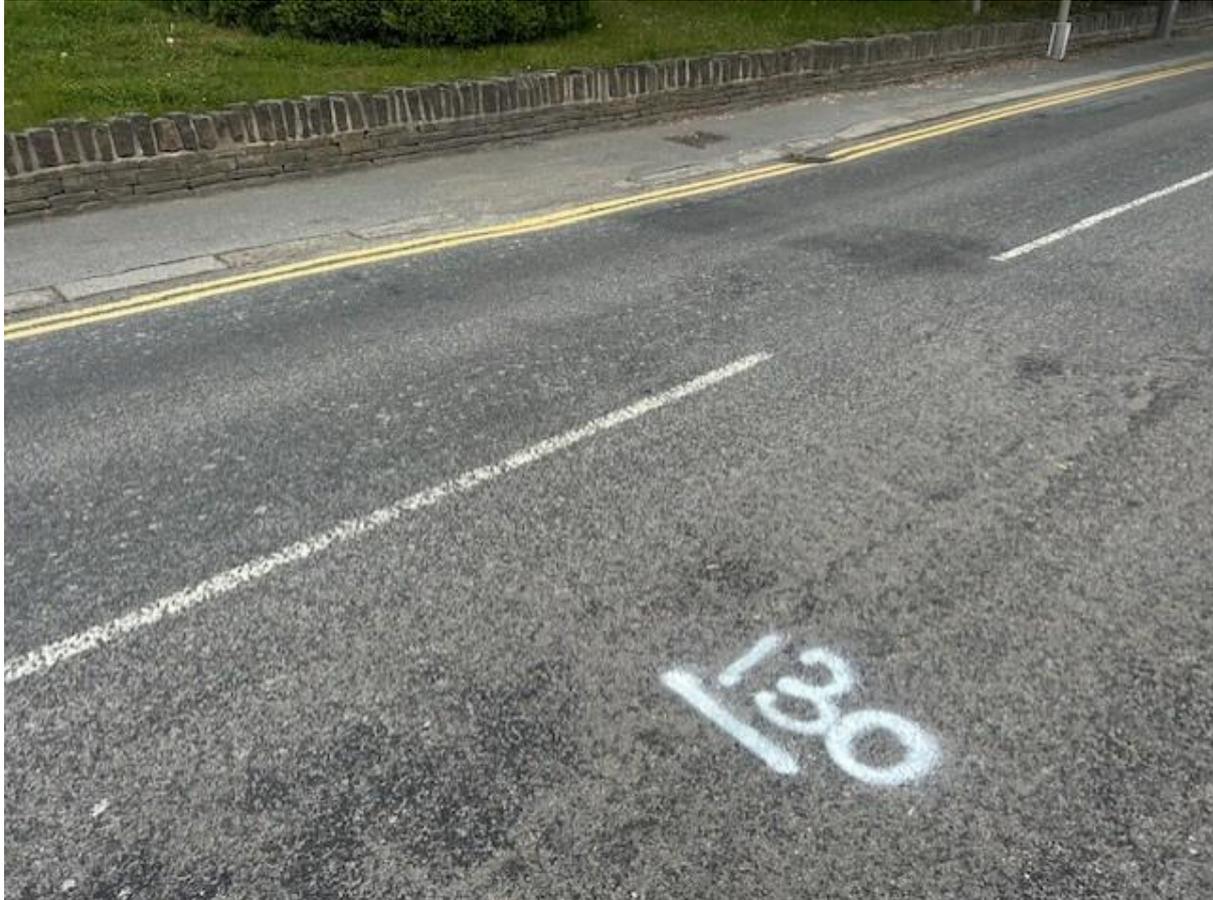
Comments – Channel line level appears to drop slightly at ch132m – Ch 135m.

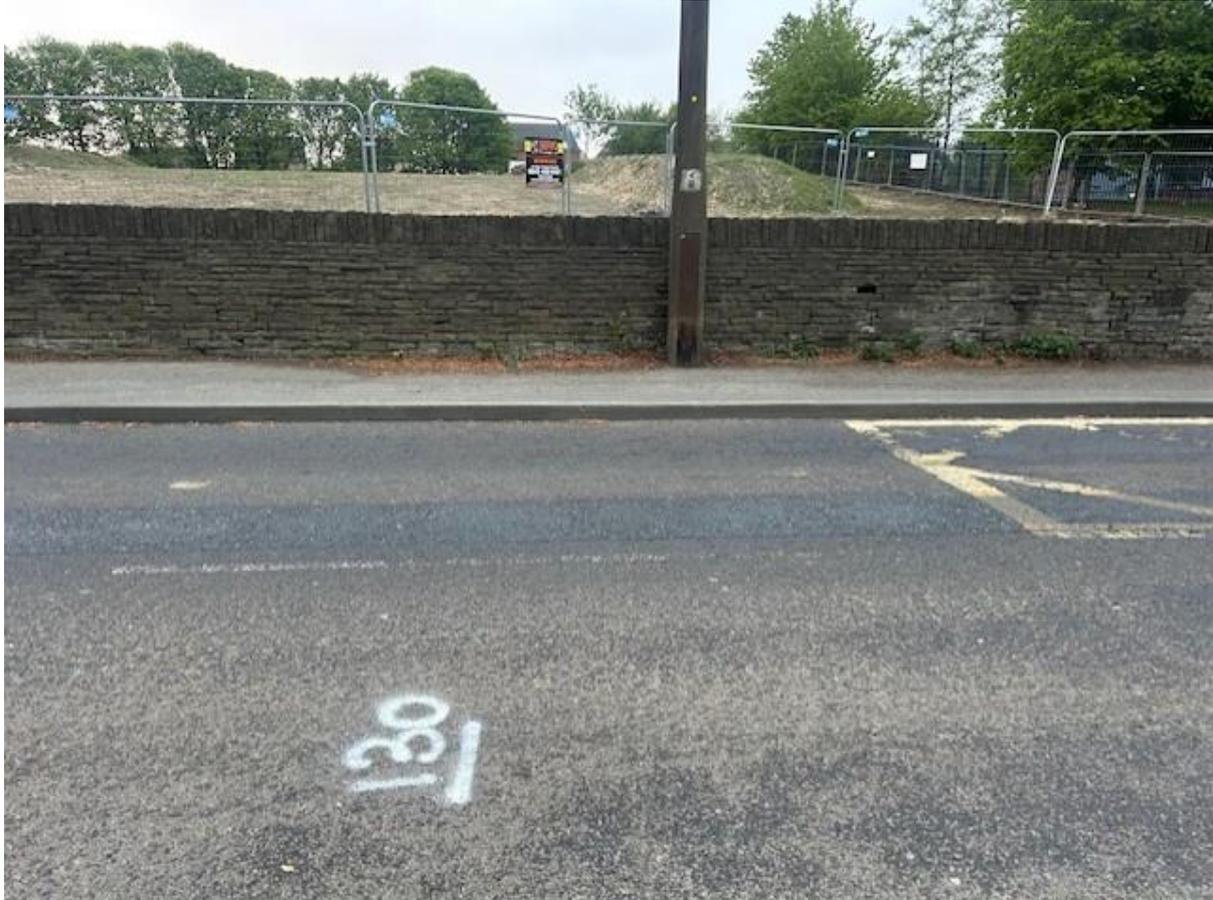
Comments – Signs of standing water where general detritus is gathering. Potential drainage problem with surface water.

Comments –see previous.

Recommendation – Highway Authority to visit site in wet weather.

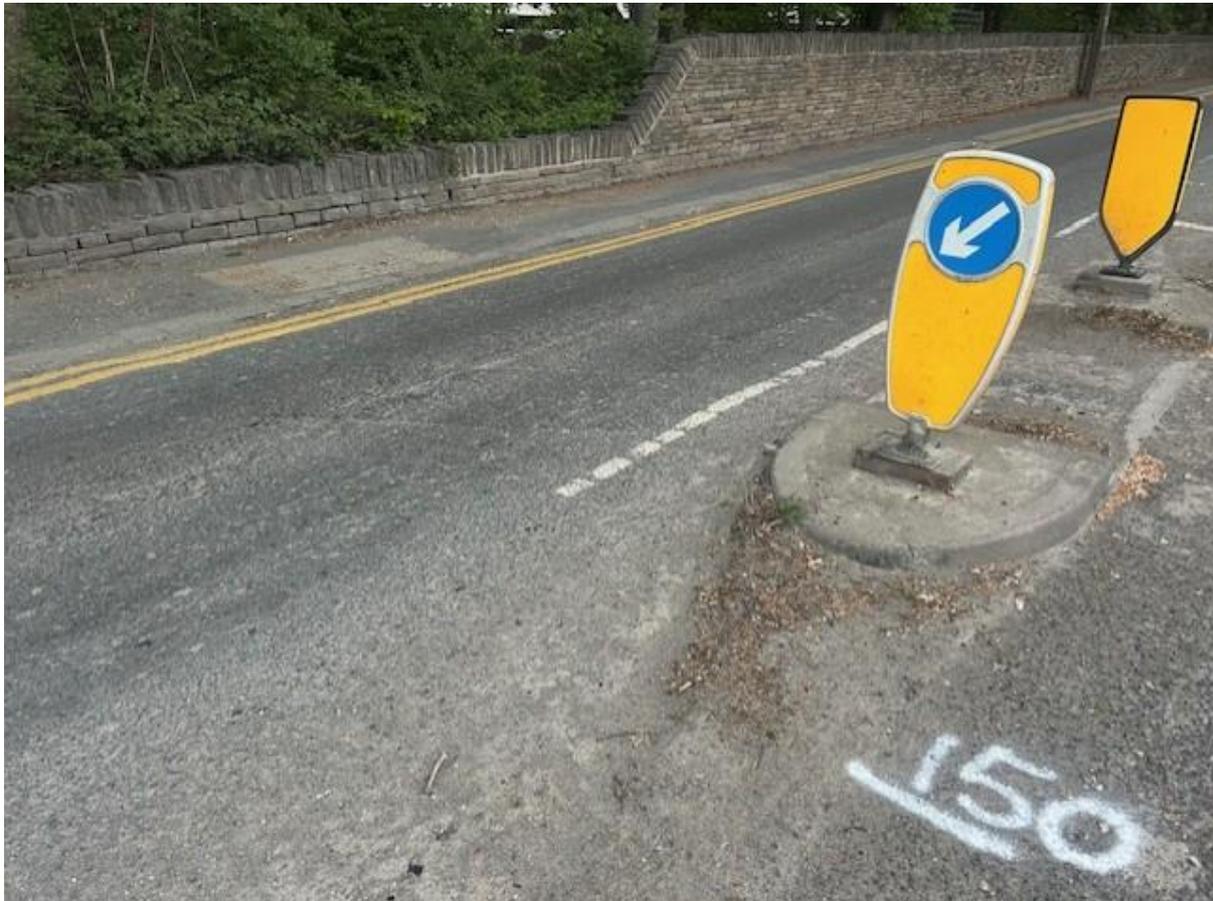
Comments – Trench reinstatements cross each other. Some signs of gaps in surface course starting to develop.

Comments – see previous.

Recommendation – Highway Authority to monitor.

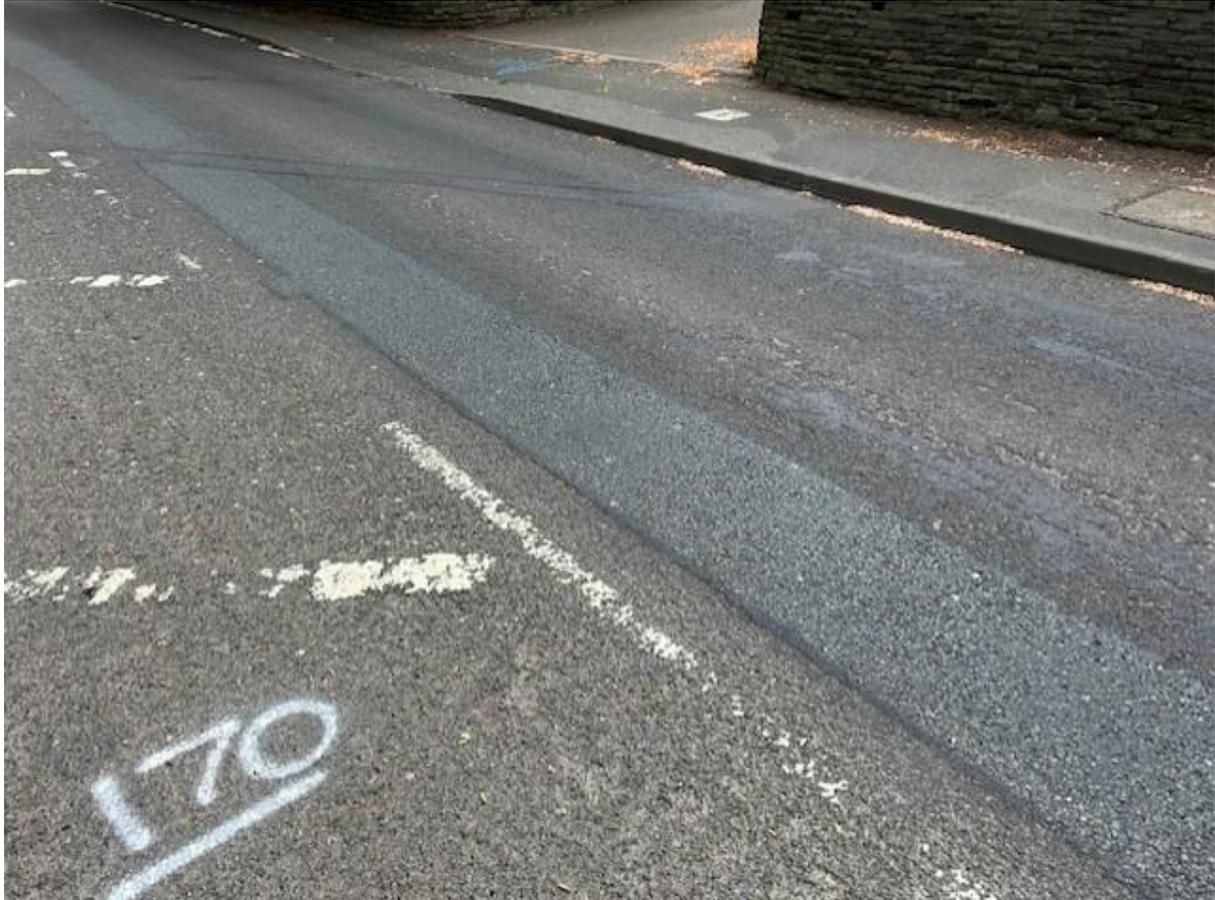
Chainage 170m

Comments – see previous.

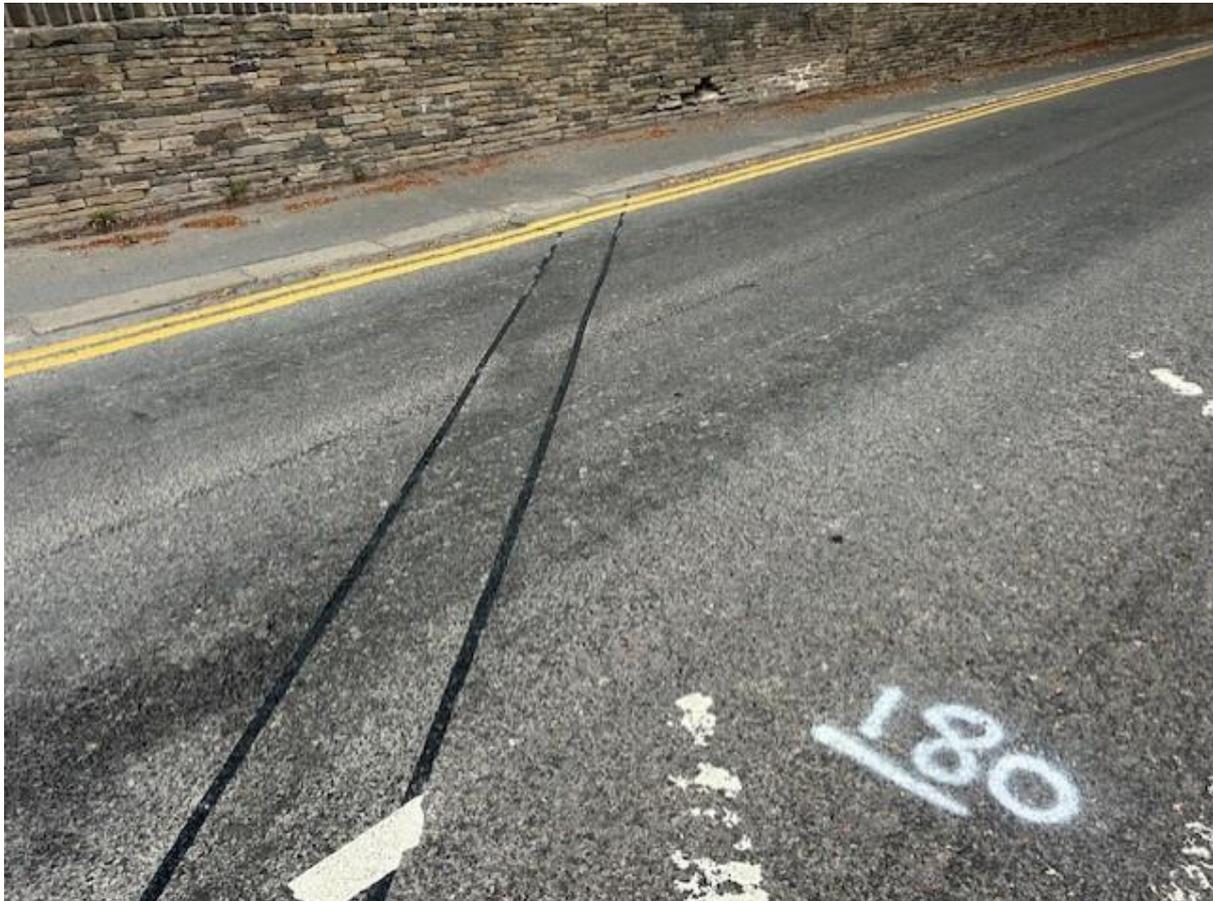
Comments – Diagonal trench reinstatement continues onto northern lane of carriageway.

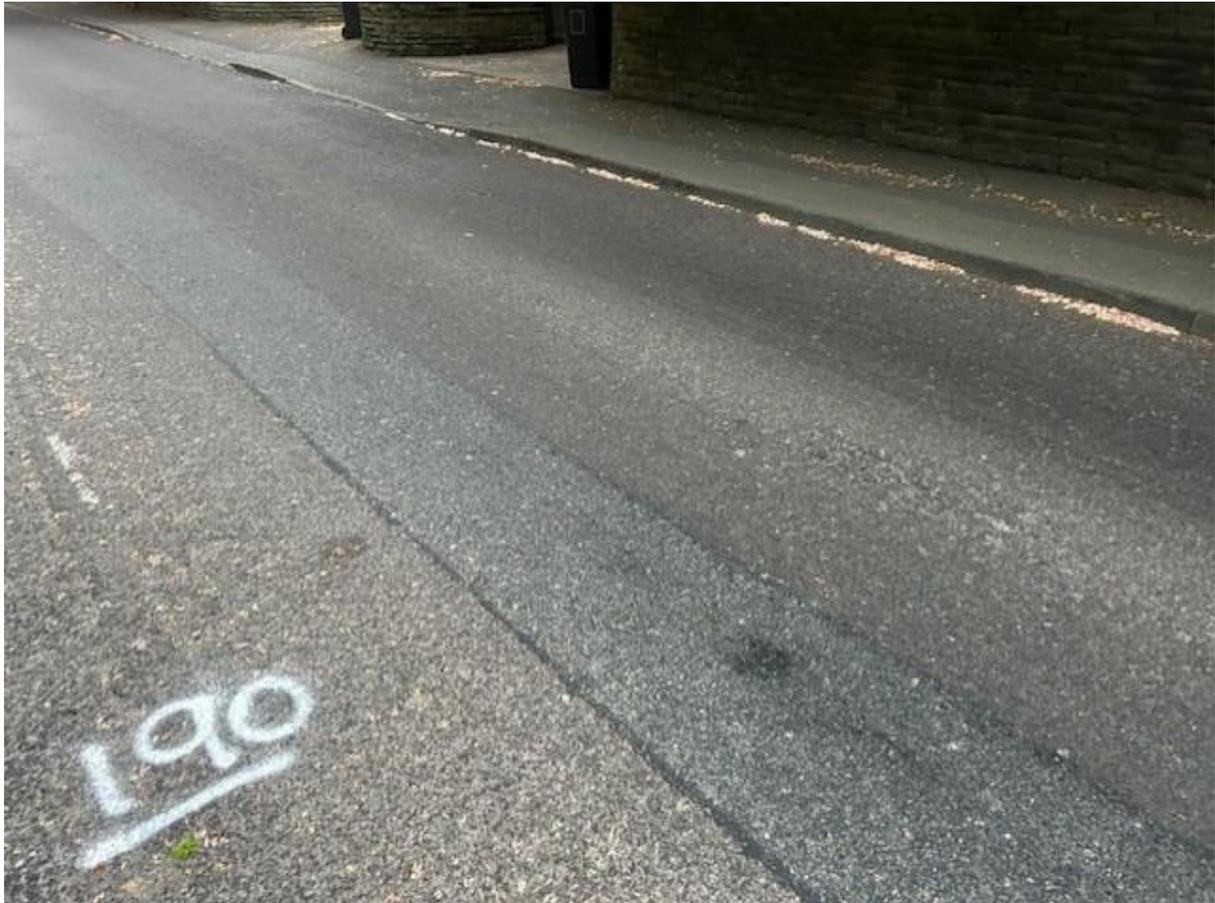
Comments – see previous.

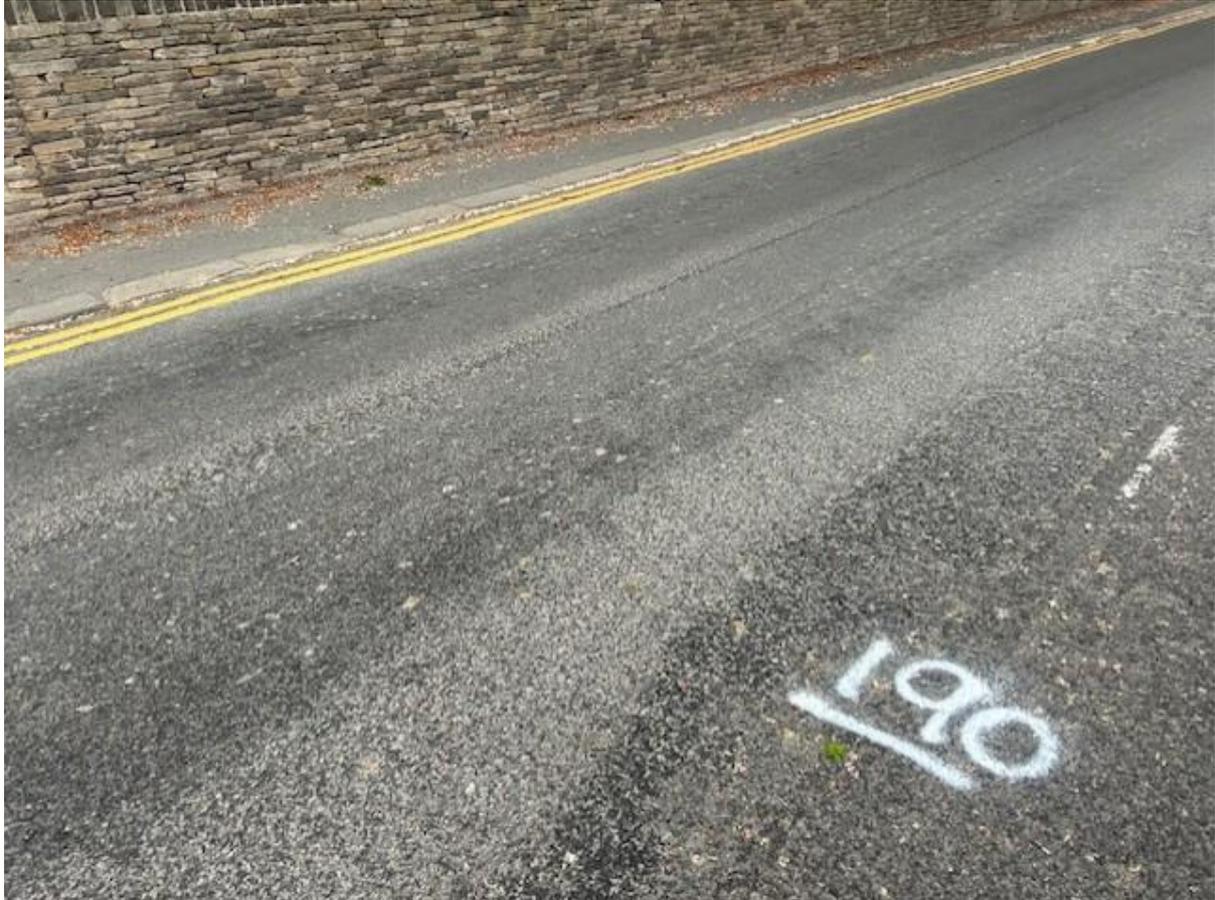
Chainage 190m

Comments – see previous.
