Condition Survey Report

Whitehall Road West, Birkenshaw.

May 2025

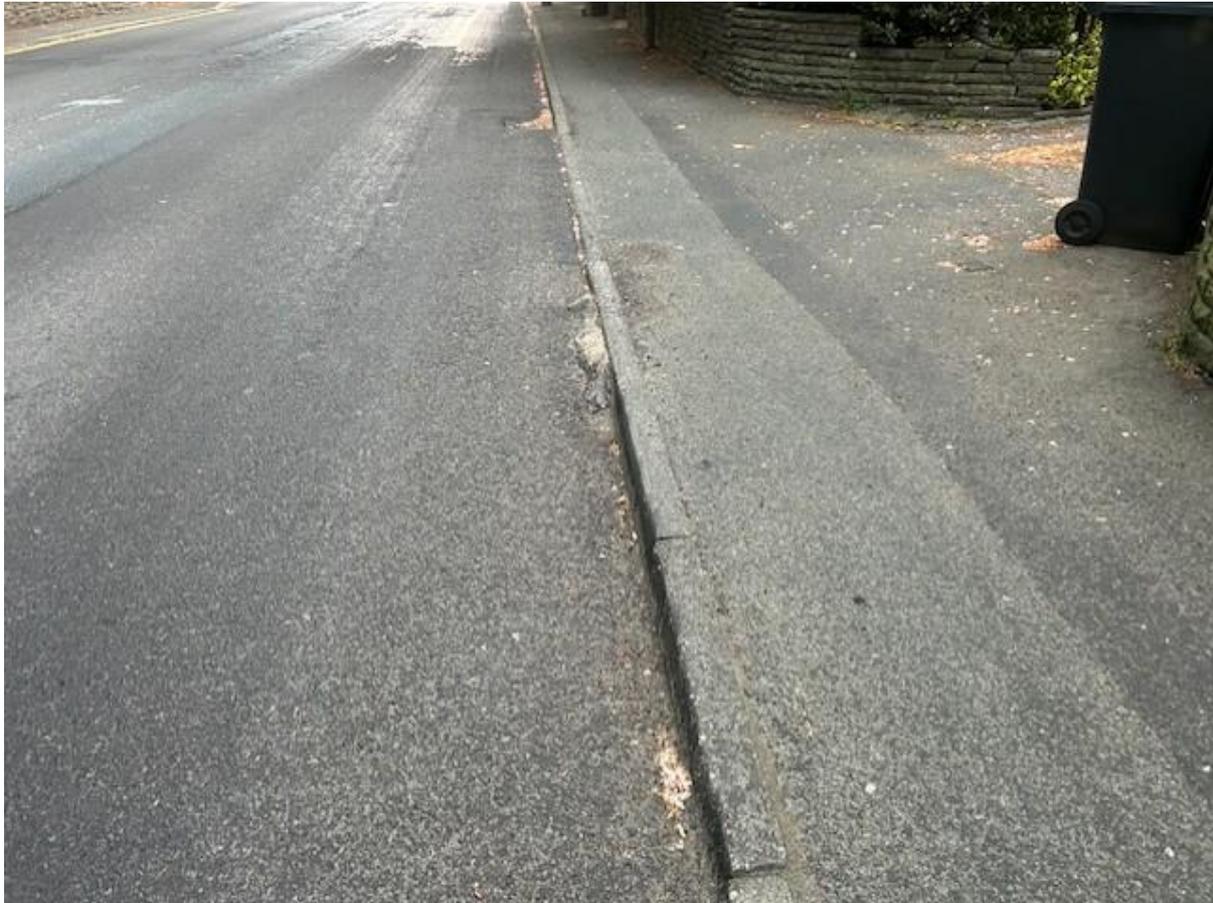
Comments – drainage channel temporarily obstructed by placement of concrete to create ramp at existing vehicular crossing.

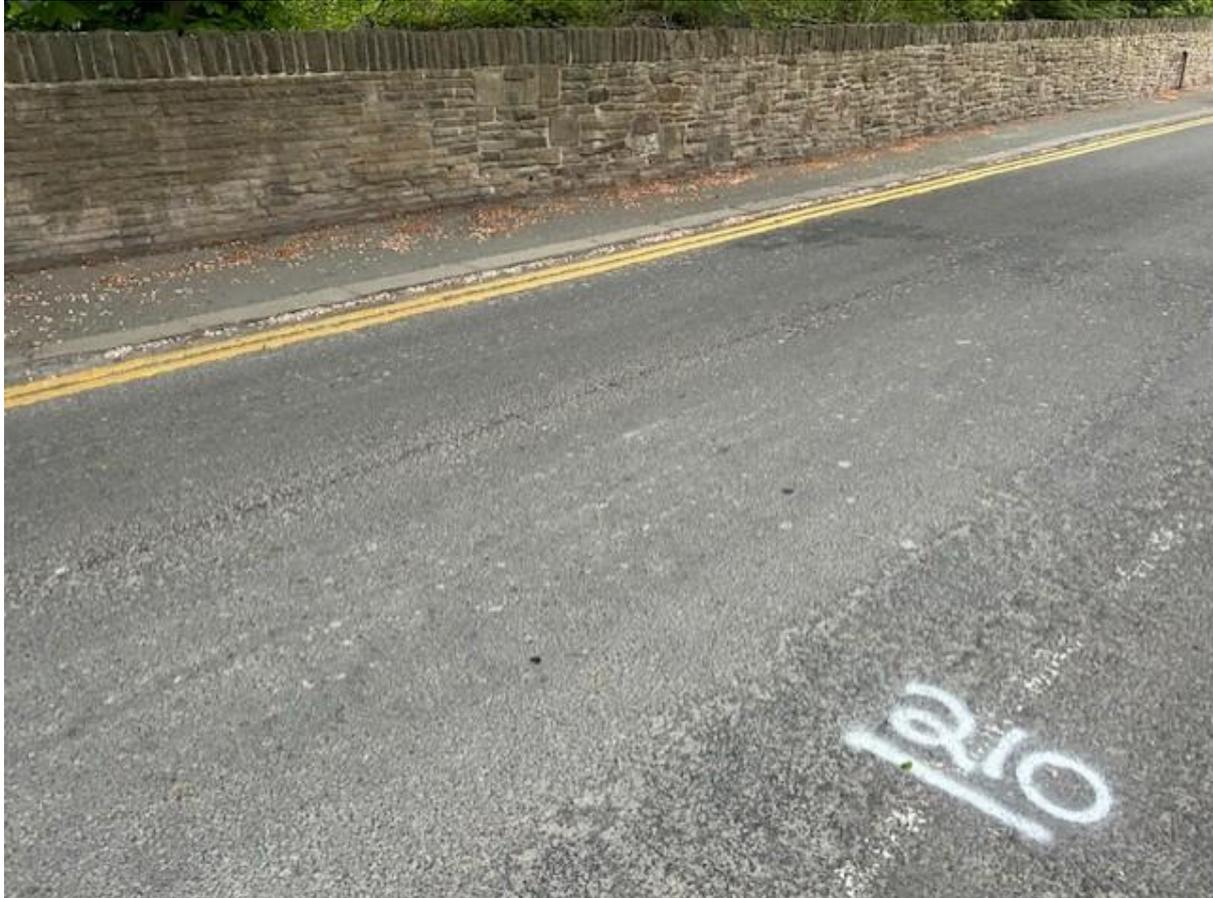
Comments – As per previous comments.

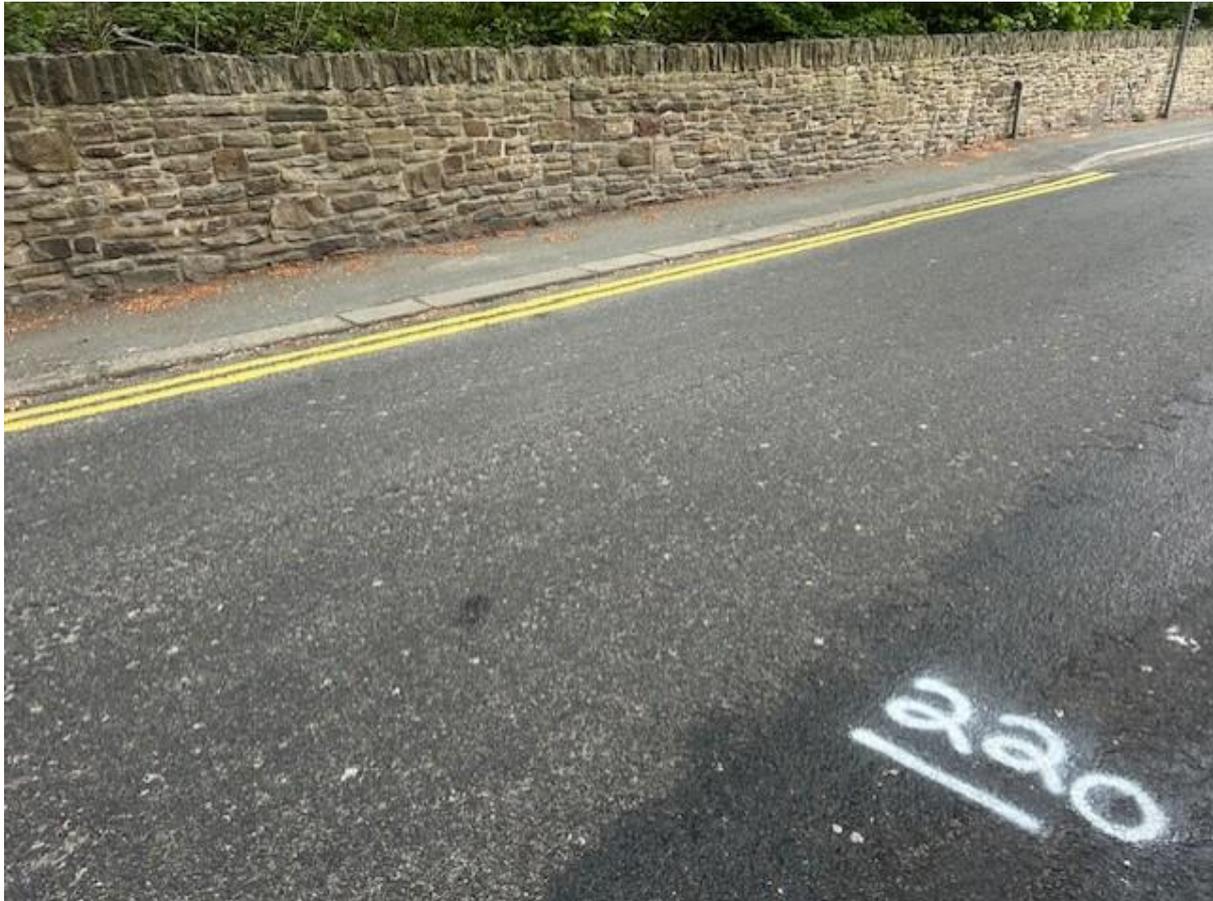
Comments – see previous.

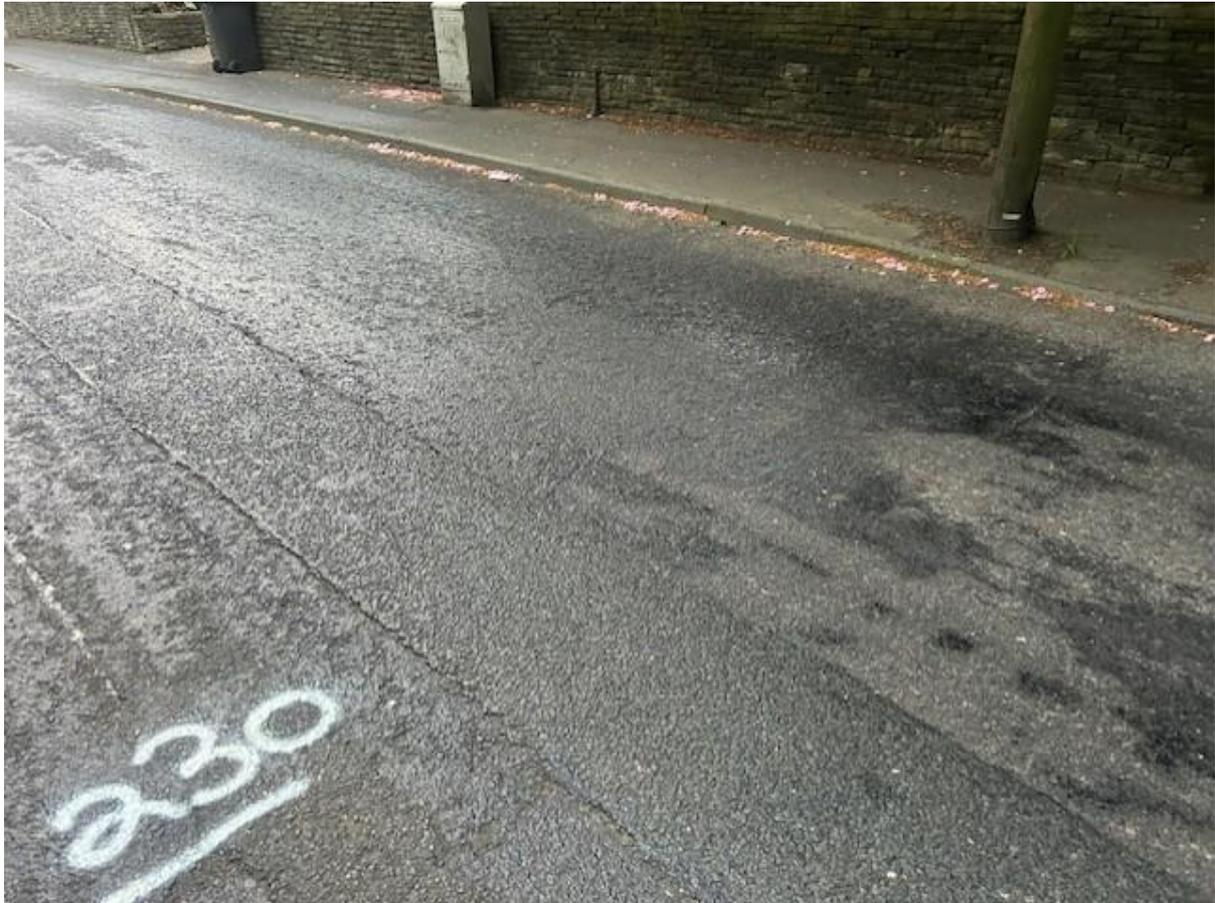
Comments – see previous.

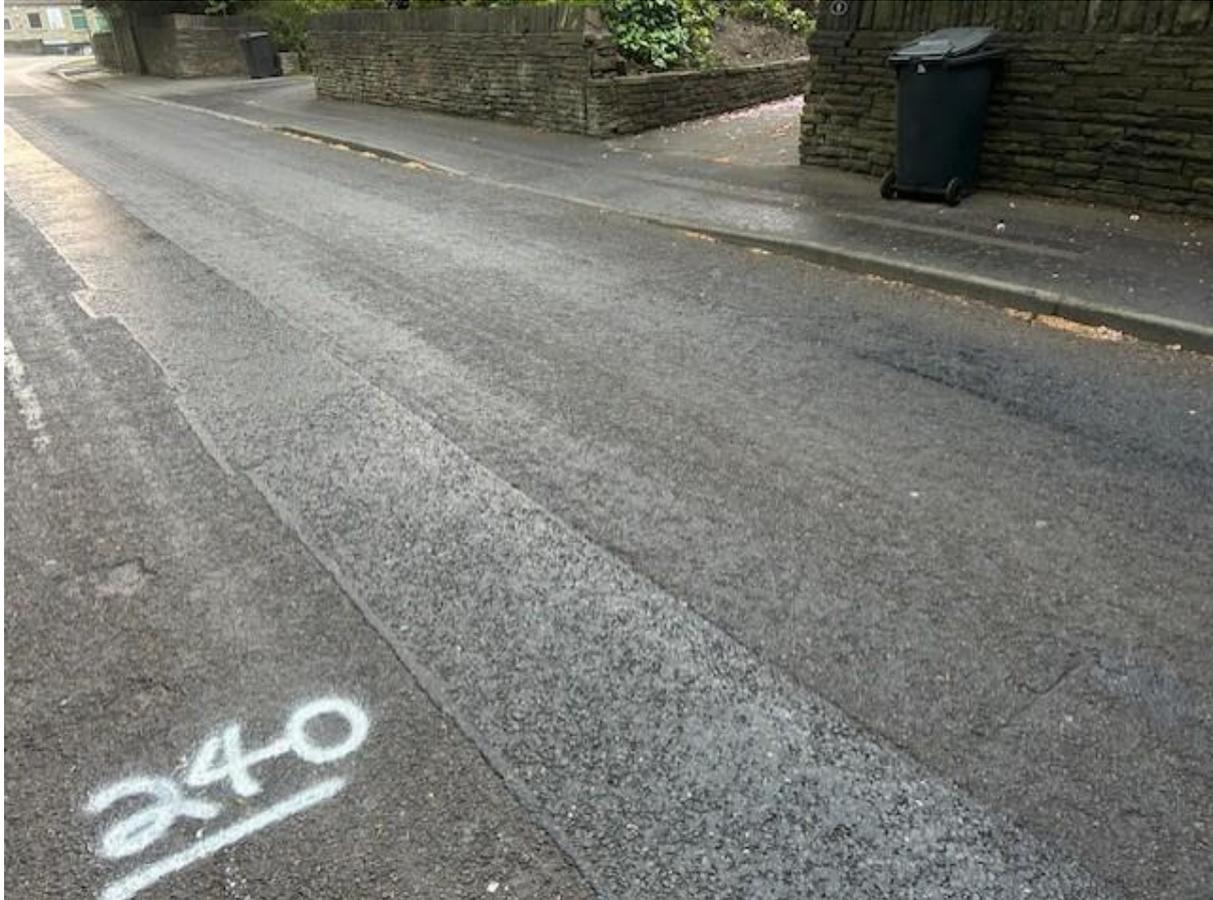
Chainage 240m

Comments – see previous.

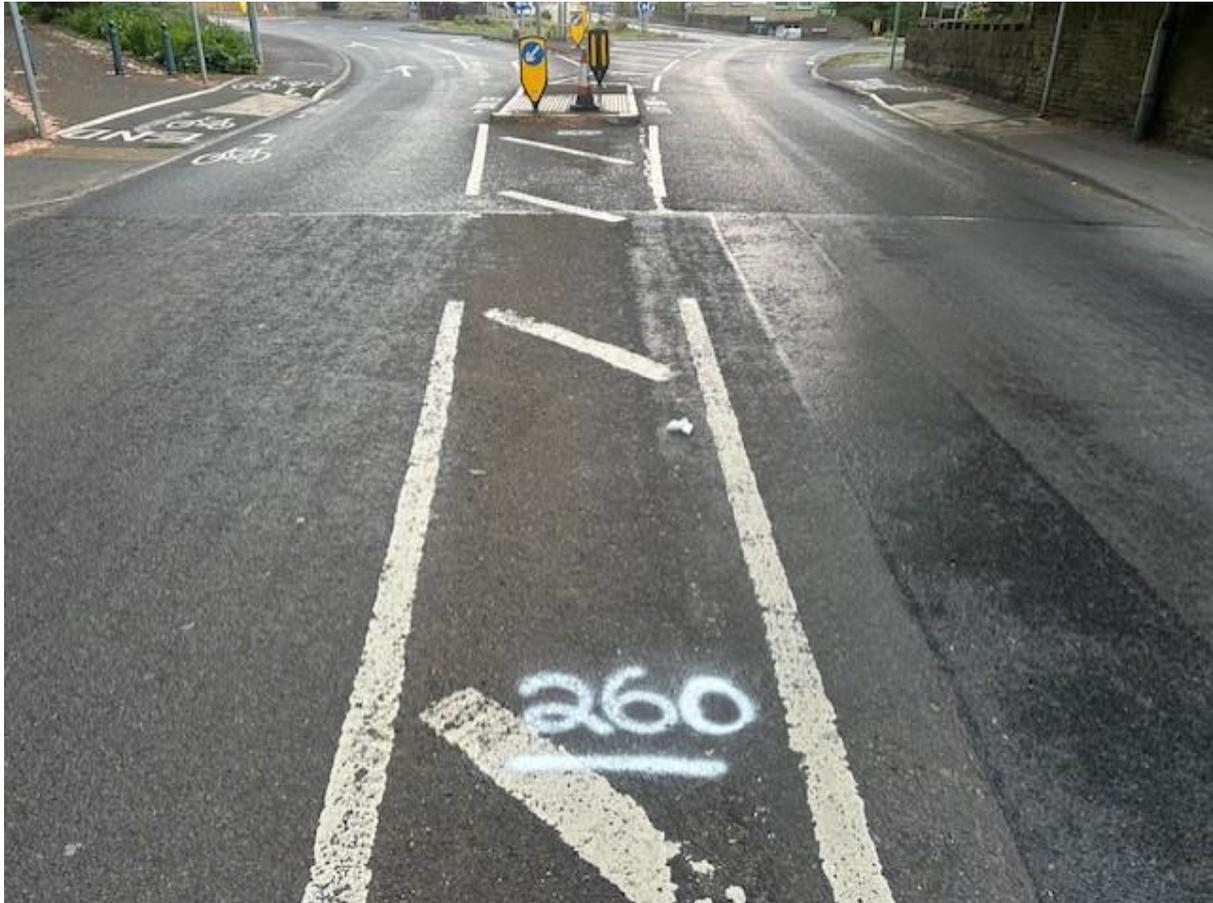
Comments – trench reinstatement continues southern flank. Note new carriageway construction at Ch 265m.

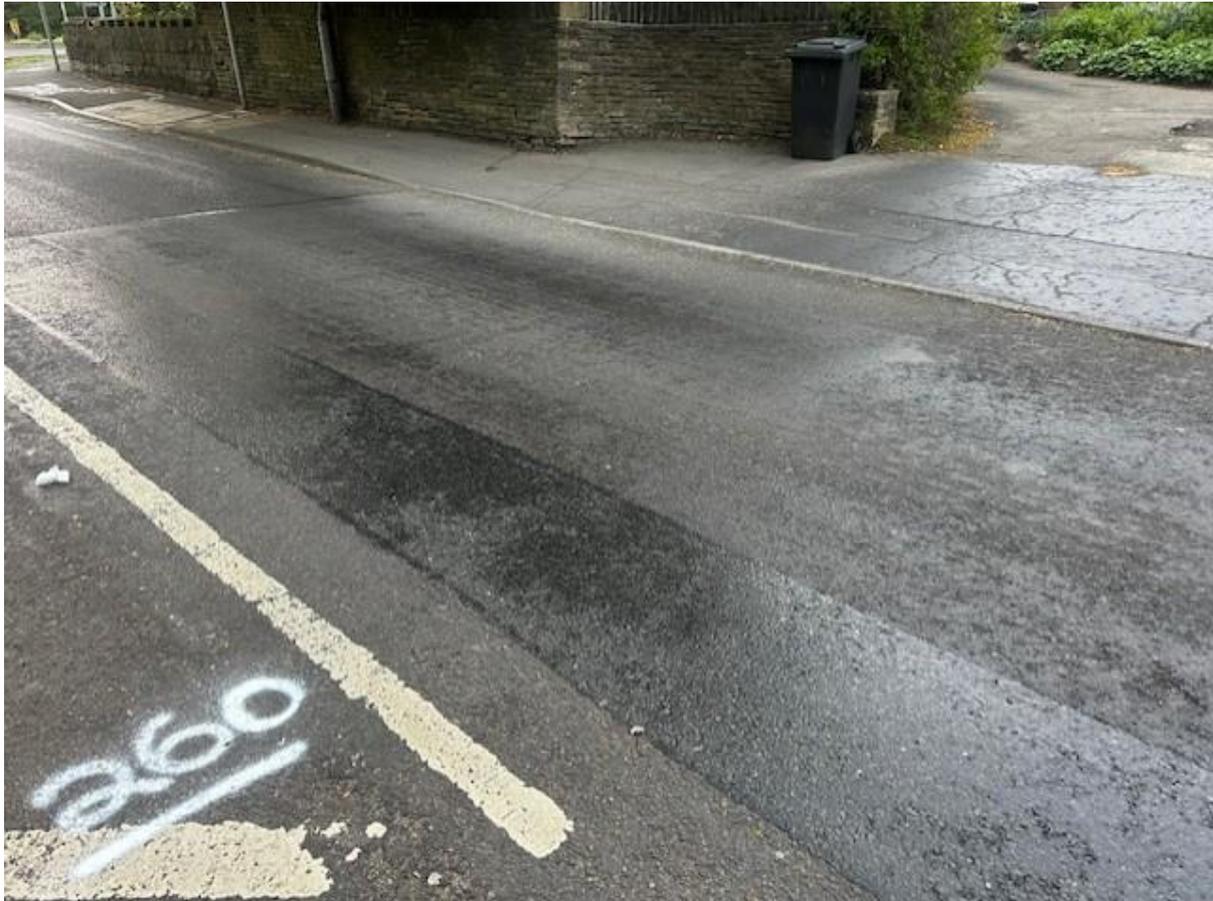
Comments – trench reinstatement continues.

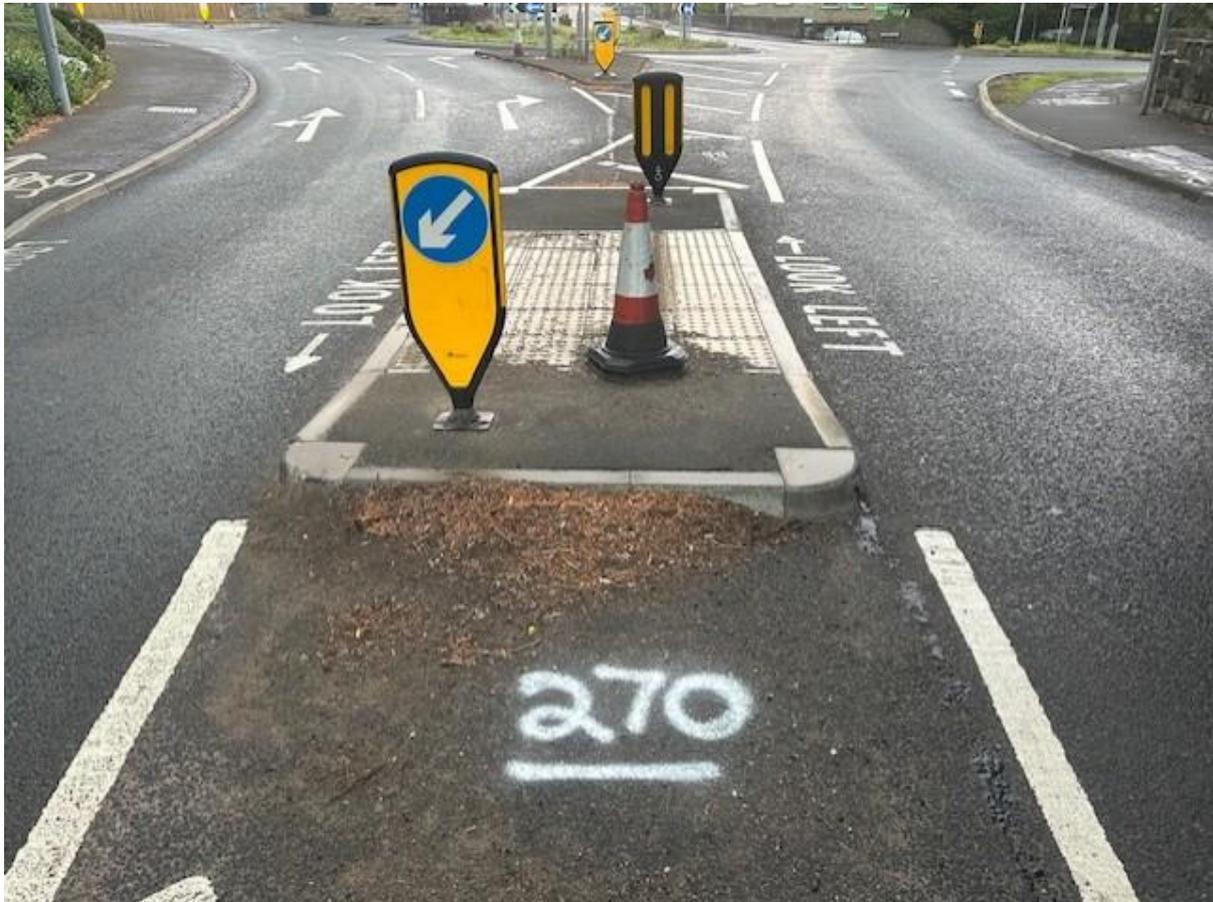
Chainage 270m

Comments – requires road sweep.
