Technical Note

250452 – Westgate, Cleckheaton

Dilapidation Survey

Our reference: AI/250452/DS01 – Rev00

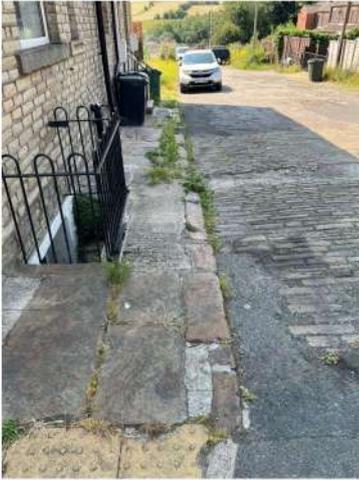
Issue 2

Stone kerbs damaged, out of line and have vegetation overgrowth between them.

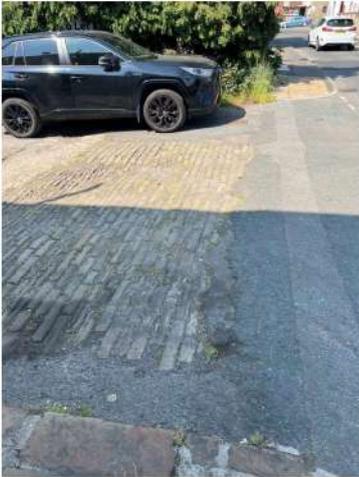
Issue 3

Carriageway surface changes to block paving. Cracking share surface changes.

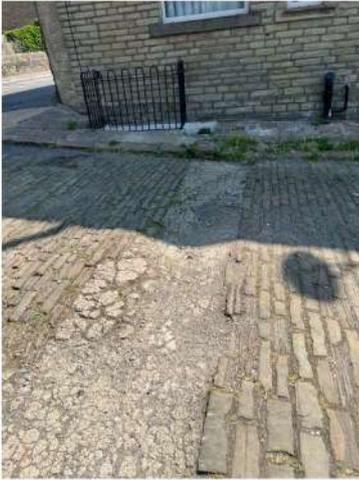
Issue 5

Severe damage to carriageway surface, localised low point.

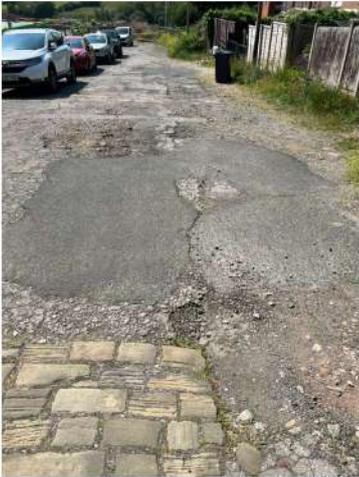
Issue 6

Pot holes in carriageway surface.

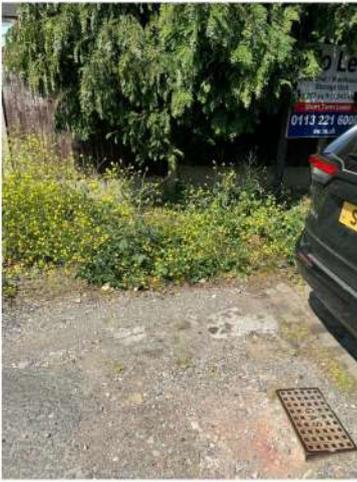
Issue 7

Vegetation overgrown, debris deposits in carriageway.

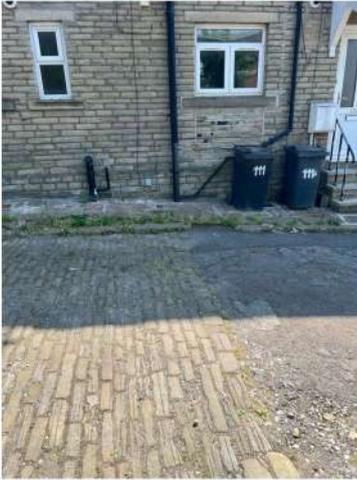
Issue 8

Vegetation overgrown, kerbs, surface and block pavers are cracked/damaged.

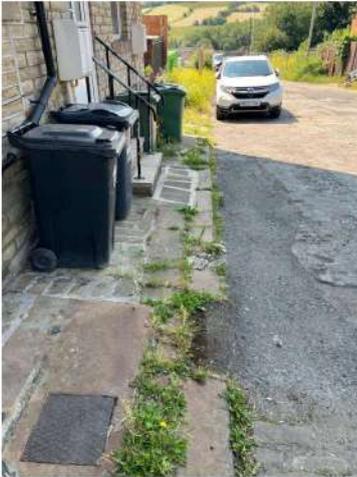
Issue 9

Kerbs and block pavers damaged, vegetation overgrown. Carriageway surface in bad state of wear.

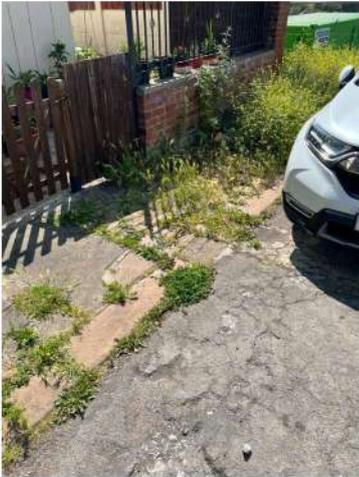
Issue 12

Stone kerbs out of place, vegetation overgrown. Footway and carriageway surface severely damaged.

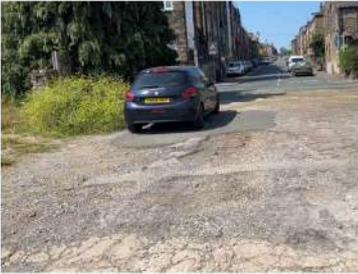
Issue 14

Carriageway surface severely damaged, vegetation overgrown

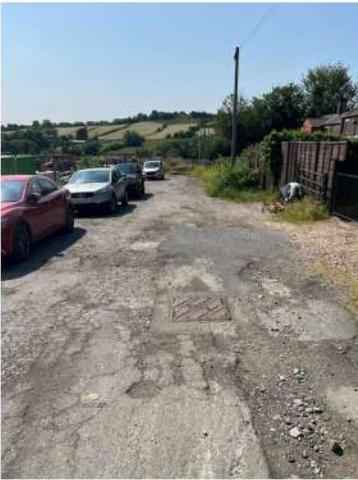
Issue 15

Carriageway surface severely damaged.

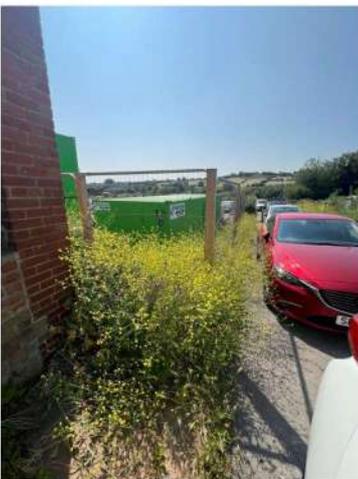
Issue 16

Vegetation overgrown

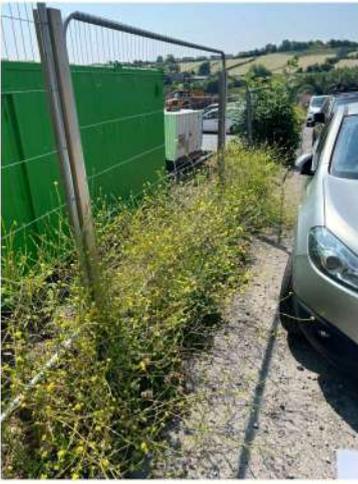
Issue 17

Vegetation overgrown and debris along fence line

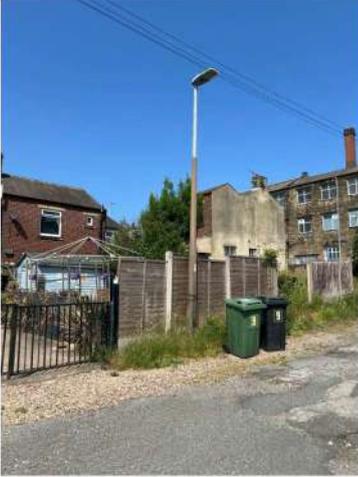
Issue 18

Lighting column in good condition.

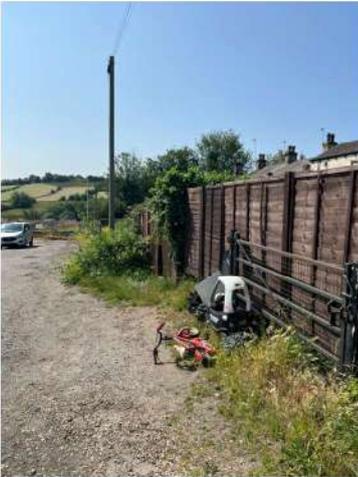
Issue 19

Vegetation overgrown , debris at fence line.

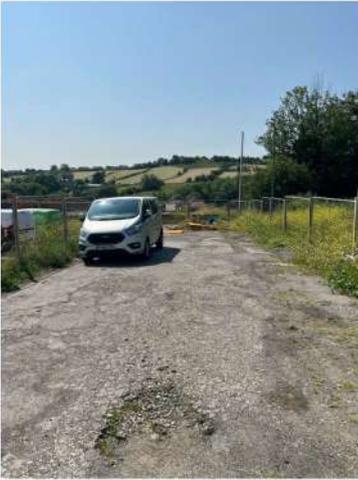
Issue 22

Carriageway surface severely damaged.

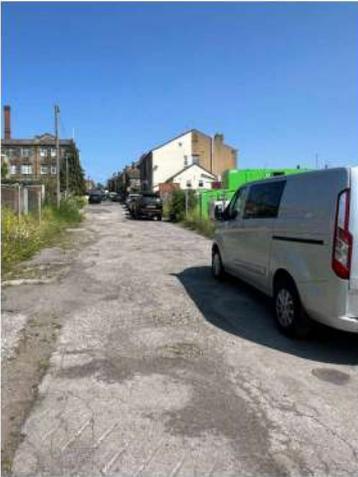
Issue 23

Overview of Iron street from bottom of road, Carriageway surface severely damaged.

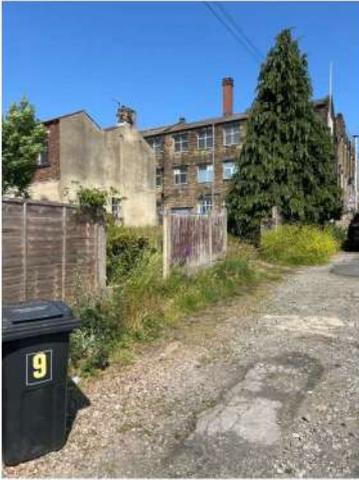
Issue 25

Fence line damaged (New defect identified during June 2025 visit)

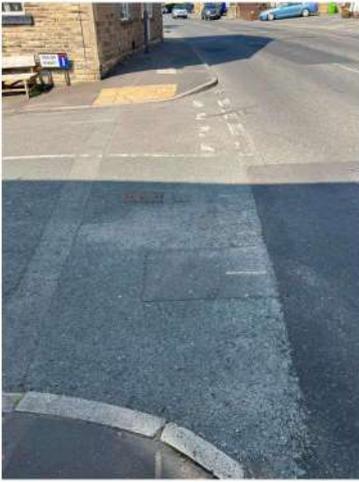
Issue 1

Trench scars and resurfacing patches on carriageways surface. Road markings are faded.

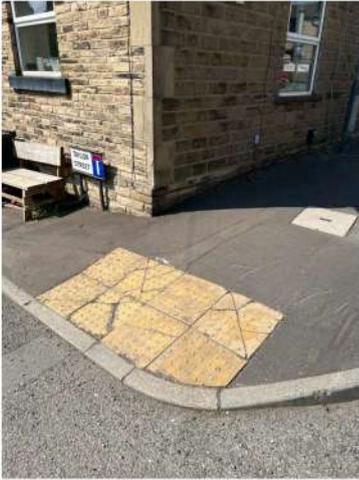
Issue 2

Footway surface damaged and has trench scarring. Tactile cracked and kerbs chipped.

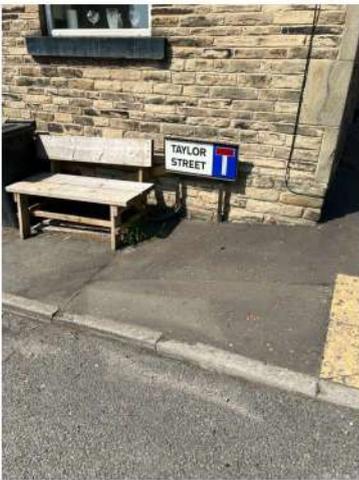
Issue 3

Scars on footway, kerbs chipped.

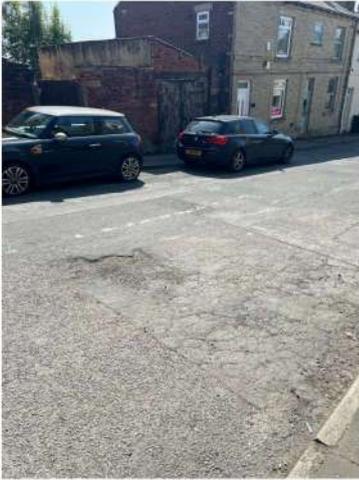
Issue 5

Carriageway surface severely damaged. Road markings are worn.

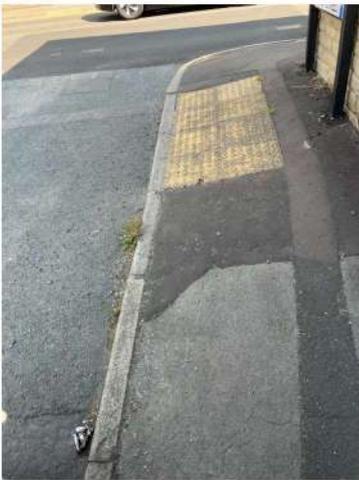
Issue 6

Kerbs are chipped. Footway surface damaged. Vegetation around kerblines.

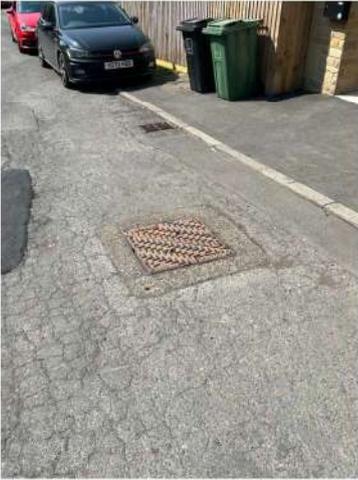
Issue 8

Carriageway surface severely damaged. Cover is in good condition.

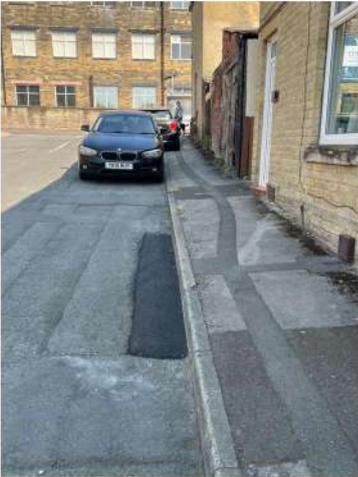
Issue 9

Footway and carriageway surface damaged. Kerbs are chipped. Trench scars in both footway and carriageway.

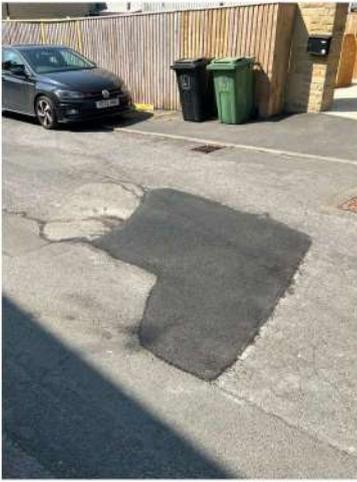
Issue 10

Resurfacing patch in centre of carriageway. Carriageway surface is uneven.

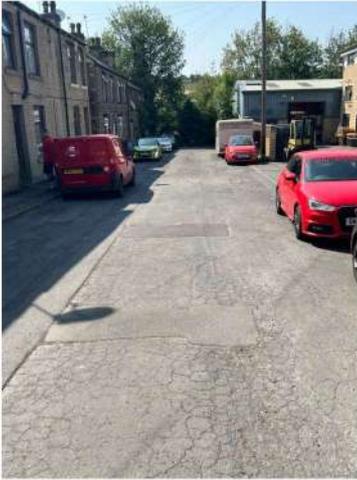
Issue 11

Carriageway surface severely damaged, trench scars damaged.

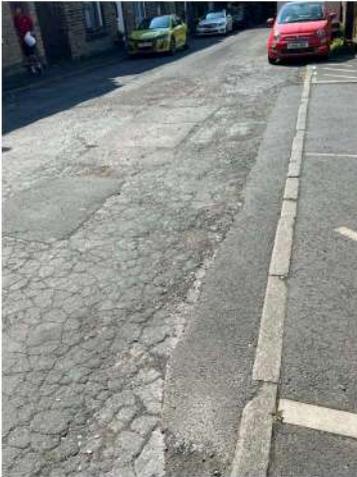
Issue 12

Carriageway surface severely damaged. Kerbs are chipped and out of line at ramp location.

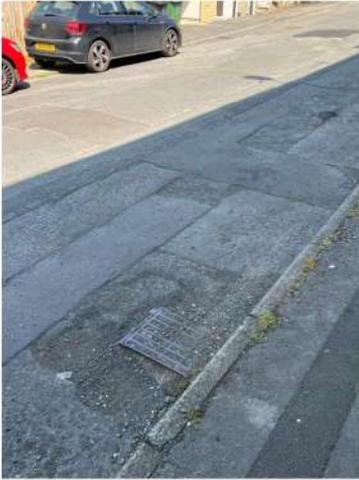
Issue 14

Gully blocked.

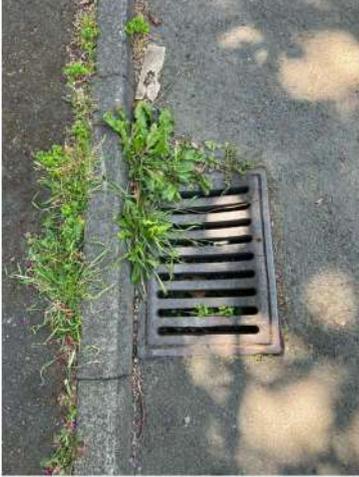
Issue 17

Vegetation grown around kerb and gully

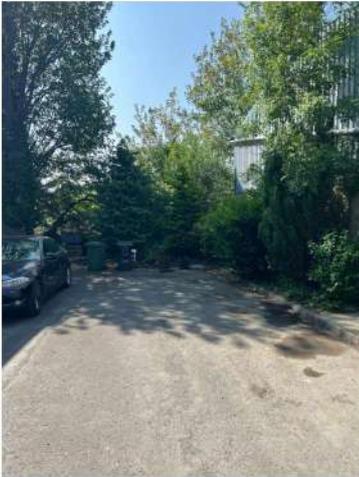
Issue 18

Overgrown vegetation

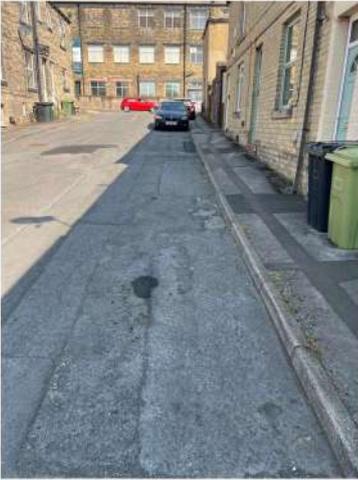
Issue 20

Visible trench scars across footway and carriageway. Carriageway surface and footway severely damaged. Vegetation growth near kerb. (New defect identified during June 2025 visit)

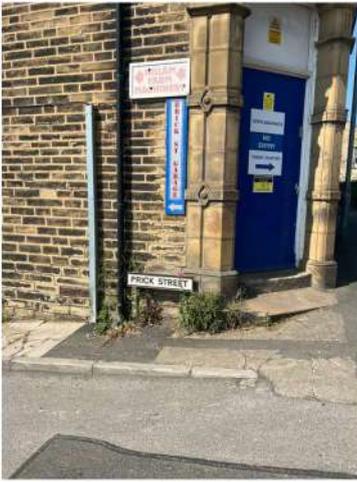
Issue 1

Street name plate vandalised. Vegetation overgrowth and footway surface is severely damaged. Kerbs are damaged and some are missing.

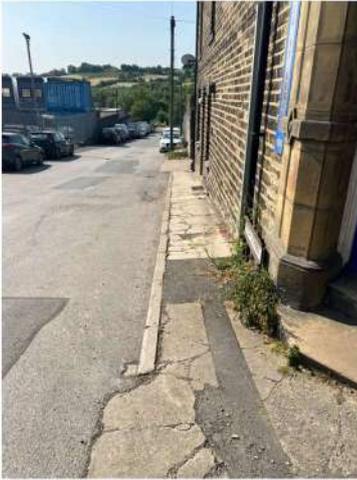
Issue 2

Footway cracked and visible trench lines.

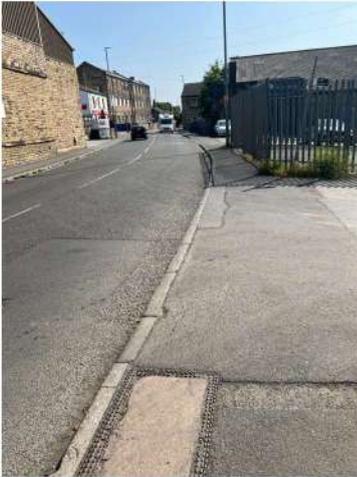
Issue 3

Kerbing is not level and chipped. There is damaged to the footway and carriageway surface, as well as the chamber surface. Visible trench scars also.

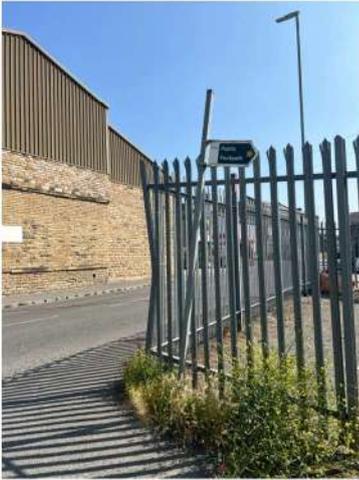
Issue 5

Public footway sign is slanted. fencing damaged.

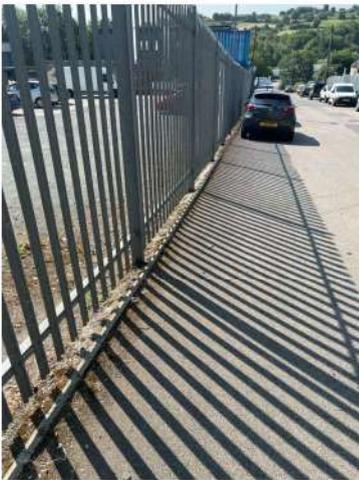
Issue 6

Edging kerbs are worn.

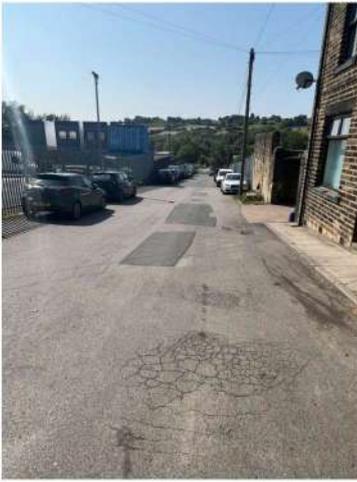
Issue 7

Carriageway and footway surface severely damaged and has some resurfacing patches.

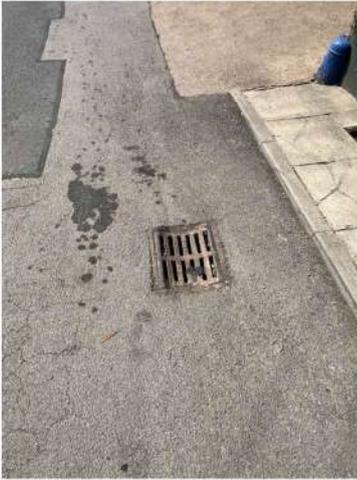
Issue 8

Gully grate depressed but clear, black staining on carriageway surface.

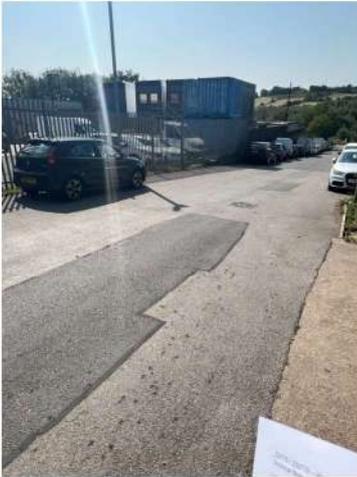
Issue 9

Resurfacing patches in centre of carriageway. Slight cracking on edge of carriageway.

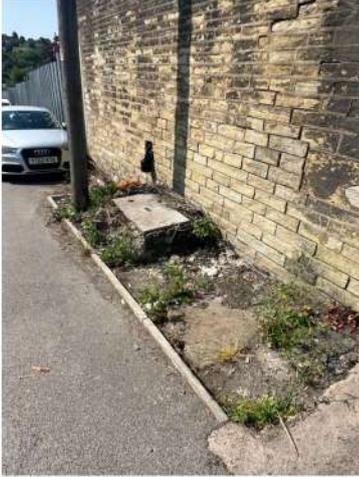
Issue 11

Vegetation area badly maintained, utility cover raised however considered to be an existing issue.

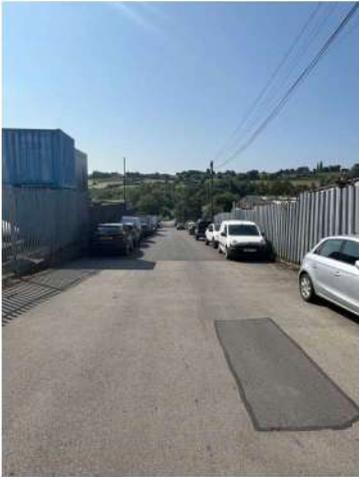
Issue 12

Generally wear of carriageway surface. Clear surfacing change midway down.

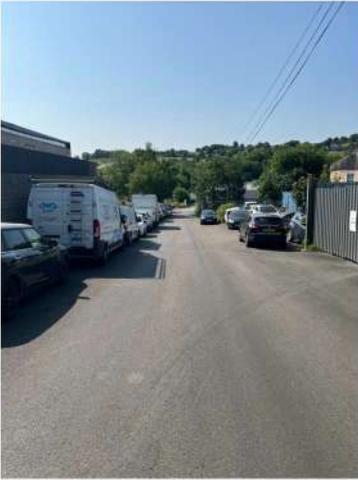
Issue 14

General wear of carriageway surface.

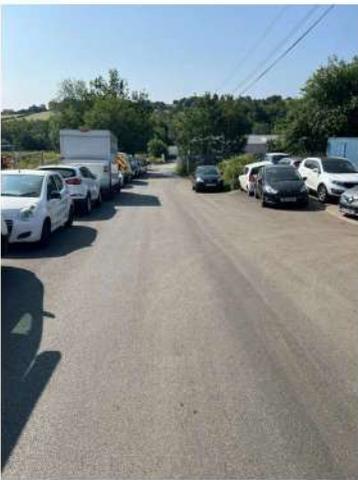
Issue 15

General wear of carriageway surface.

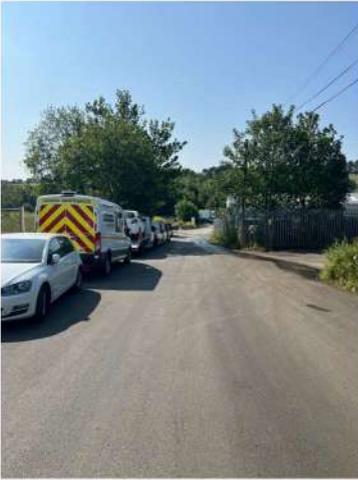
Issue 17

General wear of carriageway surface.

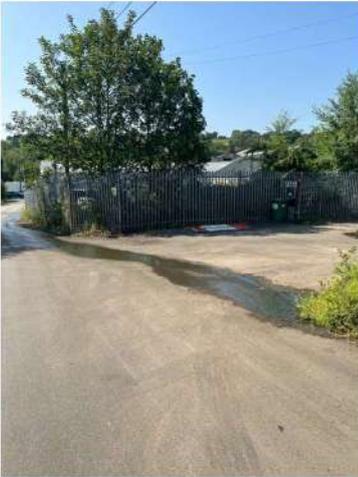
Issue 18

Water ponding at end of vegetation.

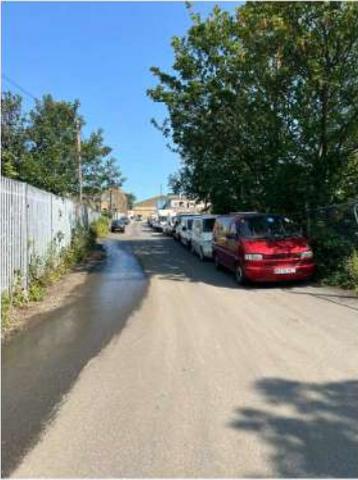
Issue 20

General wear of carriageway surface. Vegetation overgrowth on channel of carriageway

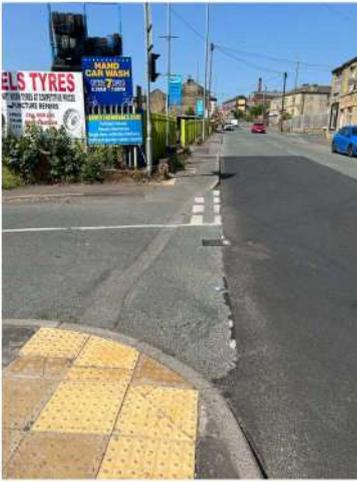
Issue 1

Road markings faded. Trench scar across junction. Tactiles cracked.

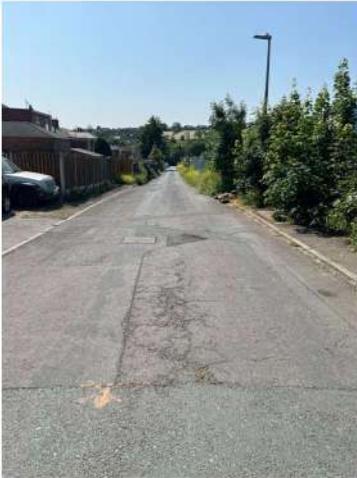
Issue 2

Carriageway surface severely cracked. Trench scars through carriageway surface.

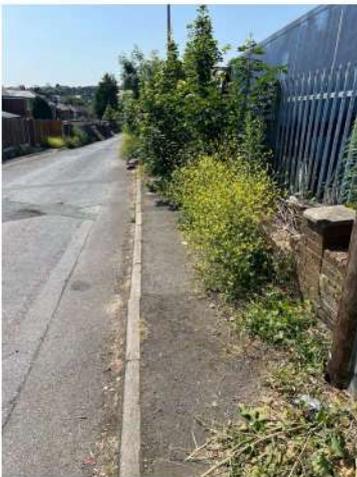
Issue 3

Kerbs are chipped and out of line and excessive vegetation growth on footway.

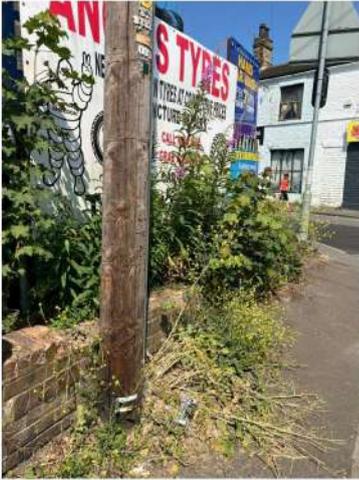
Issue 5

Vegetation overgrown on footway. Wall is in bad condition.

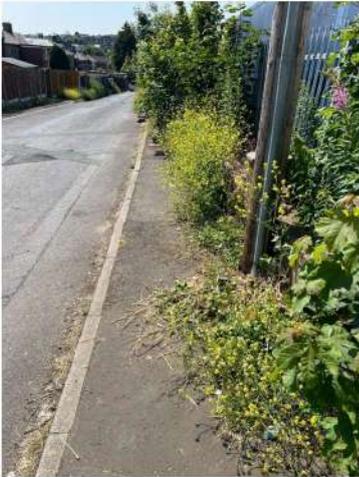
Issue 6

Kerbs are out of line. Vegetation overgrown on to the footway.

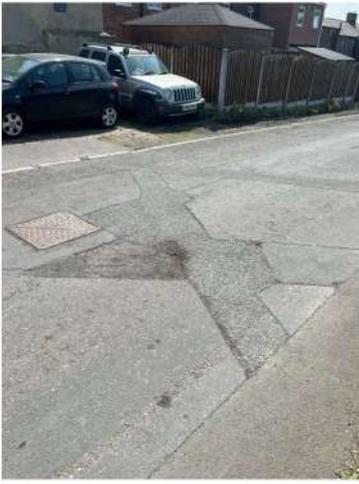
Issue 7

Trench scars in centre of carriageway.

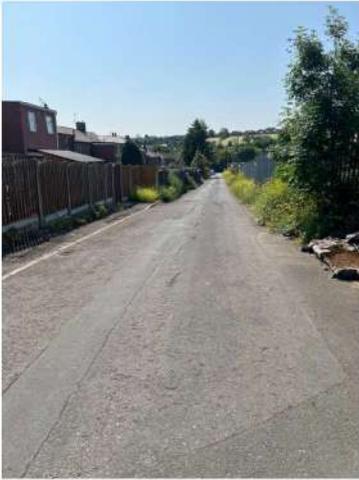
Issue 8

Longitudinal trench scars along the carriageway. Debris on side of carriageway, vegetation overgrown.

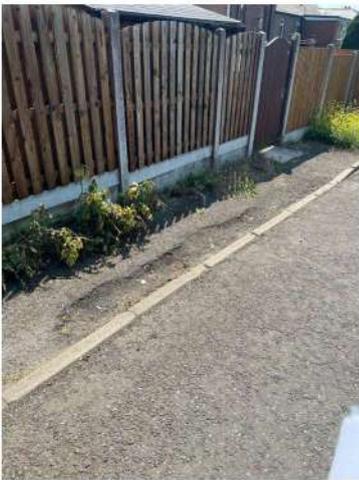
Issue 9

Severely damaged footway surfacing, vegetation overgrown and kerbs are chipped.

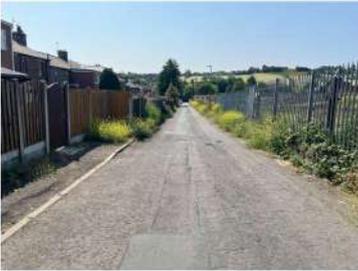
Issue 11

Carriageway and footway surface damaged. Vegetation overgrown.

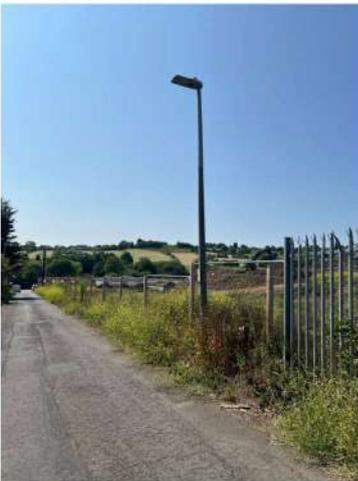
Issue 12

Lighting column is slanted.

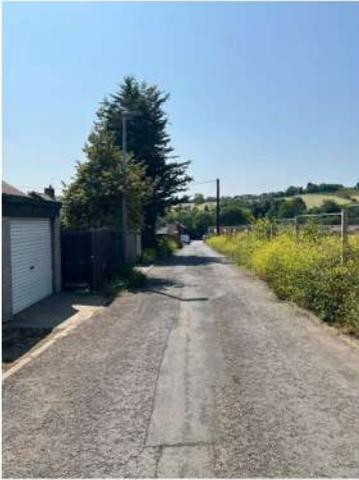
Issue 14

Cracked surfacing and overgrown vegetation.

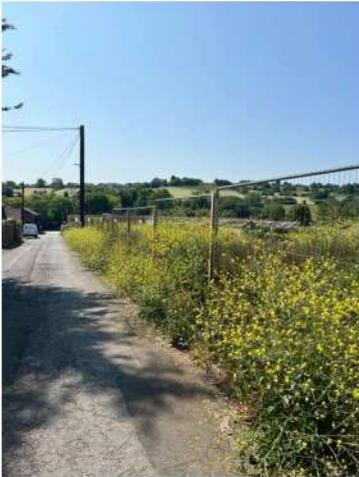
Issue 15

Cracked surfacing and overgrown vegetation.

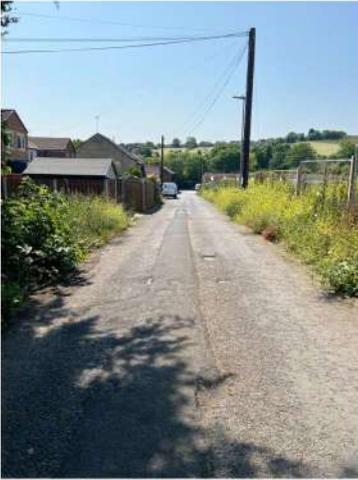
Issue 17

Carriageway surface damaged with potholes formed.

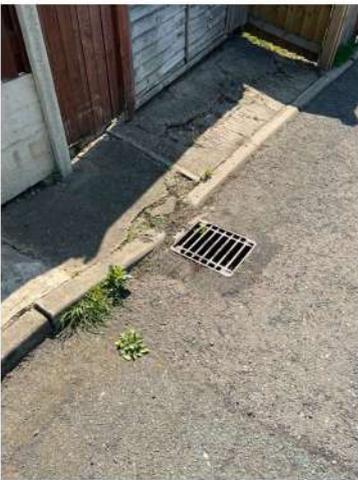
Issue 18

Gully clear. Kerbs and footway surface severely damaged.

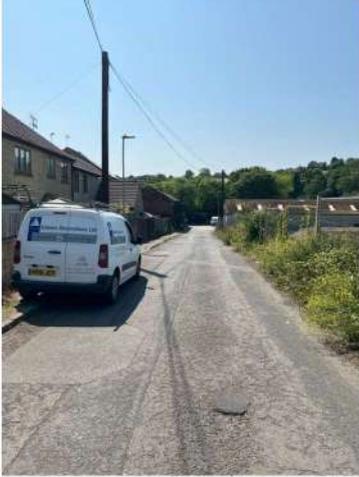
Issue 21

Cracked surfacing and overgrown vegetation. Trench scars through footway.

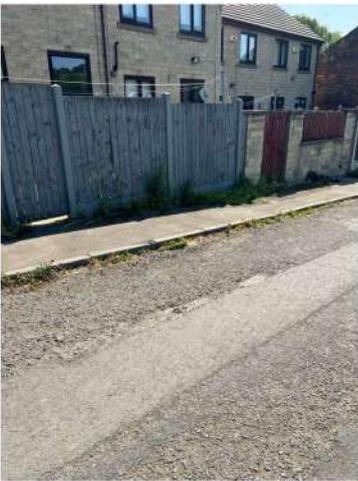
Issue 26

Kerbs are damaged and uneven. Carriageway surface is severely damaged. Vegetation grown along kerblines and back of footway.

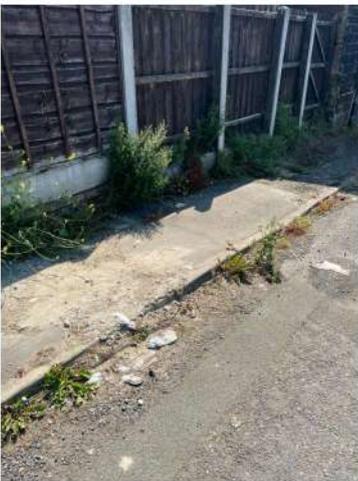
Issue 27

Sediment deposits on footway and channel, vegetation overgrown. Trench scars in carriageway.

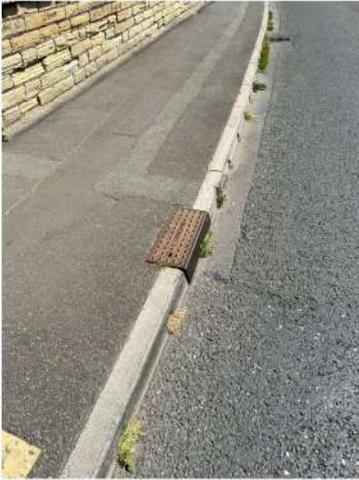
Issue 2

Beany blocks are partially blocked by vegetation. Trench scars in carriageway and footway.

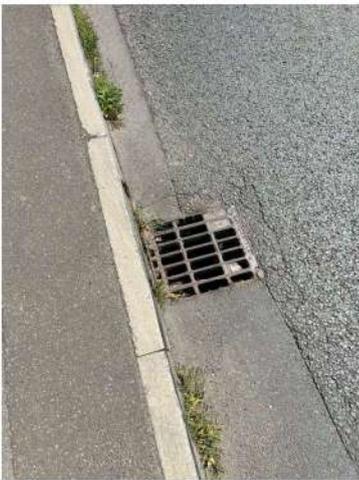
Issue 3

Slight cracking around gully, sections of gully grating blocked. Vegetation overgrown.

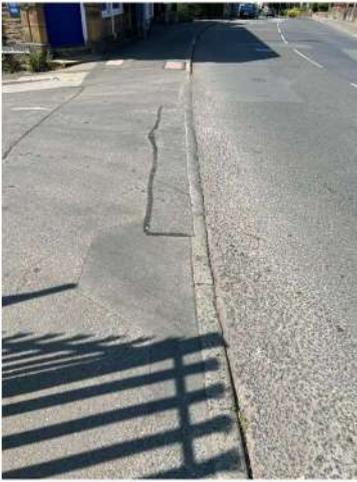
Issue 4

Cracked and out of line kerbs. Trench scars across footway and carriageway. Carriageway surface is pitted.

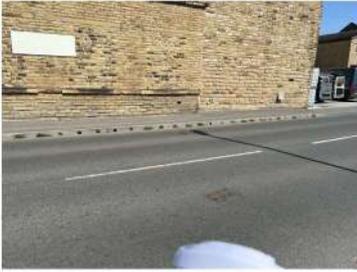
Issue 5

Beany blocks are partially blocked by vegetation.

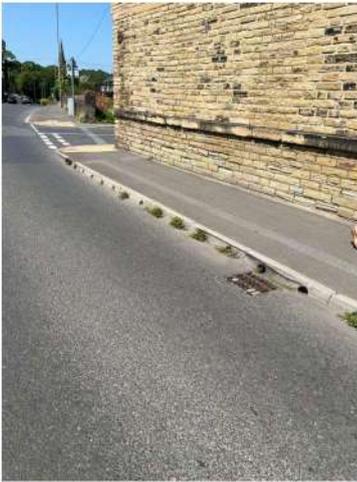
Issue 6

Gully clear, vegetation partially blocking Beany blocks.

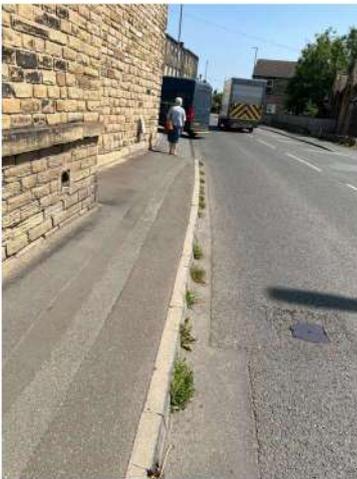
Issue 7

Trench scars along doorway and carriageway. Vegetation partially blocking beanie blocks. Cracking around valve cover.

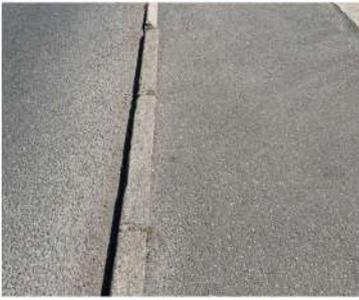
Issue 8

Kerbing is chipped.

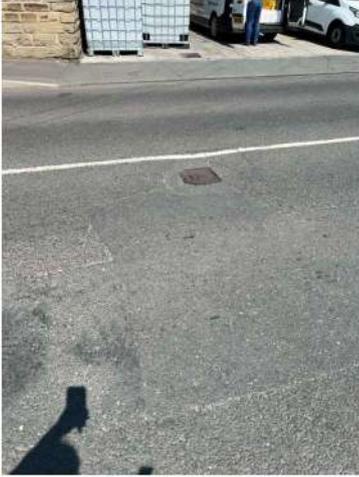
Issue 9

Carriageway surfacing failing around cover.

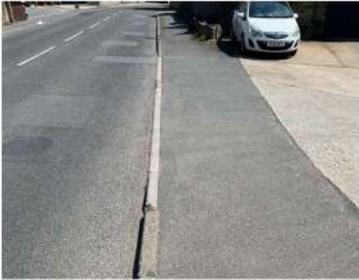
Issue 10

Kerbing at dropped crossing is damaged.

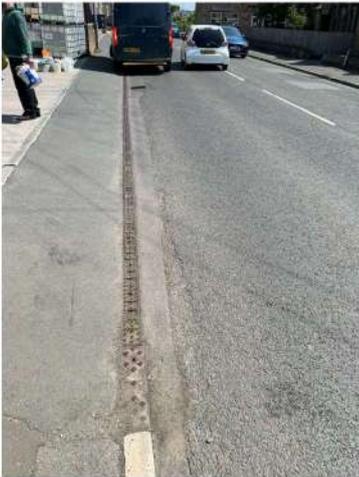
Issue 11

Sediment build up at linear drain which is out of line and uneven. Drain also has vegetation blocking some inlets.

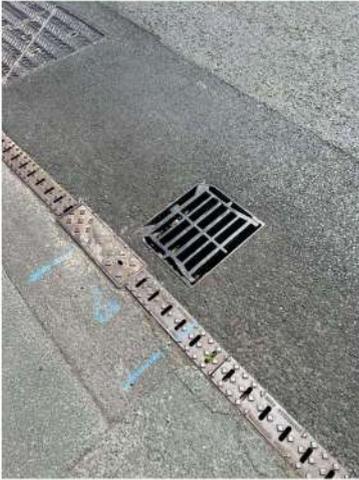
Issue 13

Gully clear.

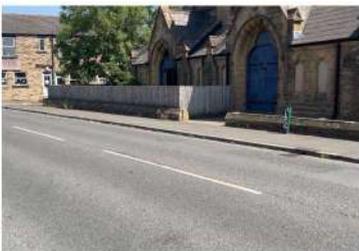
Issue 14

Vegetation growth around kerbs. Gully clear, signs of carriageway failing around gully.

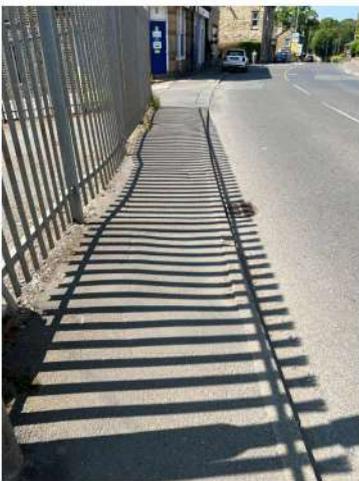
Issue 17

Trench scars along footway. Resurfacing patches on carriageway.

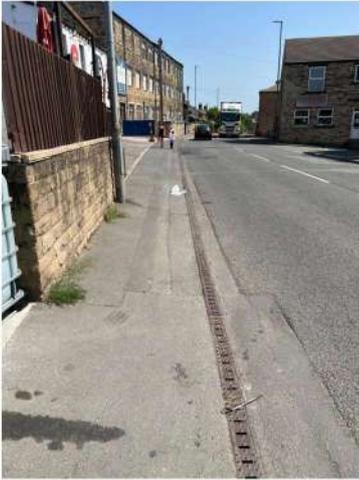
Issue 22

Cracked kerbs, trench scars in footway. Vegetation growth at channel.

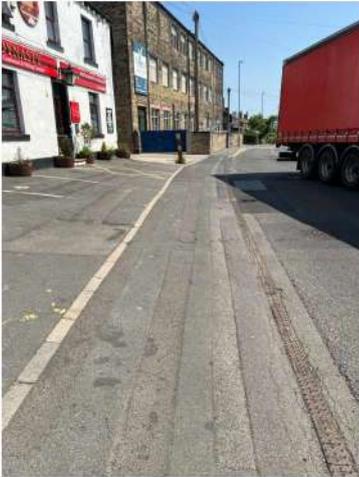
Issue 23

Trench scars in footway and carriageway. Growth of vegetation at back of footway.

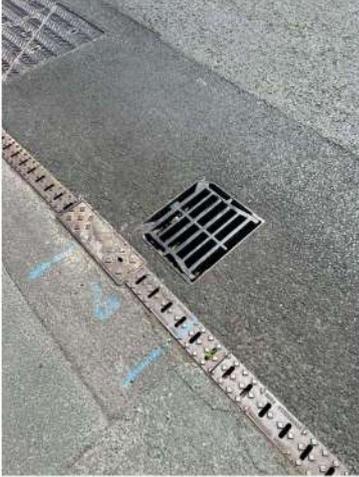
Issue 25

Trench scars in carriageway.

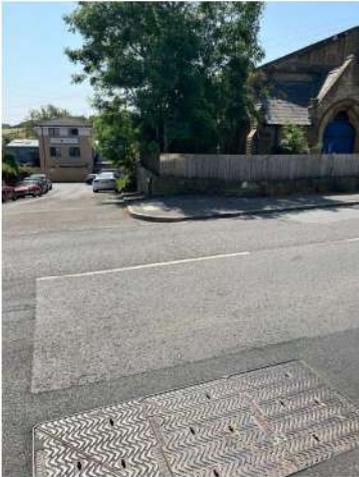
Issue 26

Carriageway cracking around linear drain, gully clear.

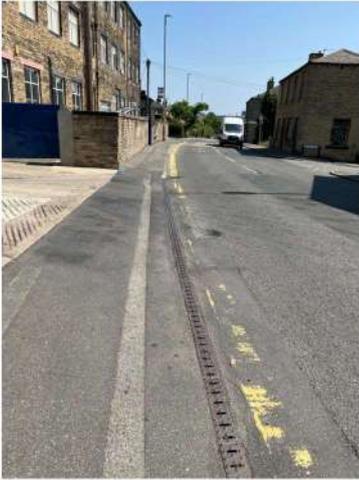
Issue 28

Faded bus stop road marking. Centre line missing from resurfacing patch. Trench scars visible.

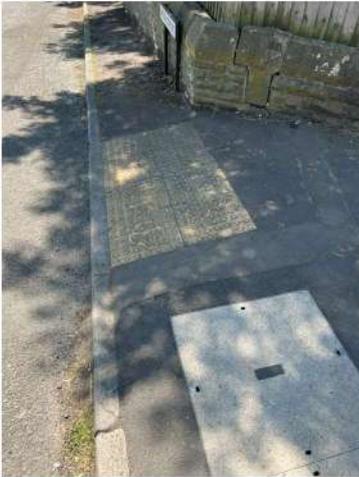
Issue 29

Faded road markings. Trench scars.

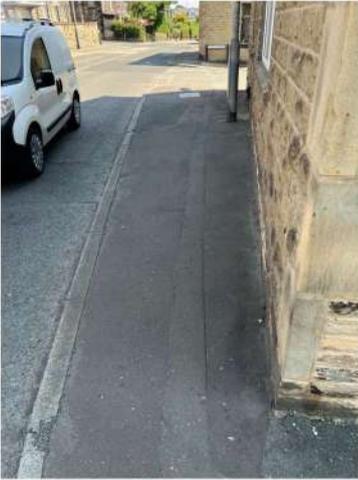
Issue 31

Trench scars in footway. Black stains in footway.

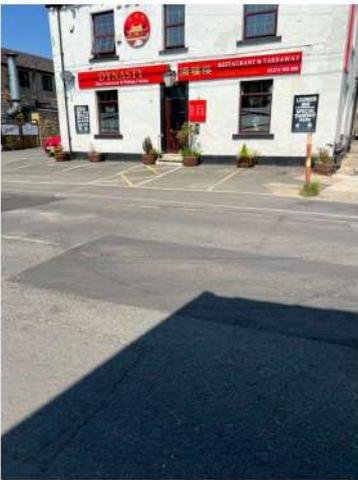
Issue 32

Cracked kerbs. Trench scars in footway.

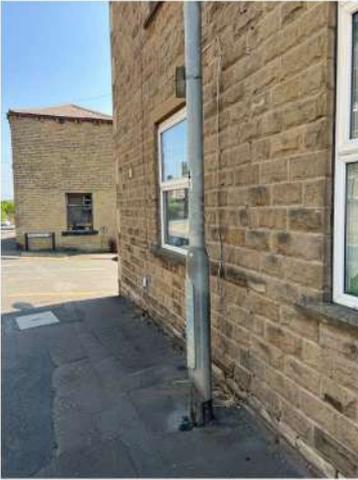
Issue 34

Sediment build up at back of kerb. Damaged kerbs. Trench scars in footway.

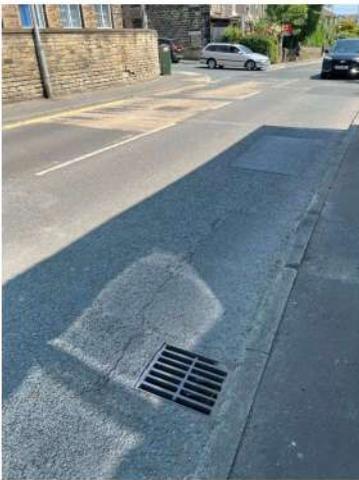
Issue 38

Resurfacing patch in carriageway. Faded road markings

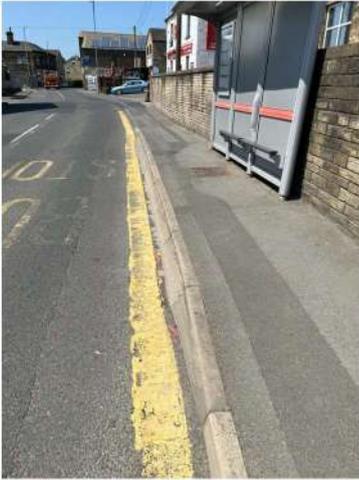
Issue 40

Cracked kerbs, sediment build up behind kerb. Resurfacing patch in carriageway.

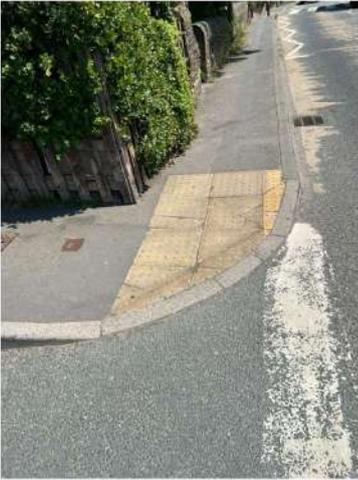
Issue 52

Tactile cracked. Kerbs in bad condition, trench scar along footway. Overgrown vegetation at back of footway and crossing.

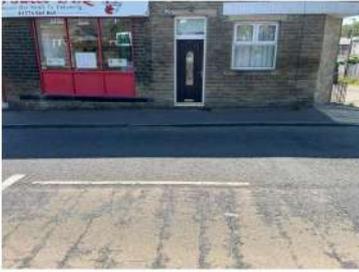
Issue 55

Carriageway surfacing worn.

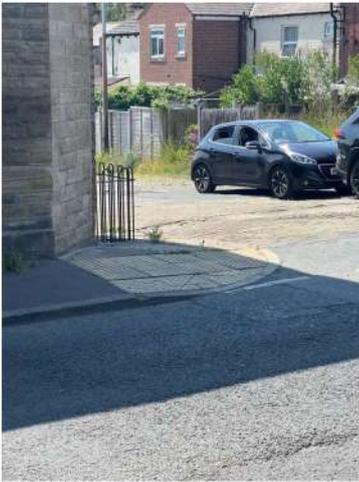
Issue 56

Uneven kerbing

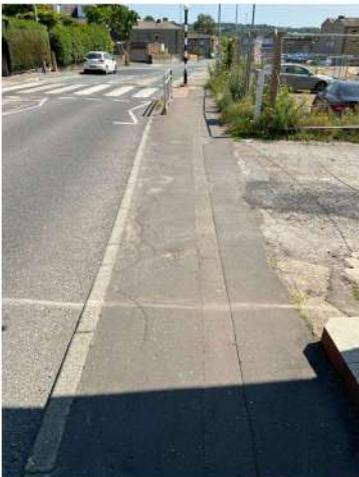
Issue 57

Chipped kerbs.

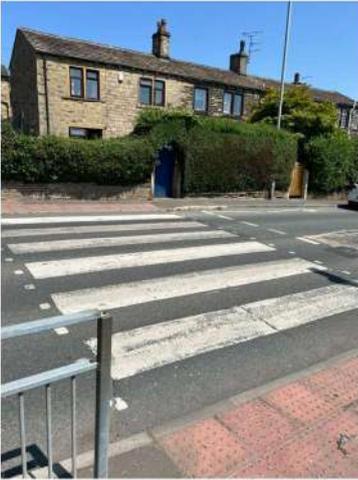
Issue 59

Pedestrian guard rail in good condition.

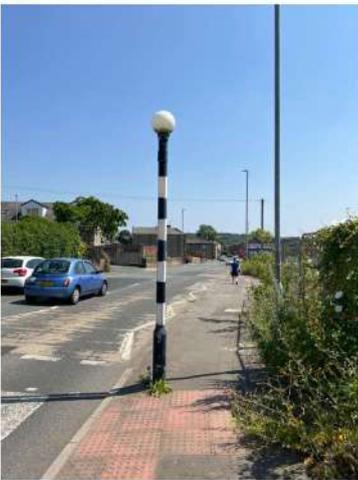
Issue 60

Zebra crossing fading.

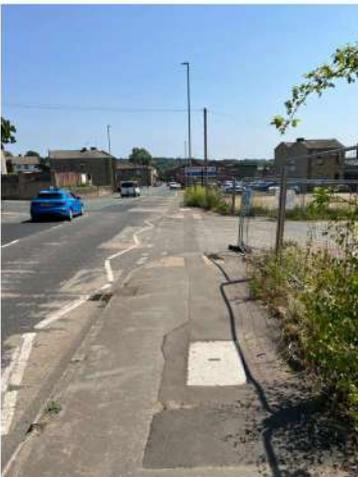
Issue 63

Gully covered in debris. Vegetation overgrowth.

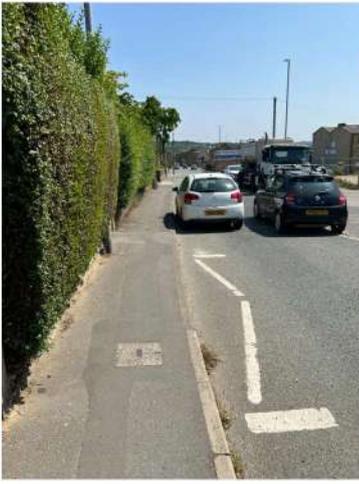
Issue 64

Trench scars in footway. Road markings faded. Vegetation overgrowth. Kerbs chipped and vegetation growing at the back of kerb.

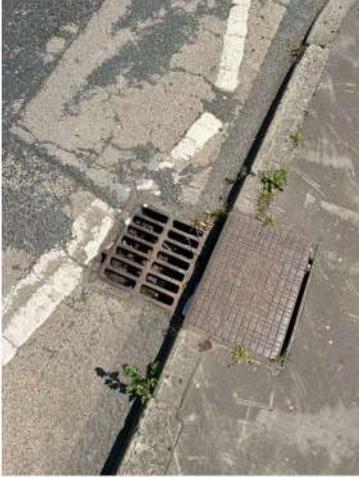
Issue 65

Trench scars in footway.

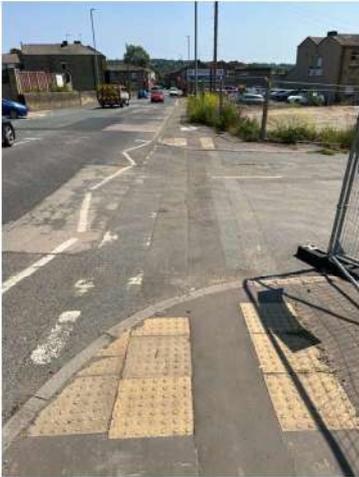
Issue 66

Surfacing worn. Vegetation growth. Gully has sediment within. Kerbs in bad condition.

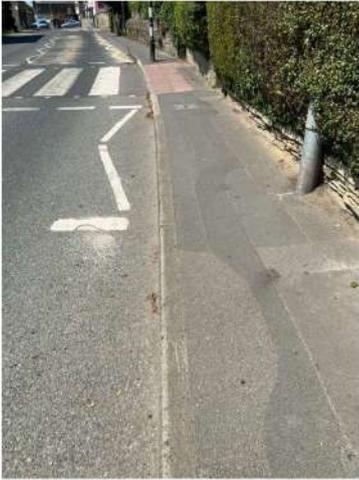
Issue 68

Surfacing faded. Resurfacing patches with missing road markings.

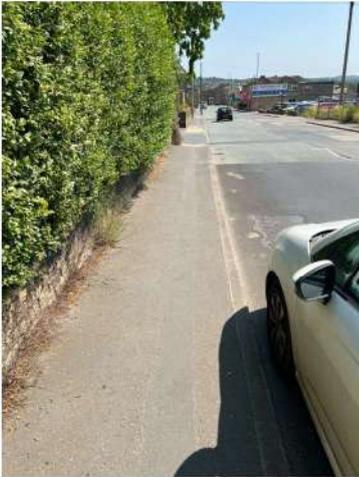
Issue 69

Trench scars in footway. Lighting column has vegetation growing around base.

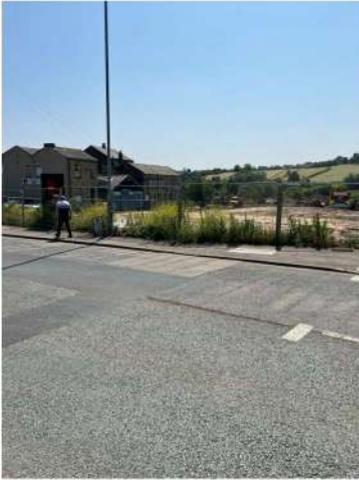
Issue 71

Surfacing worn on half the carriageway. Road markings faded.

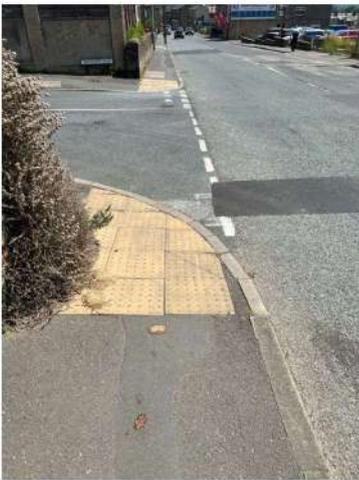
Issue 72

Surfacing cracked in centre of carriageway. Surfacing worn.

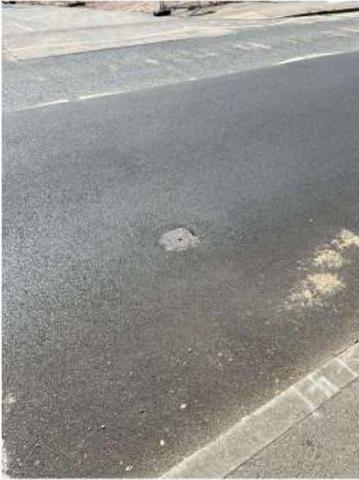
Issue 74

Trench scars visible in footway. Surfacing worn. Overgrown vegetation.

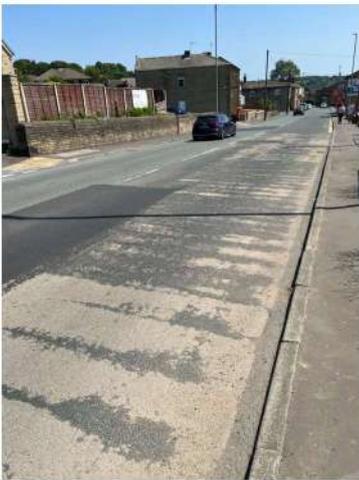
Issue 75

Surfacing worn on half the carriageway. Cover in good condition.

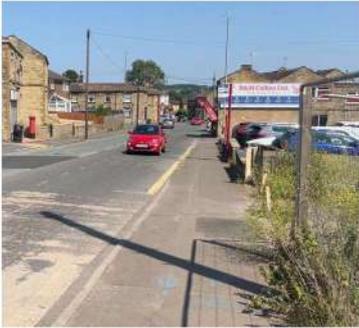
Issue 77

Trench scar in footway. Rest of carriageway surface is worn.

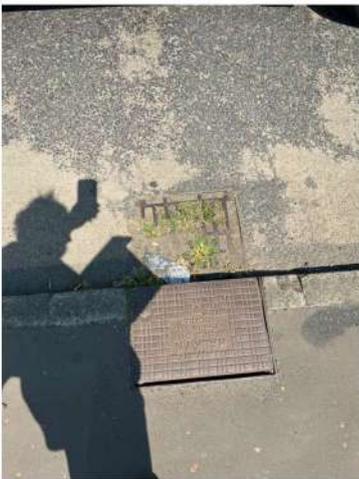
Issue 78

Trench scars in footway. Vegetation overgrown at back of footway. Road markings worn.

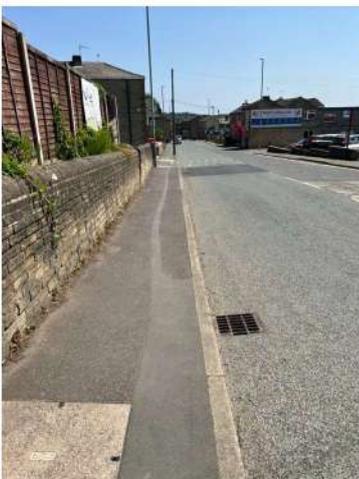
Issue 79

Gully blocked.

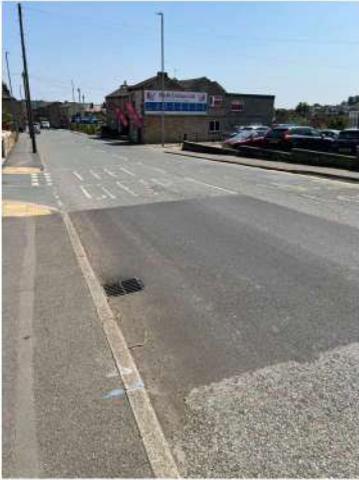
Issue 81

Road markings faded. Kerb line misaligned. Carriageway cracking on joint of the centreline of carriageway. Resurfacing patch in carriageway.

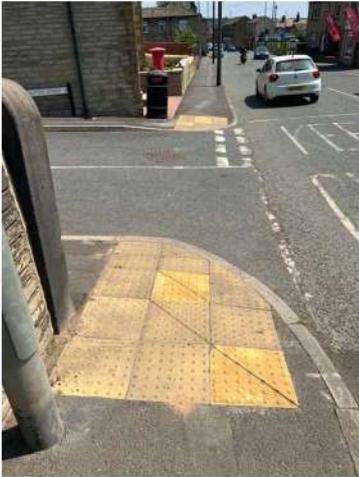
Issue 82

Road markings faded. Resurfacing patch in carriageway. Trench scar on footway.

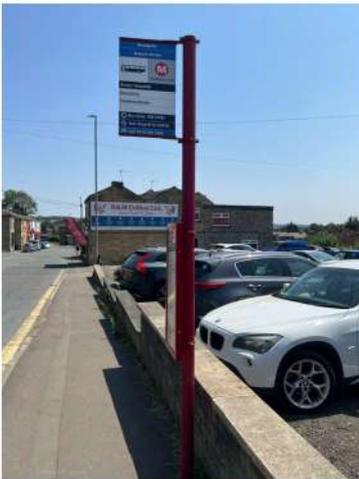
Issue 87

Trench scars in footway.

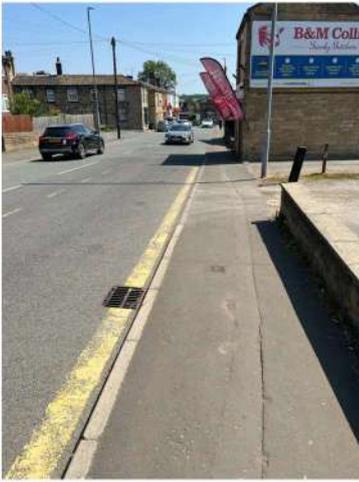
Issue 89

Trench scars in footway. Road marking faded.

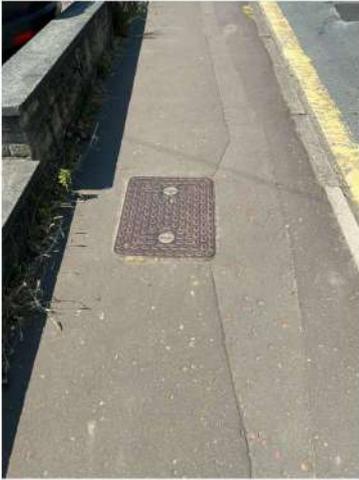
Issue 90

Trench scars in footway. Road marking faded.

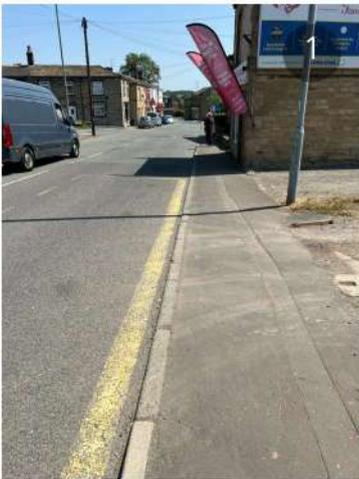
Issue 92

Road markings faded. Kerbs cracked. Trench scars in footway.

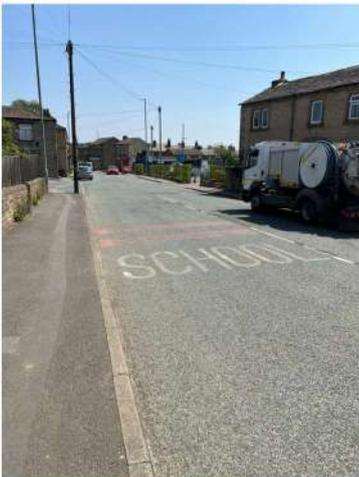
Issue 95

Road markings faded. Carriageway cracked, trench scar in centre of footway.

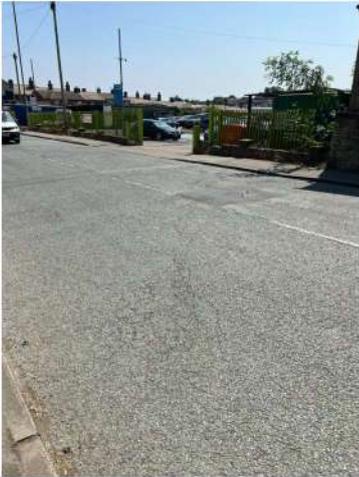
Issue 97

Carriageway surface damaged.

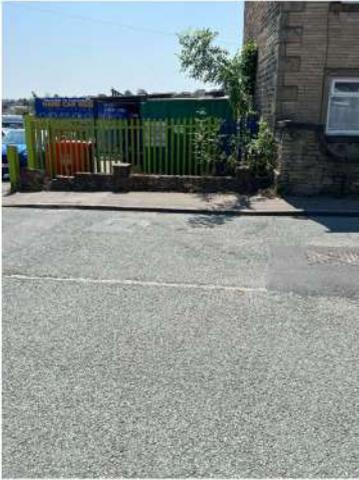
Issue 99

Trench scar in carriageway. Road marking faded.

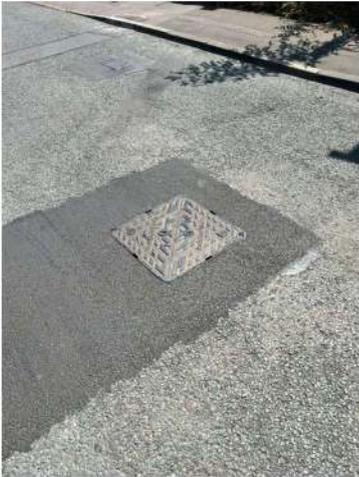
Issue 100

Carriageway surface damaged.

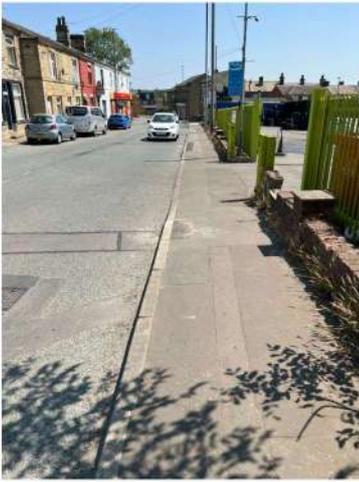
Issue 101

Resurfacing patch around chamber cover.

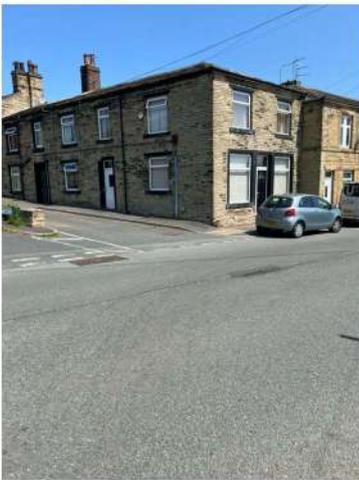
Issue 103

Kerbs cracked. Trench scars in footway and carriageway. Black stains on footway.

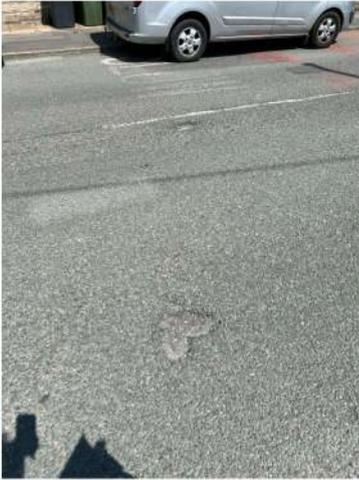
Issue 105

Potholes in carriageway. Road markings faded.

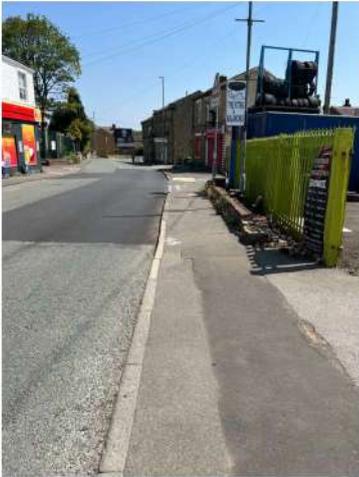
Issue 106

Potholes in carriageway surface.

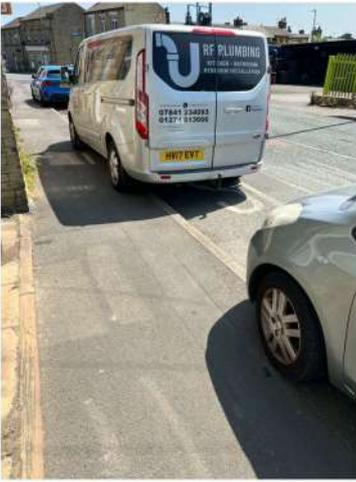
Issue 110
Road markings faded. Carriageway surfacing is worn.

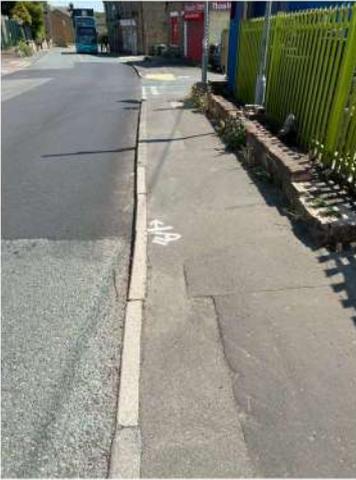
Issue 111

Trench scars in footway, carriageway worn. Evidence of vehicles parking partially on the footway.

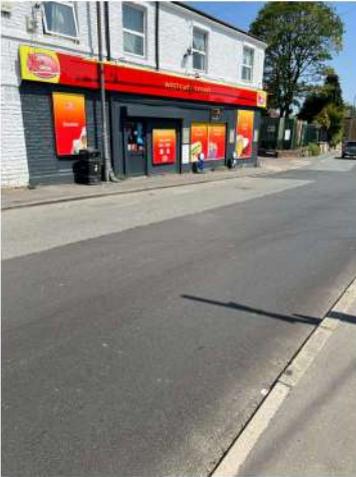
Issue 112

Kerbs are misaligned. Trench scars in footway.
