Technical Note

250452 – Westgate, Cleckheaton

Dilapidation Survey

Our reference: AI/250452/DS01 – Rev00

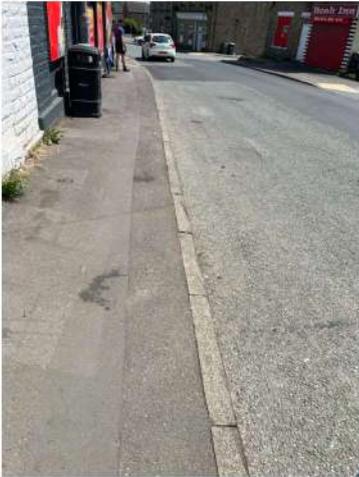
Issue 115

Majority of carriageway section has been resurfaced, no centreline.

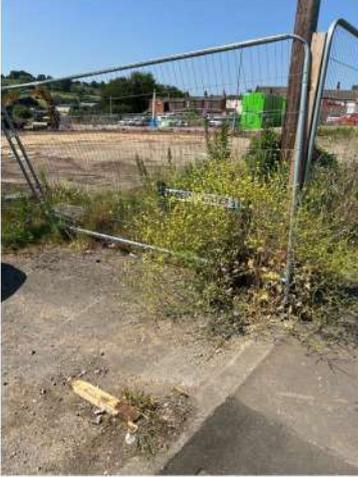
Issue 1

Damaged bollards at entry. Footway surfacing in bad conditions and scarred.

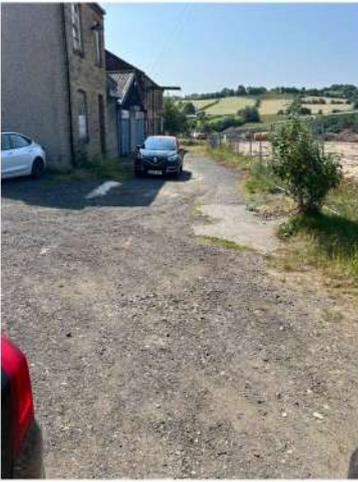
Issue 3

Surface of carriageway is in bad state of wear.

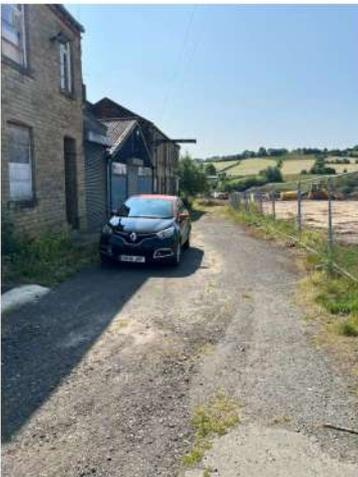
Issue 5

Surface of carriageway is in bad state of wear, vegetation overgrown.

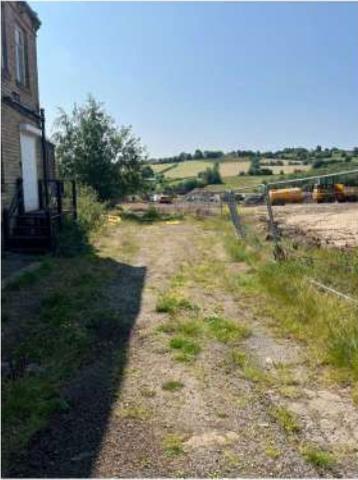
Issue 7

Surface of carriageway is in bad state of wear, vegetation overgrown.

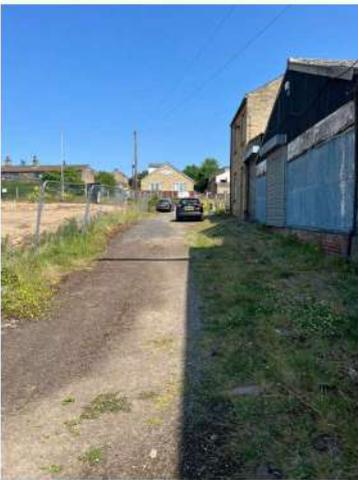
Issue 8

Surface of carriageway is in bad state of wear, vegetation overgrown.

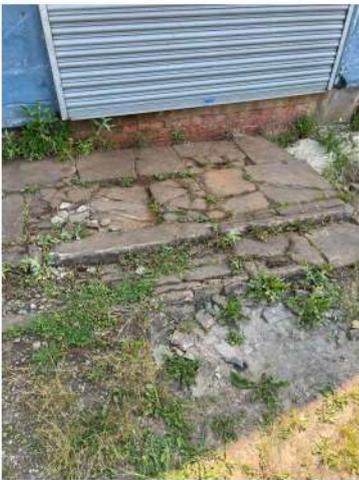
Issue 11

Vegetation overgrown. Footway is uneven and cracked. (New defect identified during June 2025 visit)
