Condition Survey Report

Denby Lane, Grange Moor.

Ref: HDC/ENG/DENBY LANE/FINAL

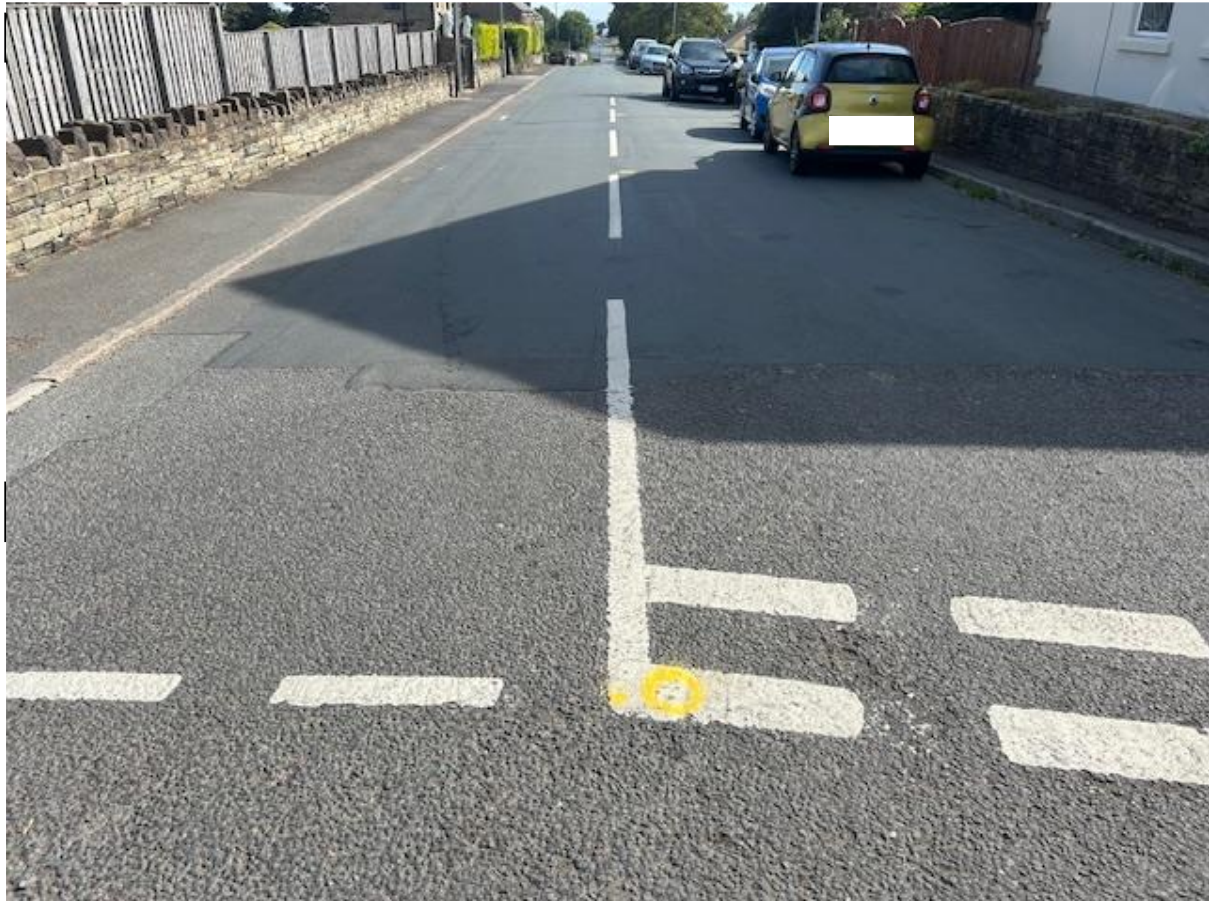
Comments – The surface course of Bristfield Road is made up of a Hot Rolled Asphalt with coated chippings; this continues along Denby Lane for 2.0m at which point it changes to a Stone Mastic Asphalt (SMA). No evidence of any specific joint between the two surface courses.

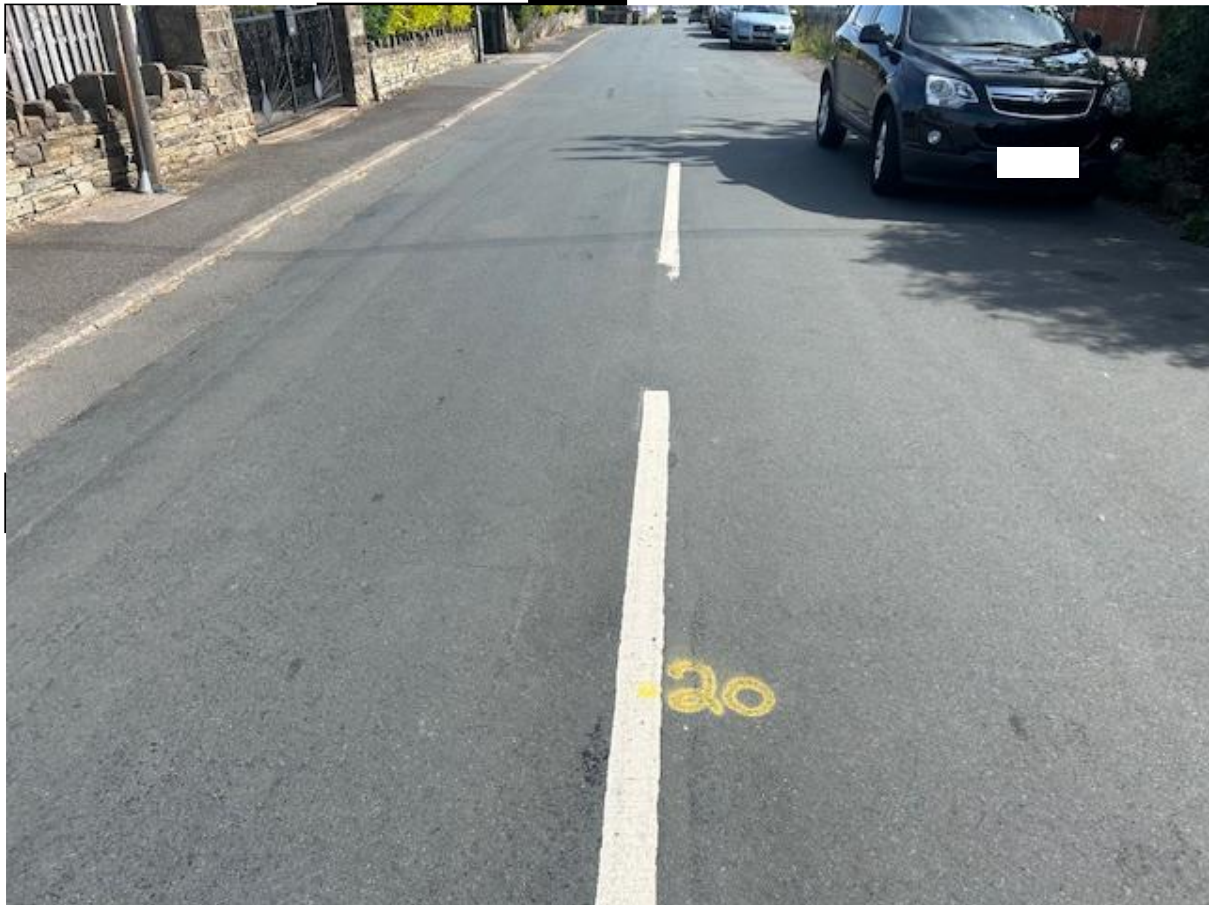
Comments – evidence of trench reinstatement and surface path repair along north side of carriageway.

Comments – as above.

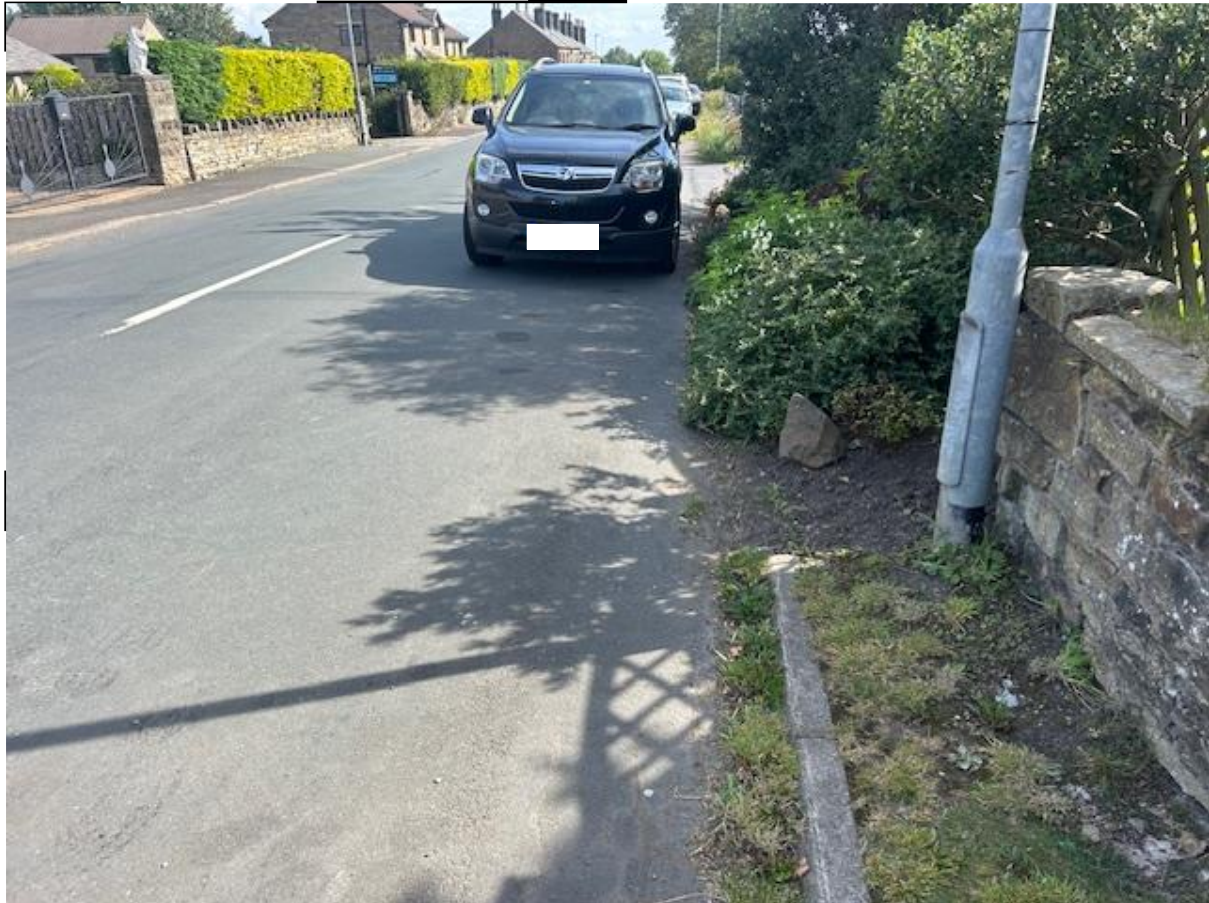
Comments – significant weed growth along southern kerb and drainage channel.

Comments – as above

Recommendation – Highway Authority inspection.

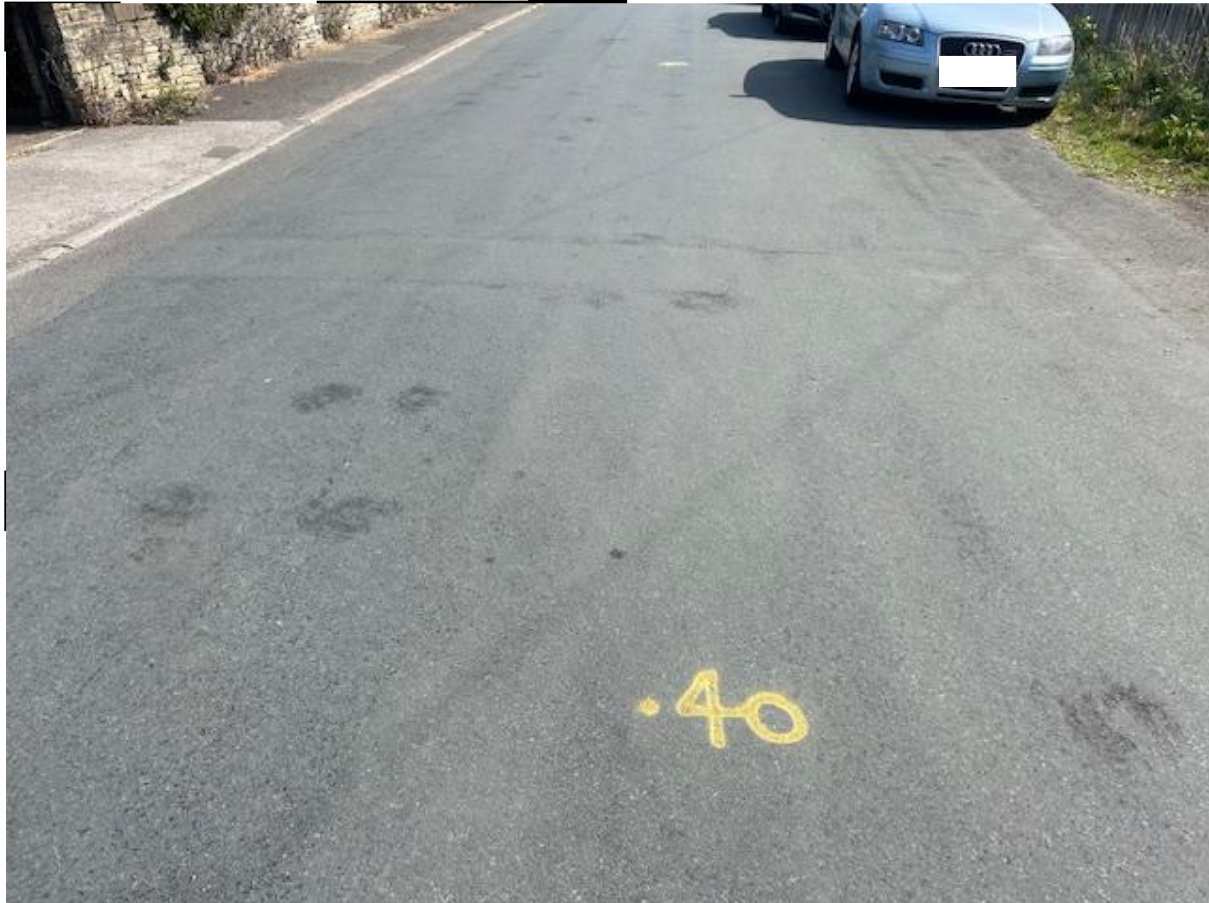
Comments – perpendicular trench reinstatement across Denby Lane at Ch 43m and surface course trench reinstatement along northern drainage channel.

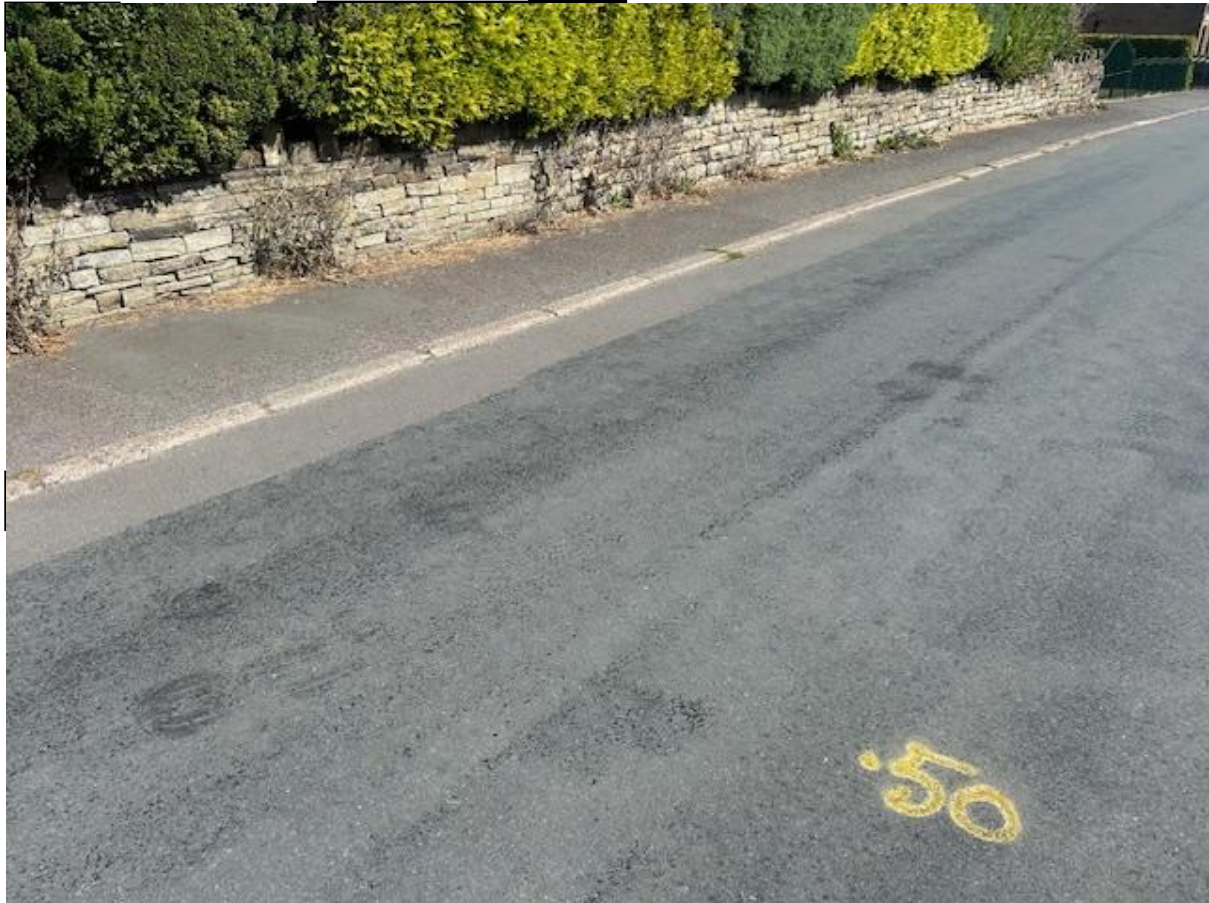
Comments – minor surface course / trench reinstatement along northern channel line.

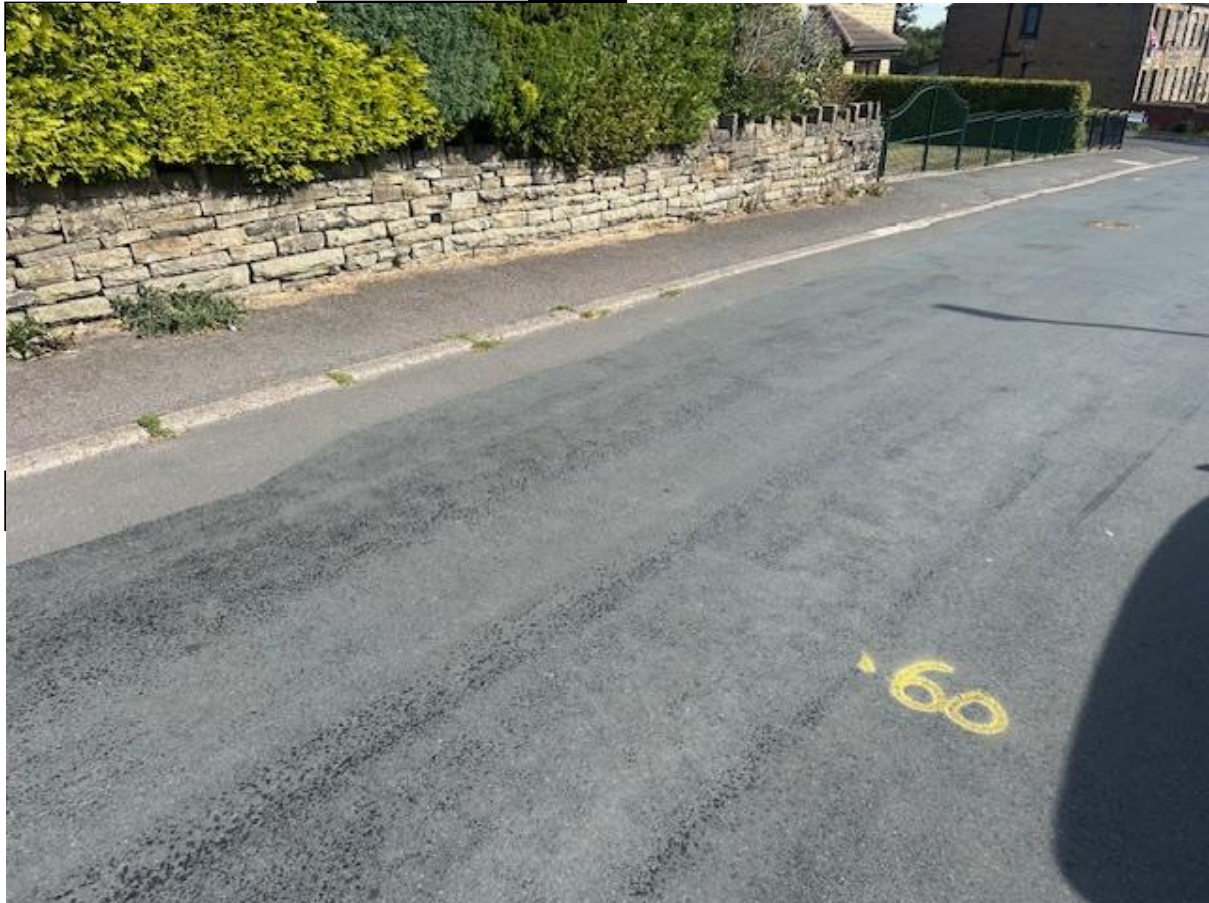
Comments – minor trench reinstatement along channel line with some weed growth between kerbs.

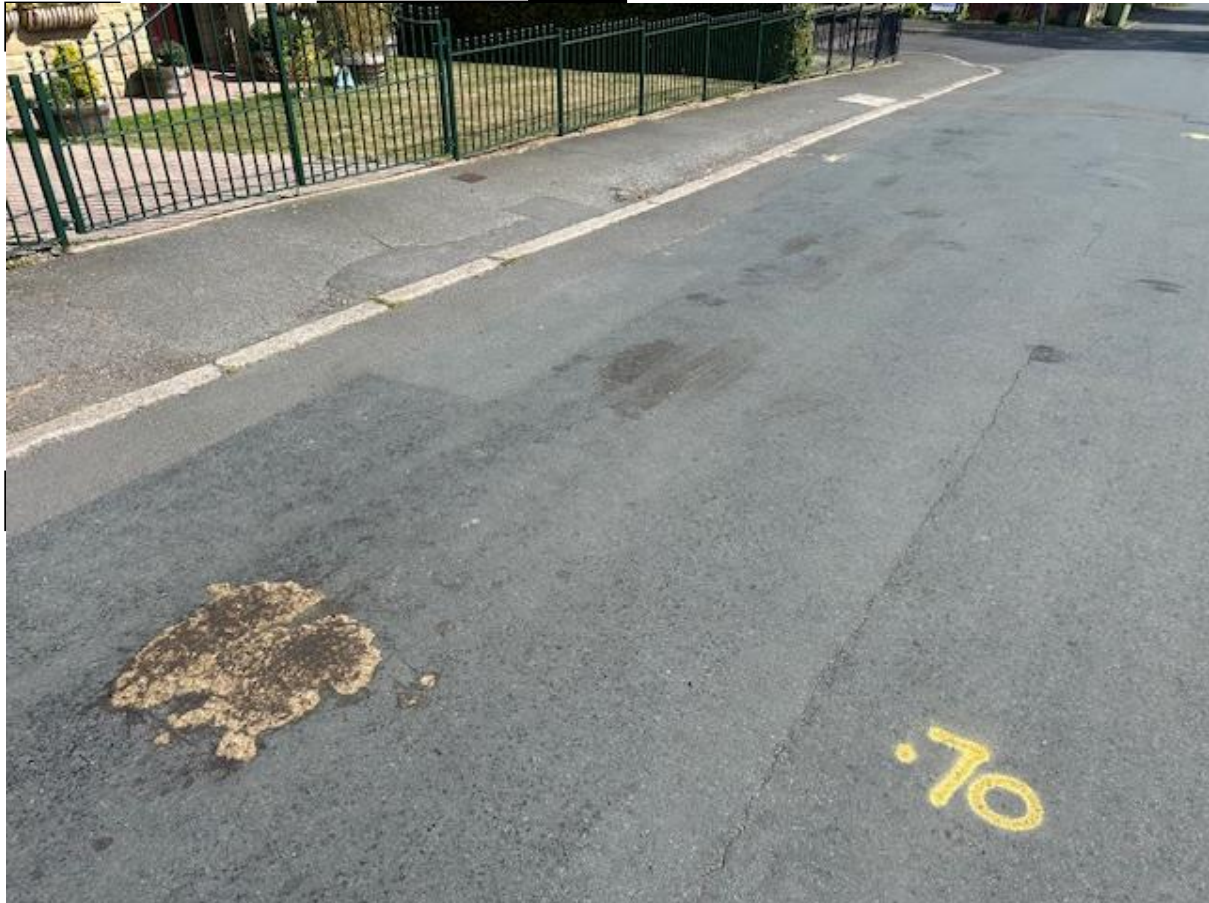
Comments – as previous with some evidence of uneven kerb line. Trench reinstatement along drainage channel.

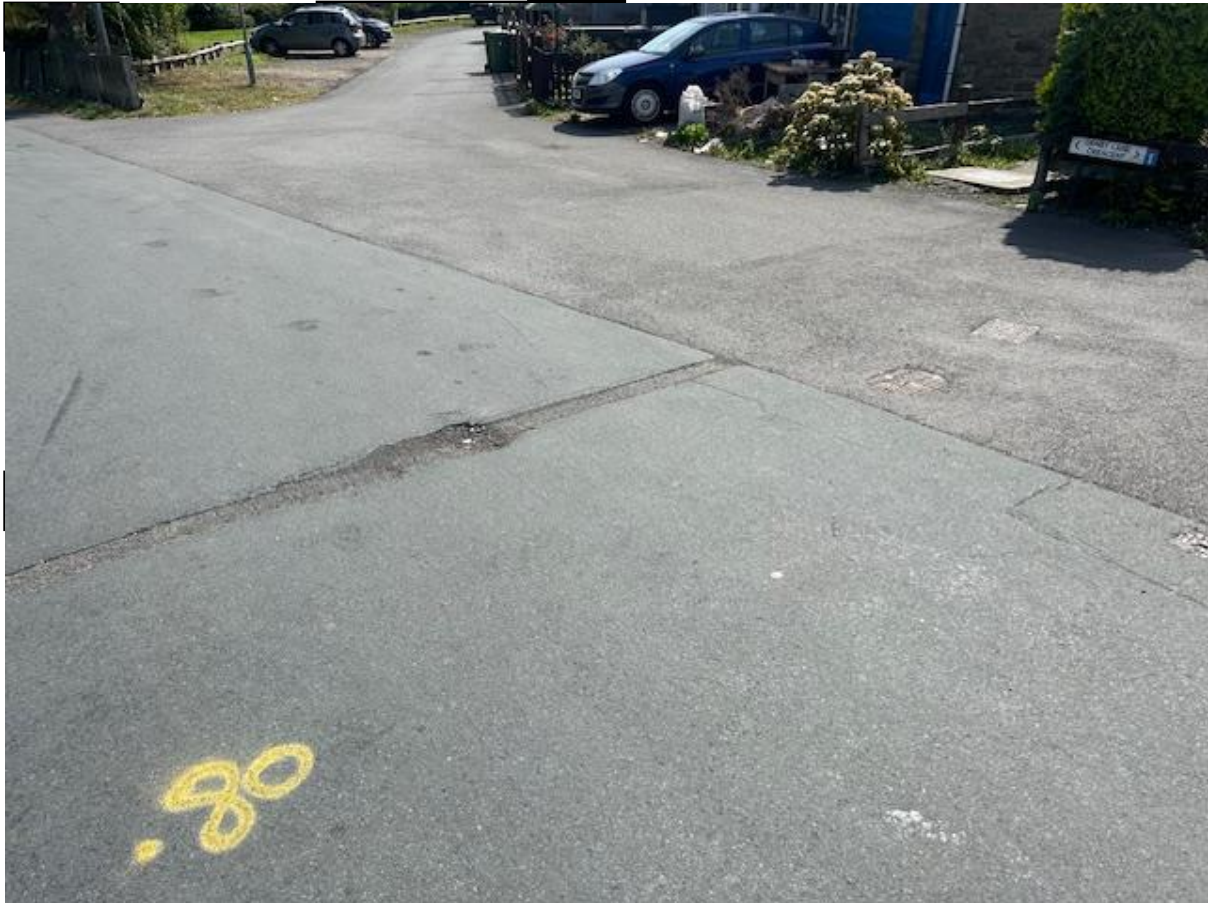
Comments – trench reinstatement showing signs of settlement across Denby Lane.

Comments – as above.

Recommendation – Highway Authority Inspection and monitor internally.

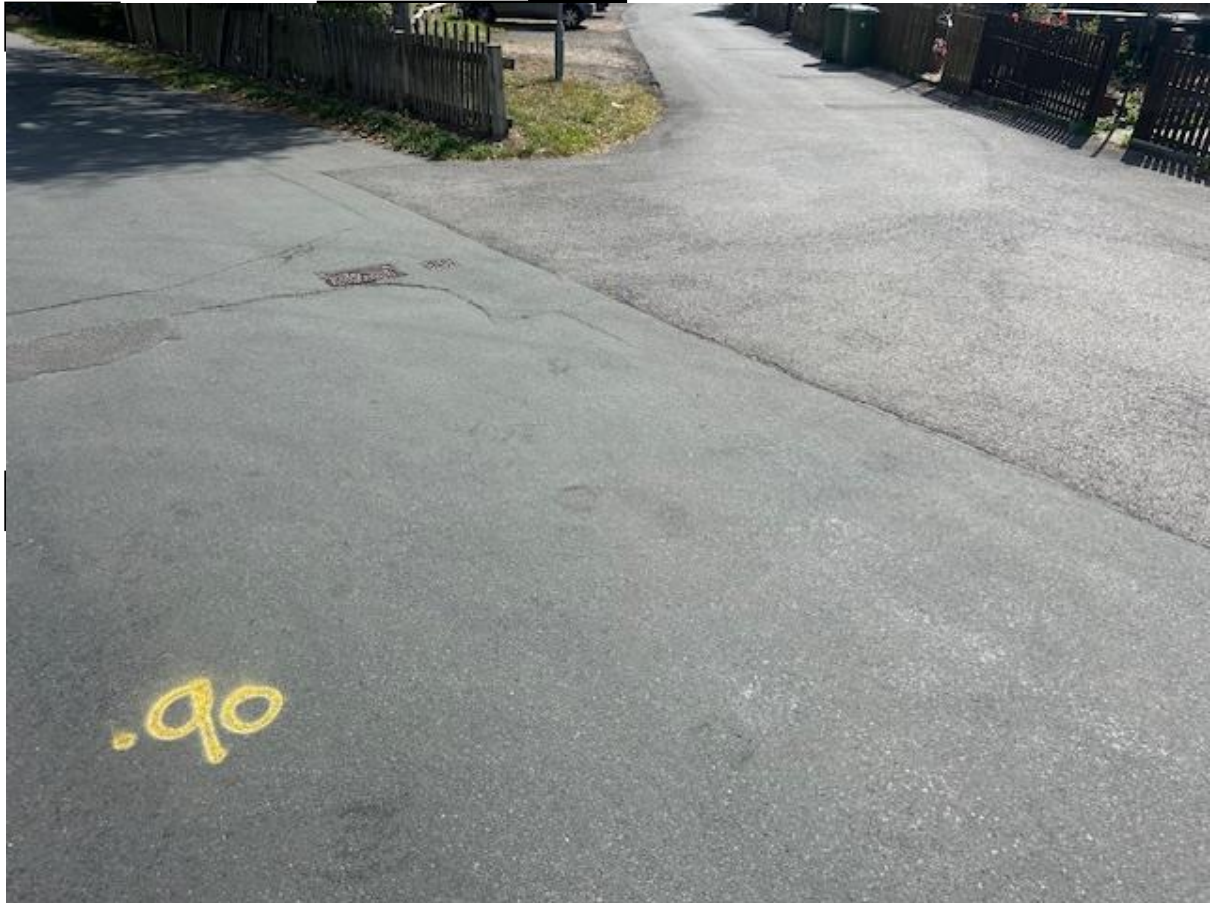
Comments – trench reinstatement across Denby Lane showing signs of settlement.

Comments – as above.

Recommendation – Highway Authority Inspection and monitor internally.

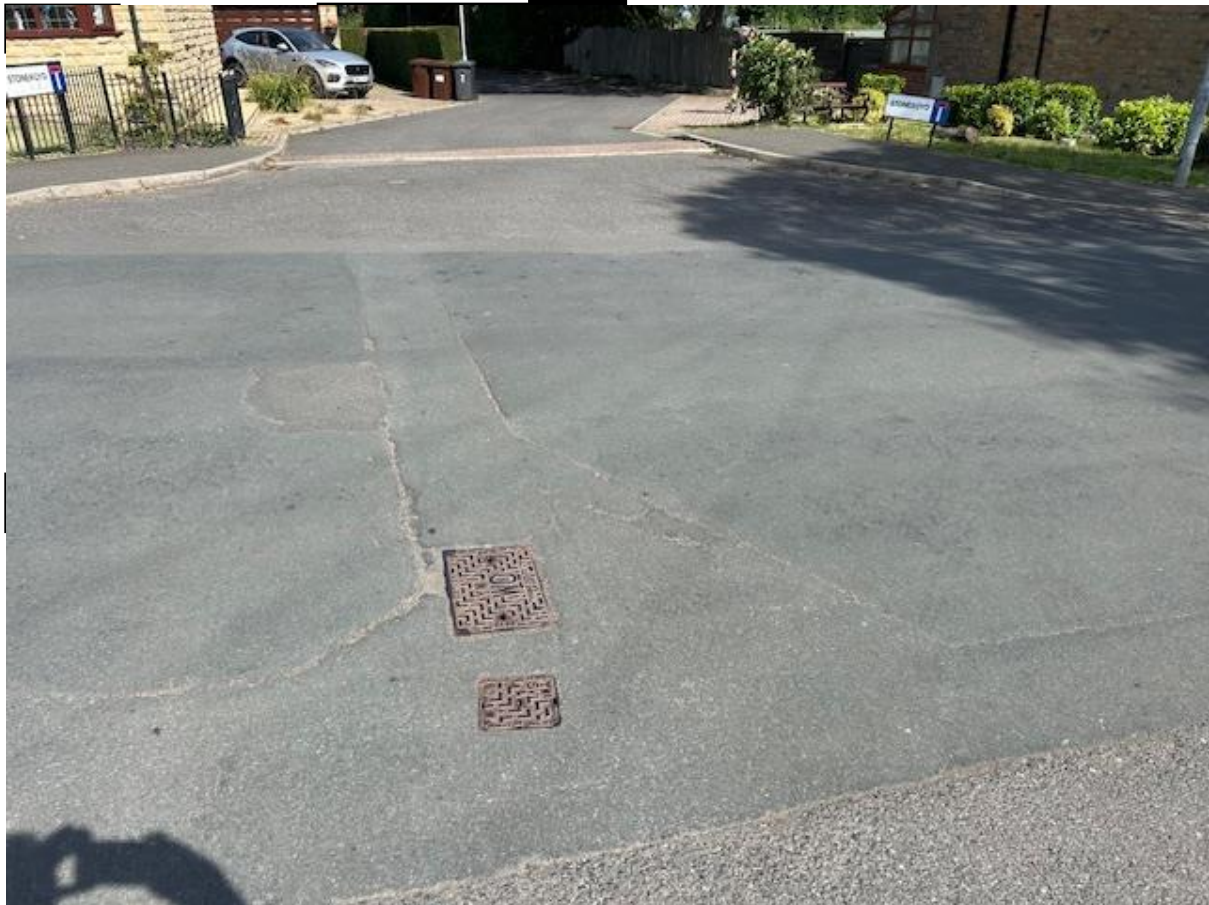
Comments – poor surface course reinstatement leading up to ironwork.

Comments – as above.

Recommendation – Highway Authority Inspection and monitor internally.

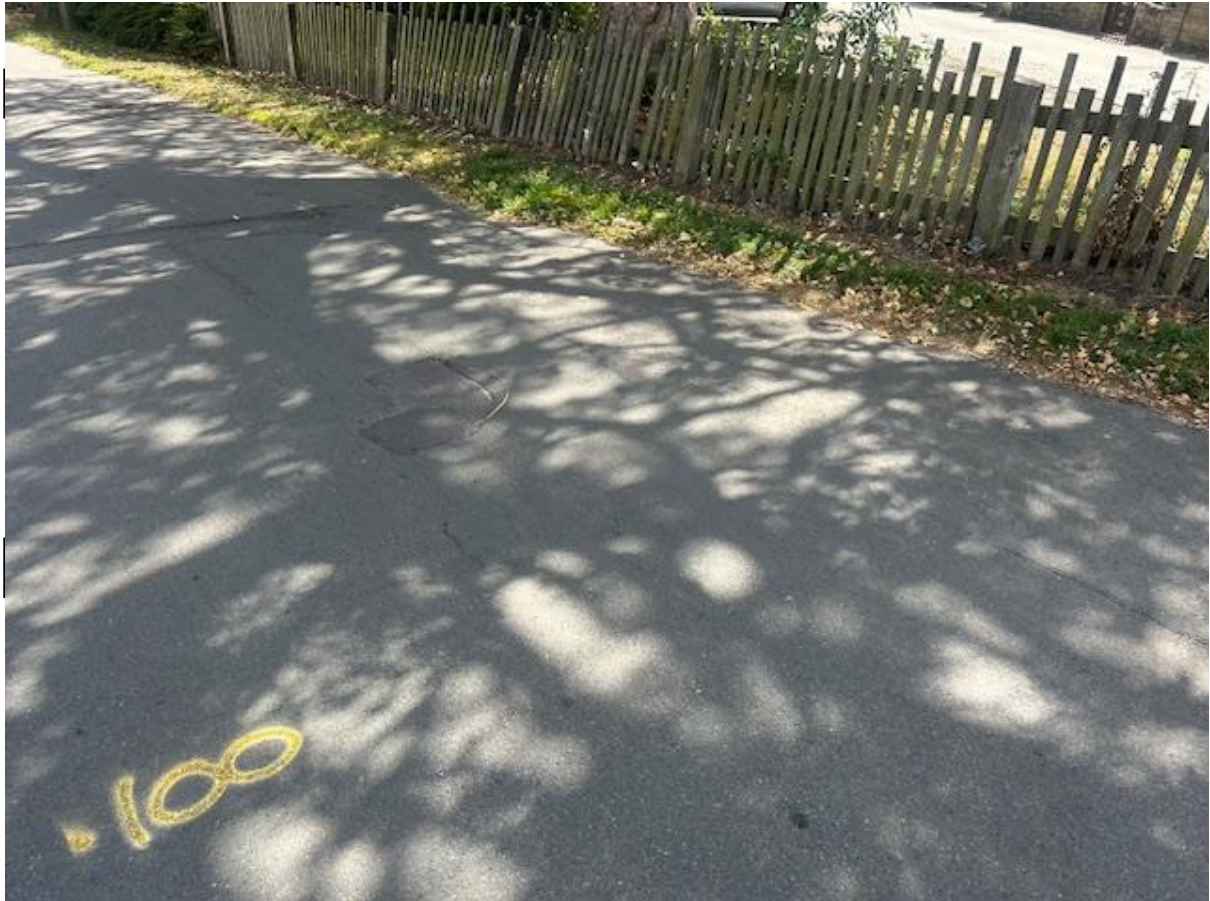
Comments – trench reinstatement across Denby Lane plus separate patch repair. Some settlement observed.

Comments – as above.

Recommendation – Highway Authority Inspection and monitor internally.

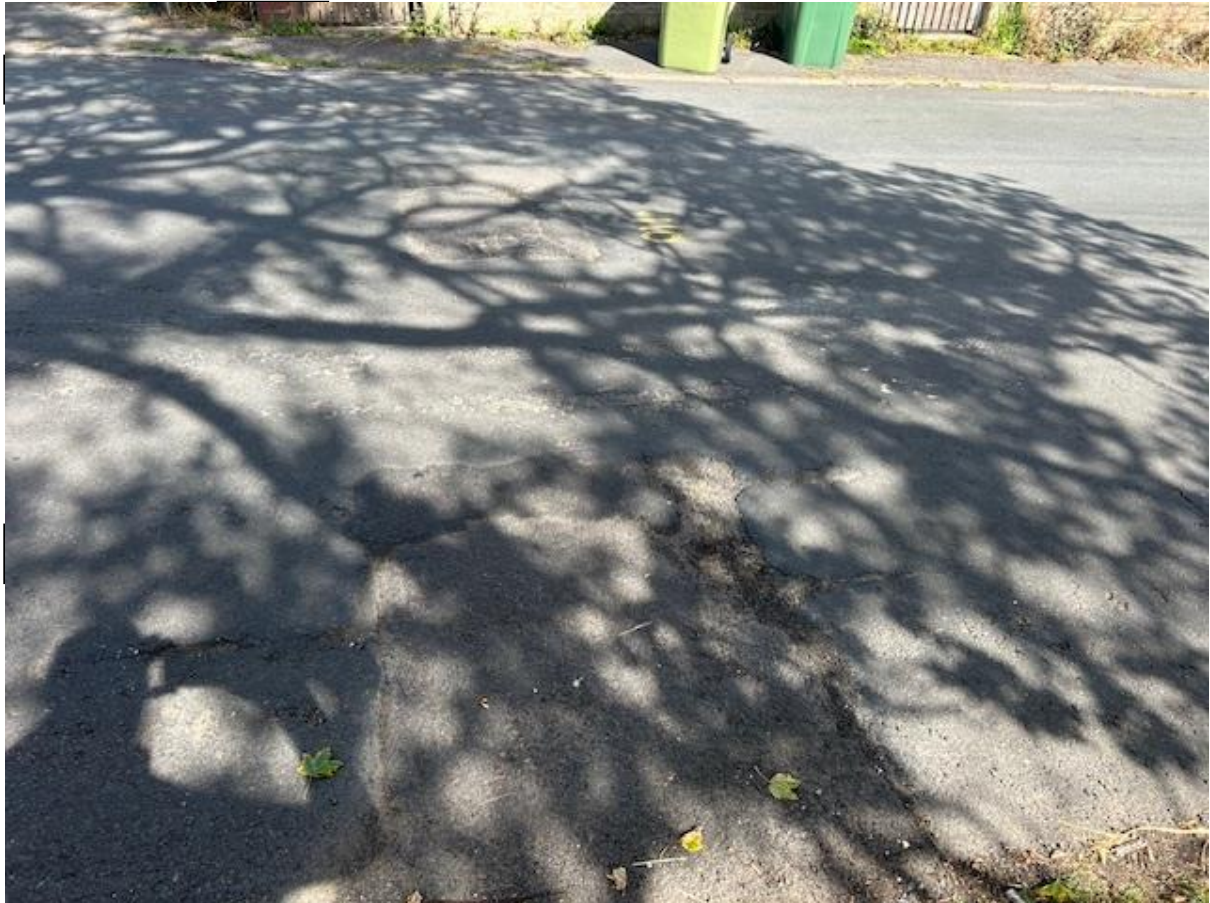
Comments – as above plus evidence of weeds growing in footway.

Comments – as above

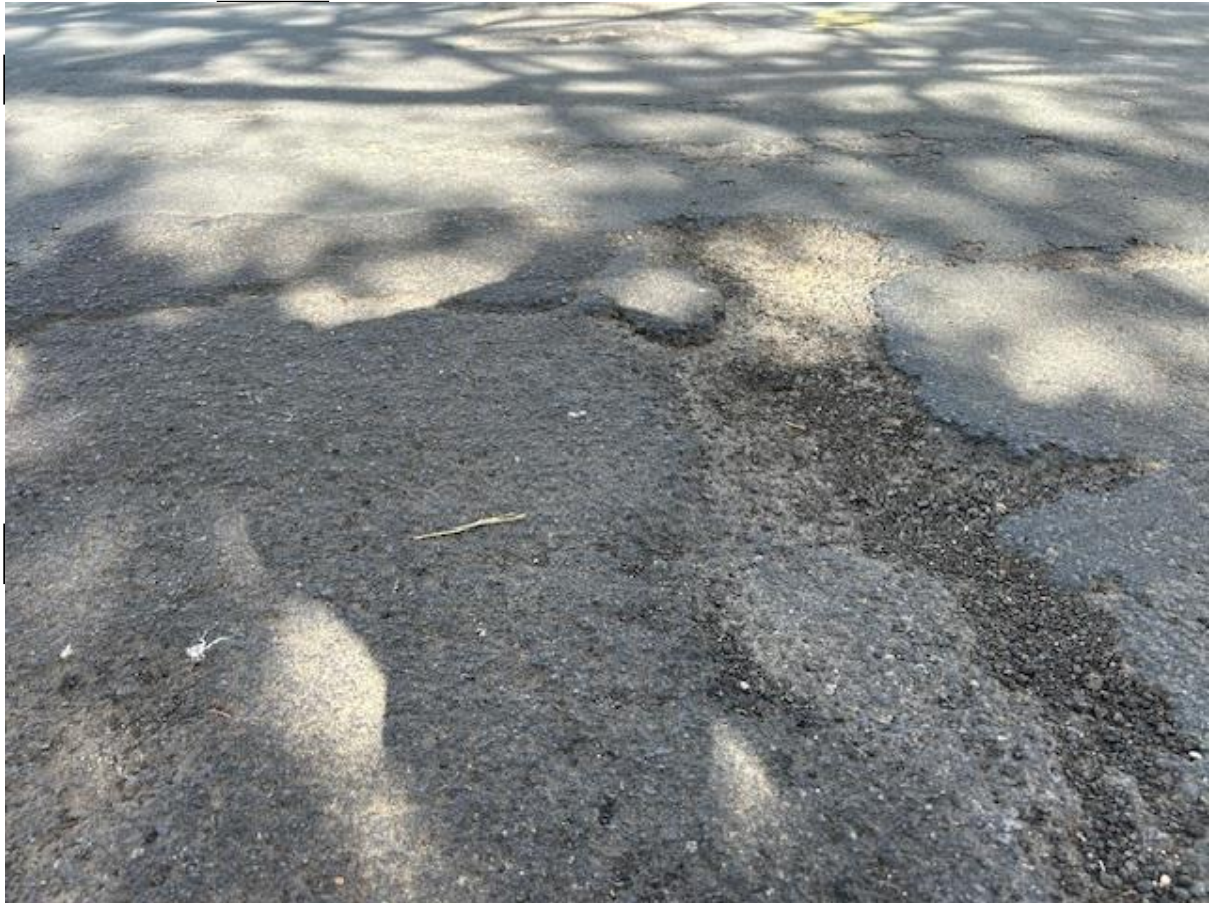
Comments – as above.

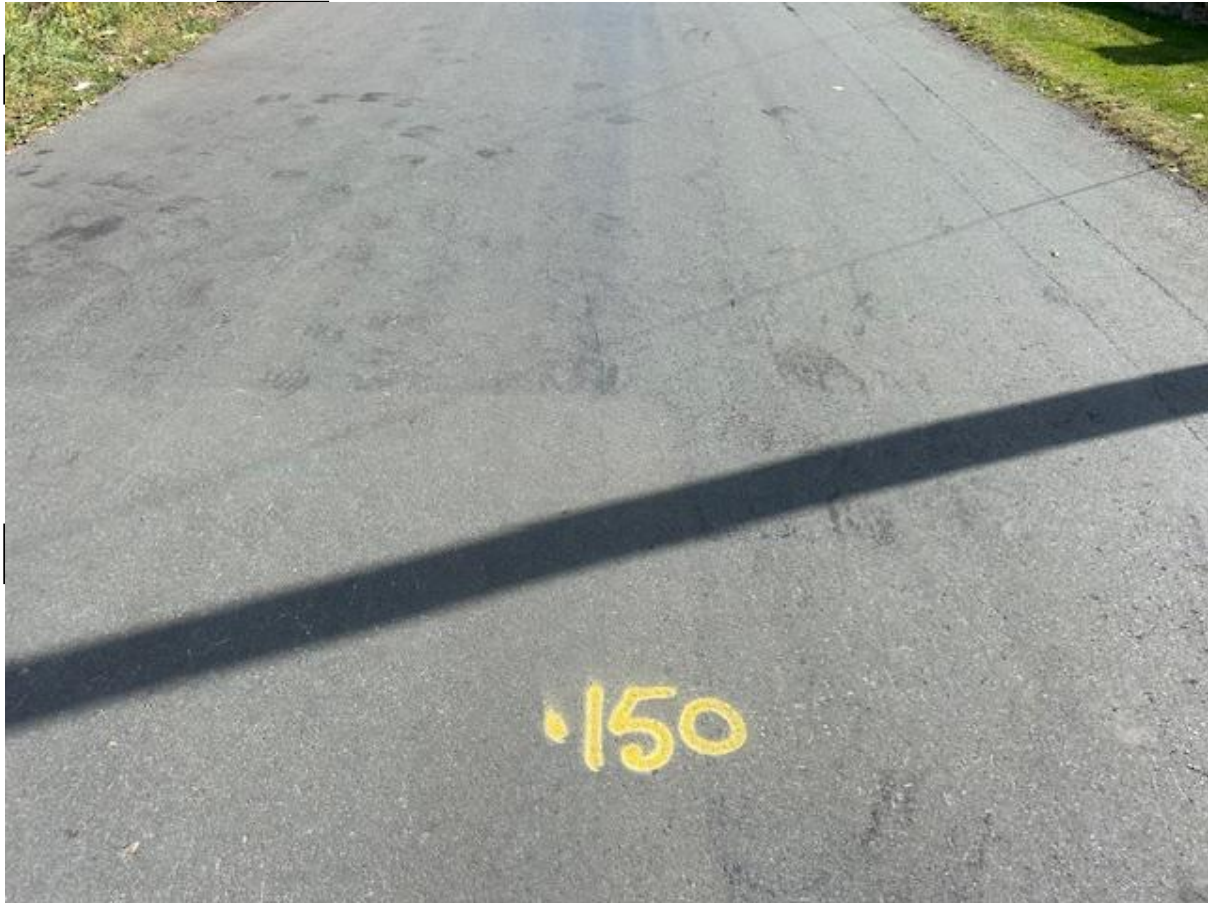
Comments – trench reinstatement along southern flank of Deneby Lane.

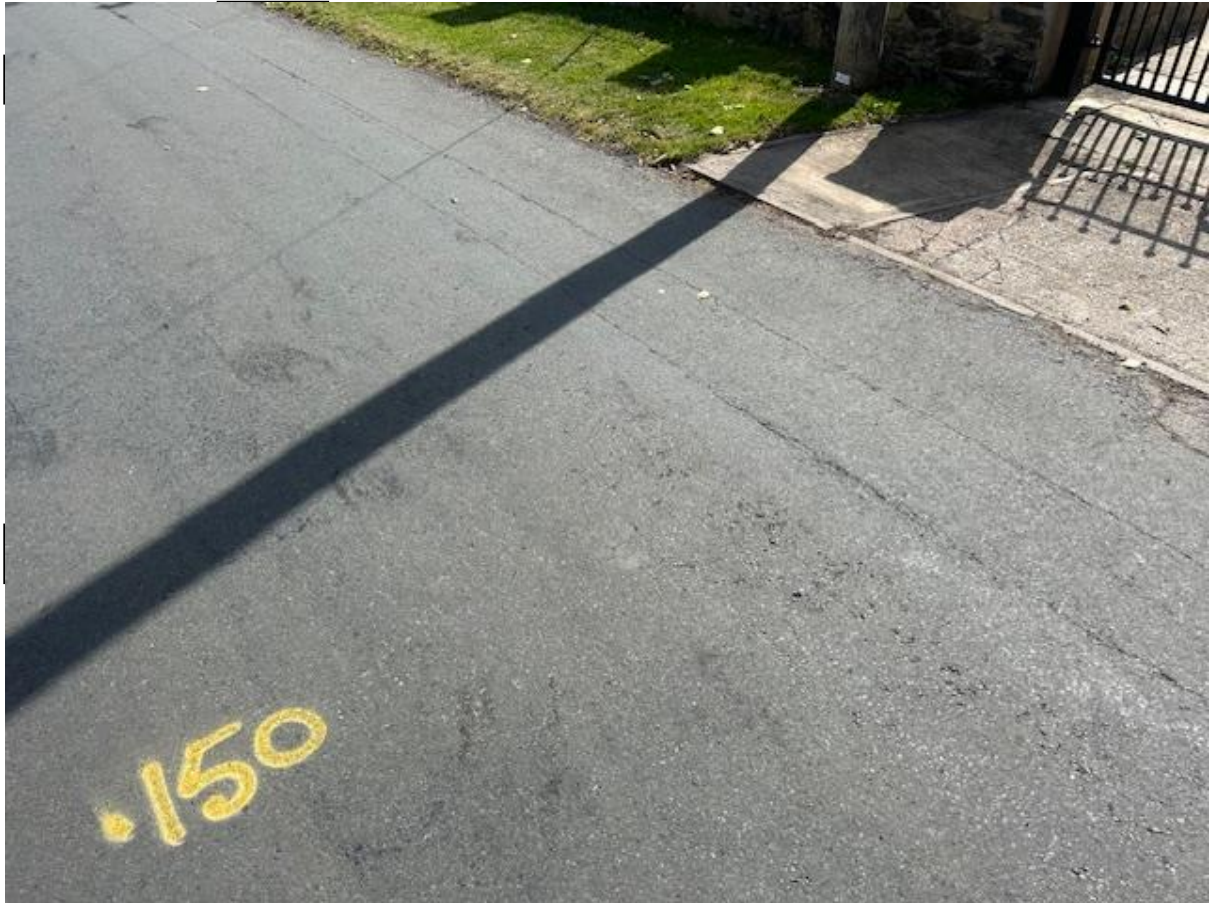
Comments – as above.

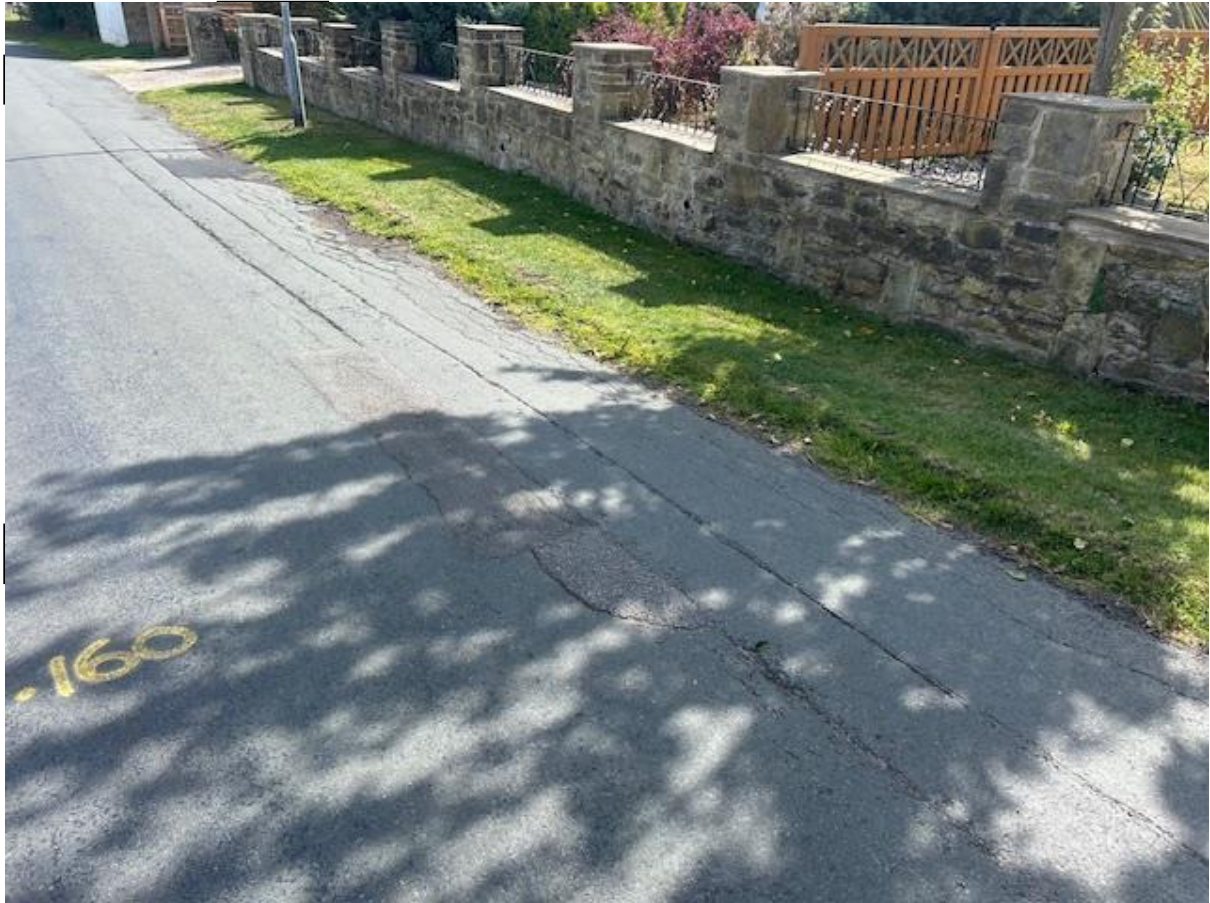
Comments – trench reinstatement joints starting to fail plus poor surface course patch repair.

Comments – as above.

Recommendation – Highway Authority Inspection and monitor internally.

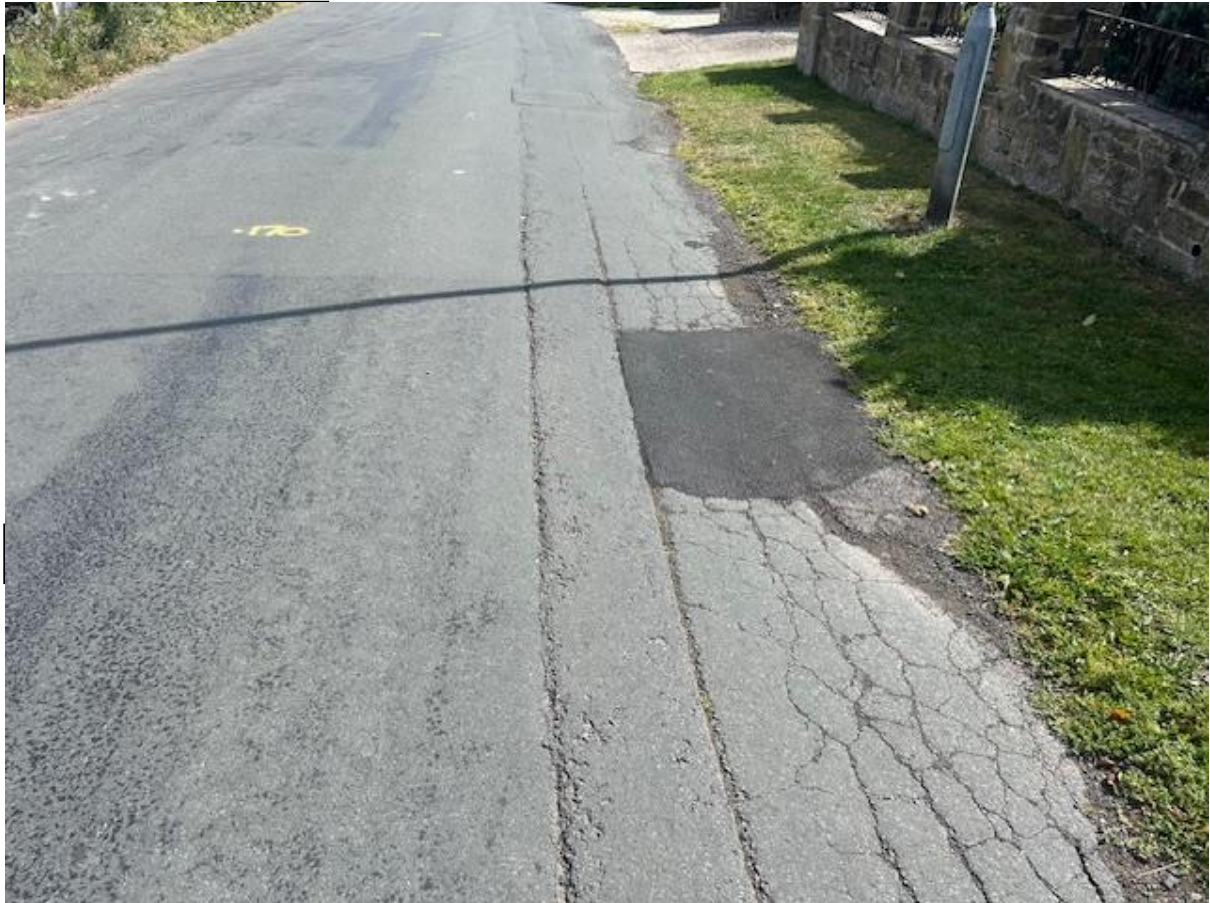
Comments – evidence of tensile cracks developing alongside poor trench reinstatement.

Comments – as above.

Recommendation – Highway Authority Inspection and monitor internally.

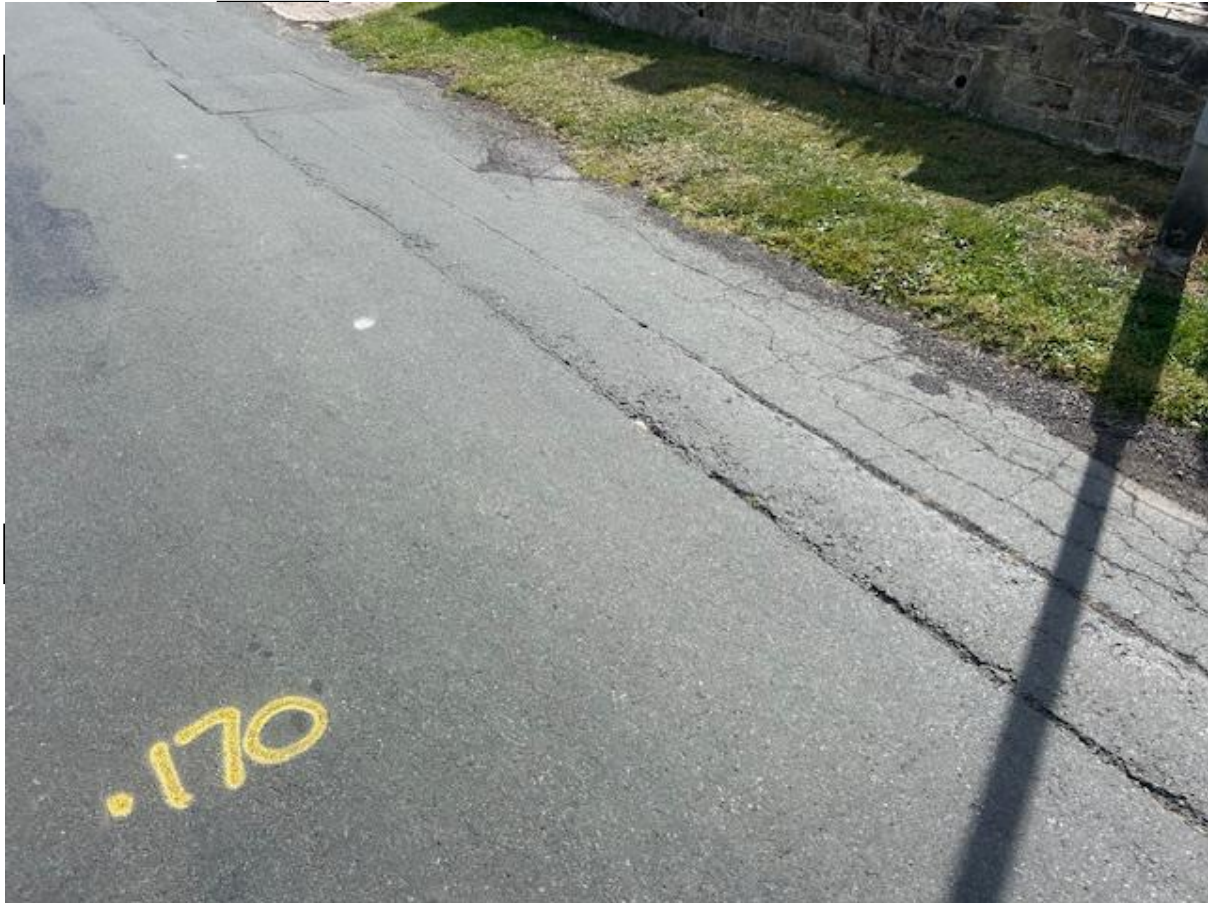
Comments – as above.

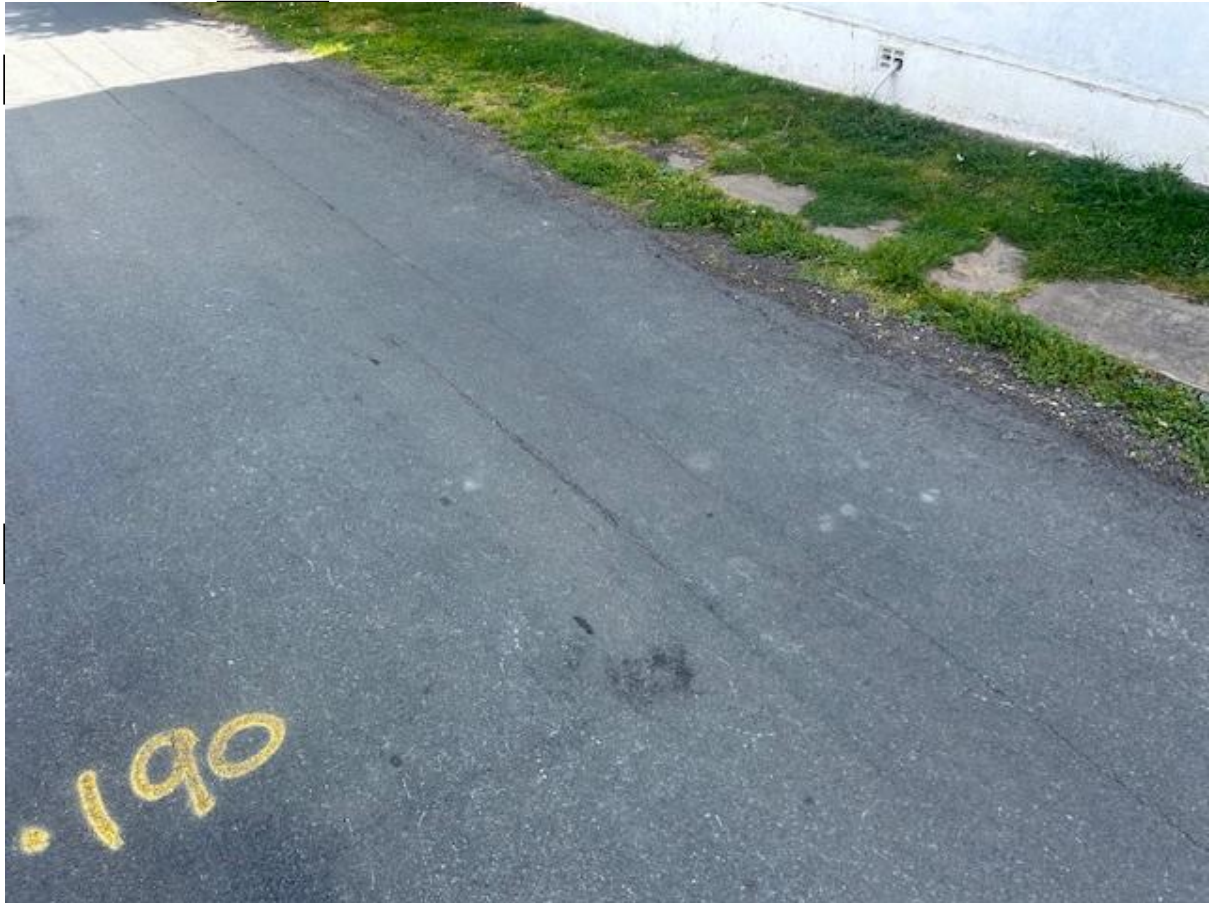
Comments – as above.

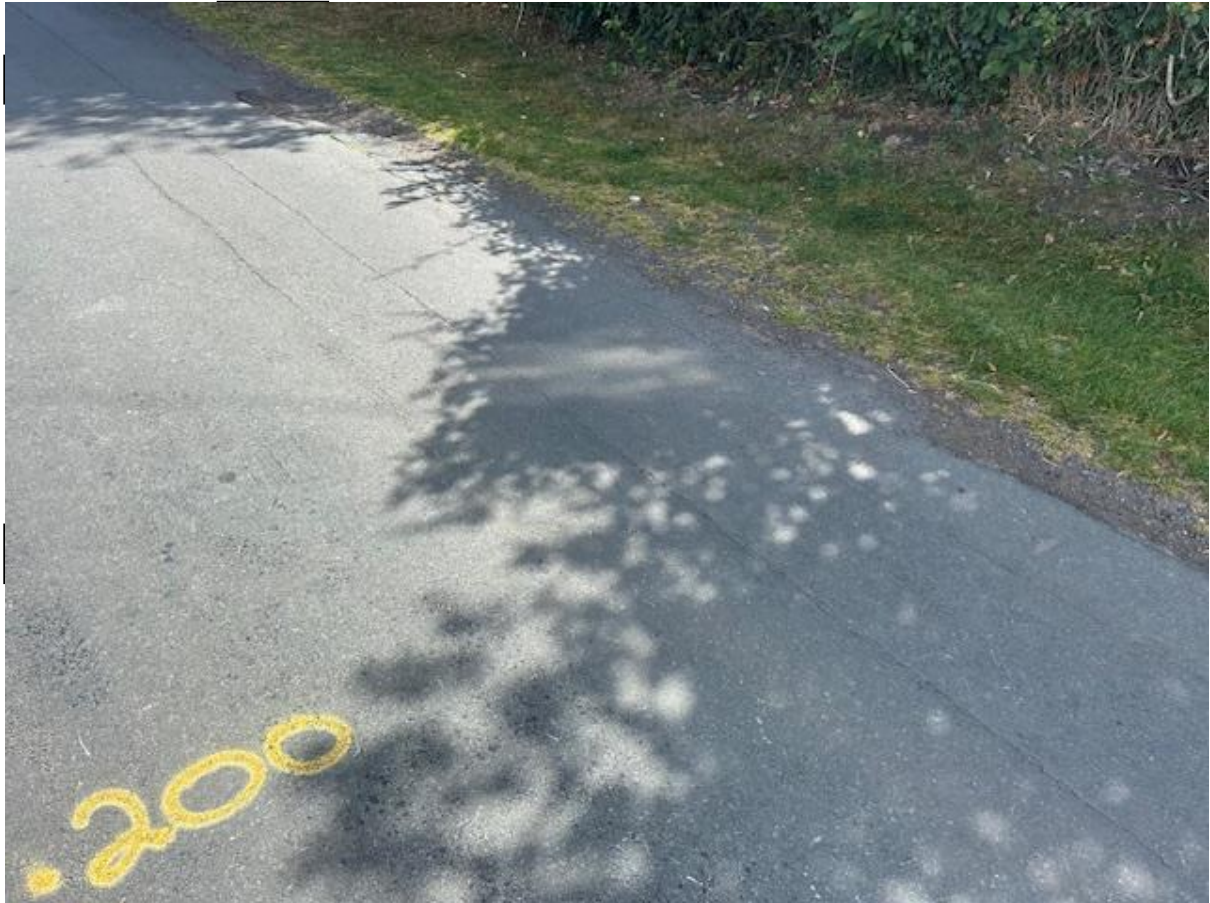
Comments as above.
