Condition Survey Report

Denby Lane, Grange Moor.

Ref: HDC/ENG/DENBY LANE/FINAL

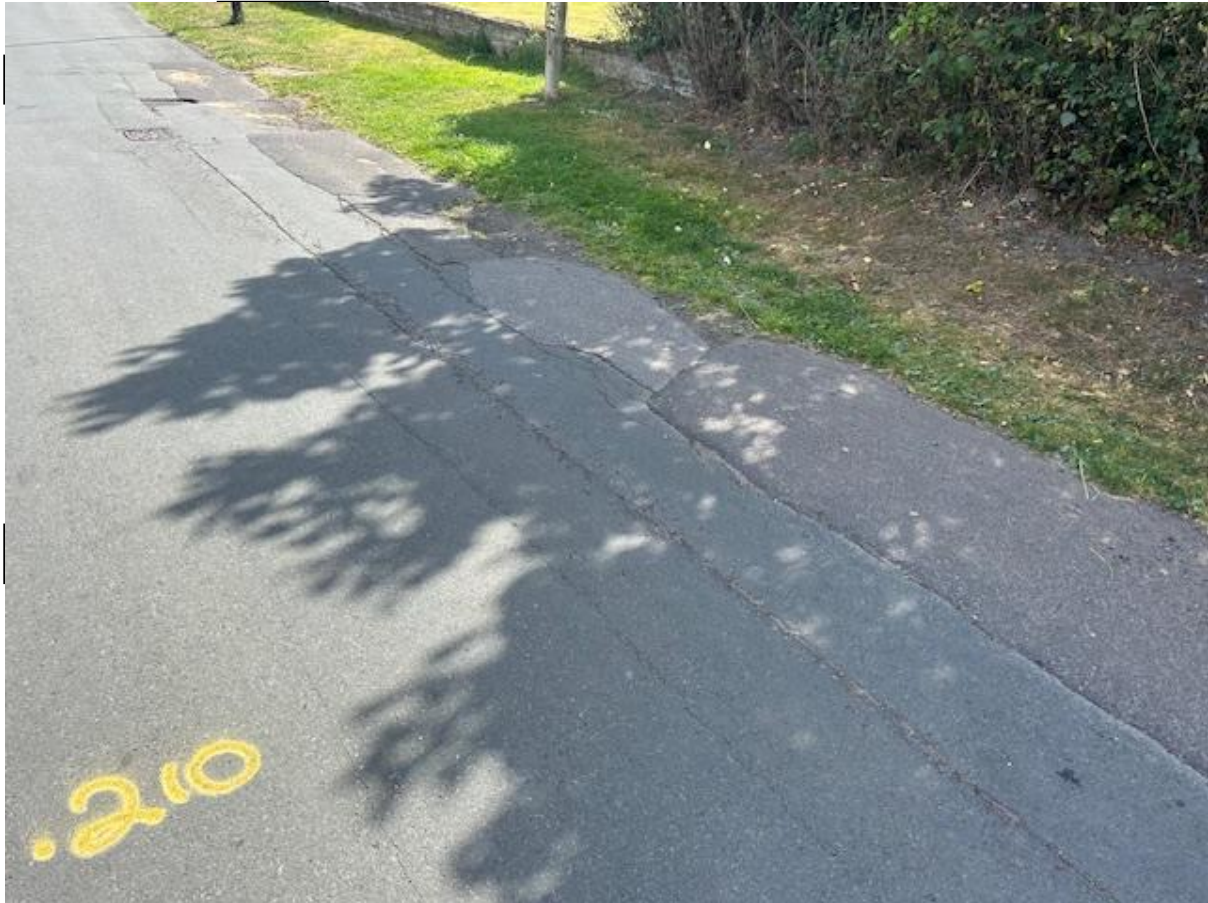
Comments – as above.

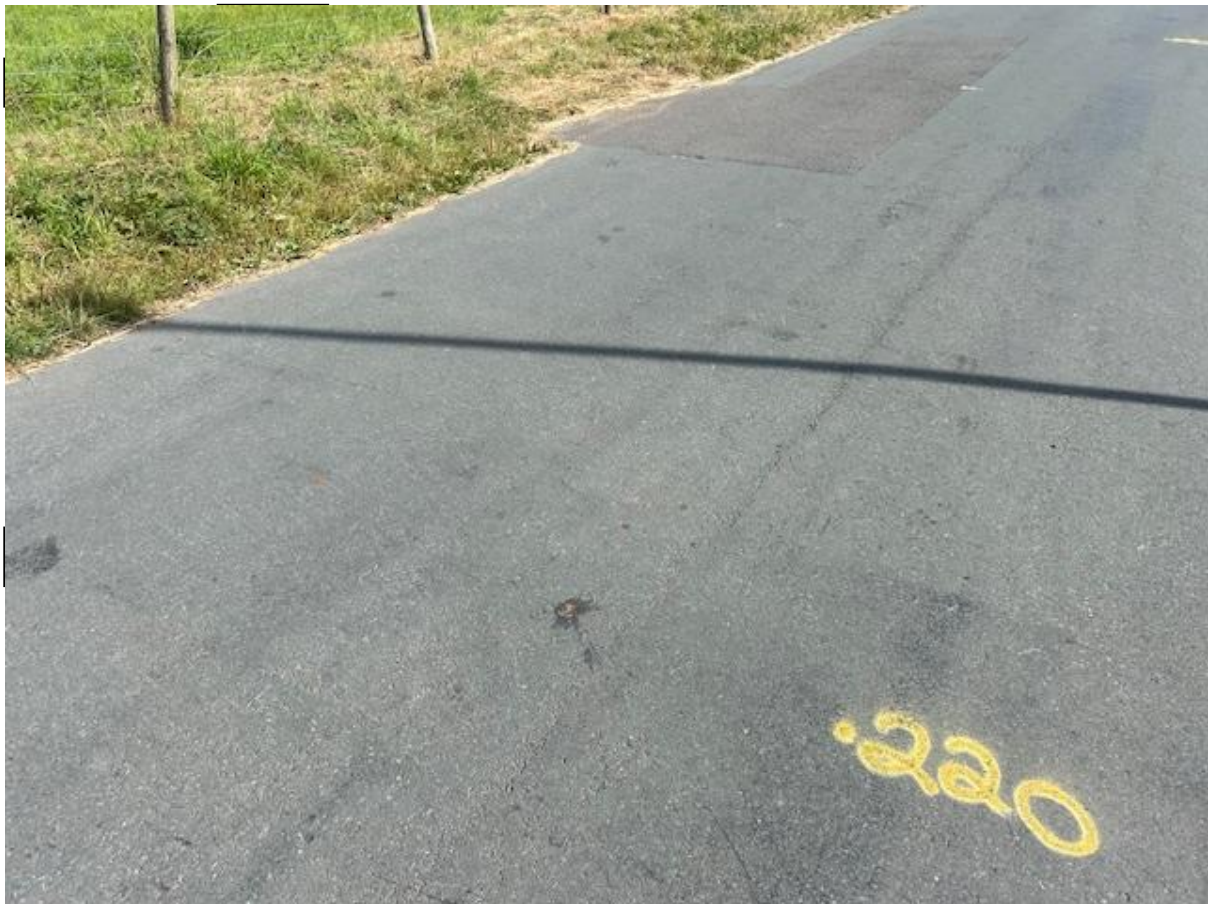
Comments – as above.

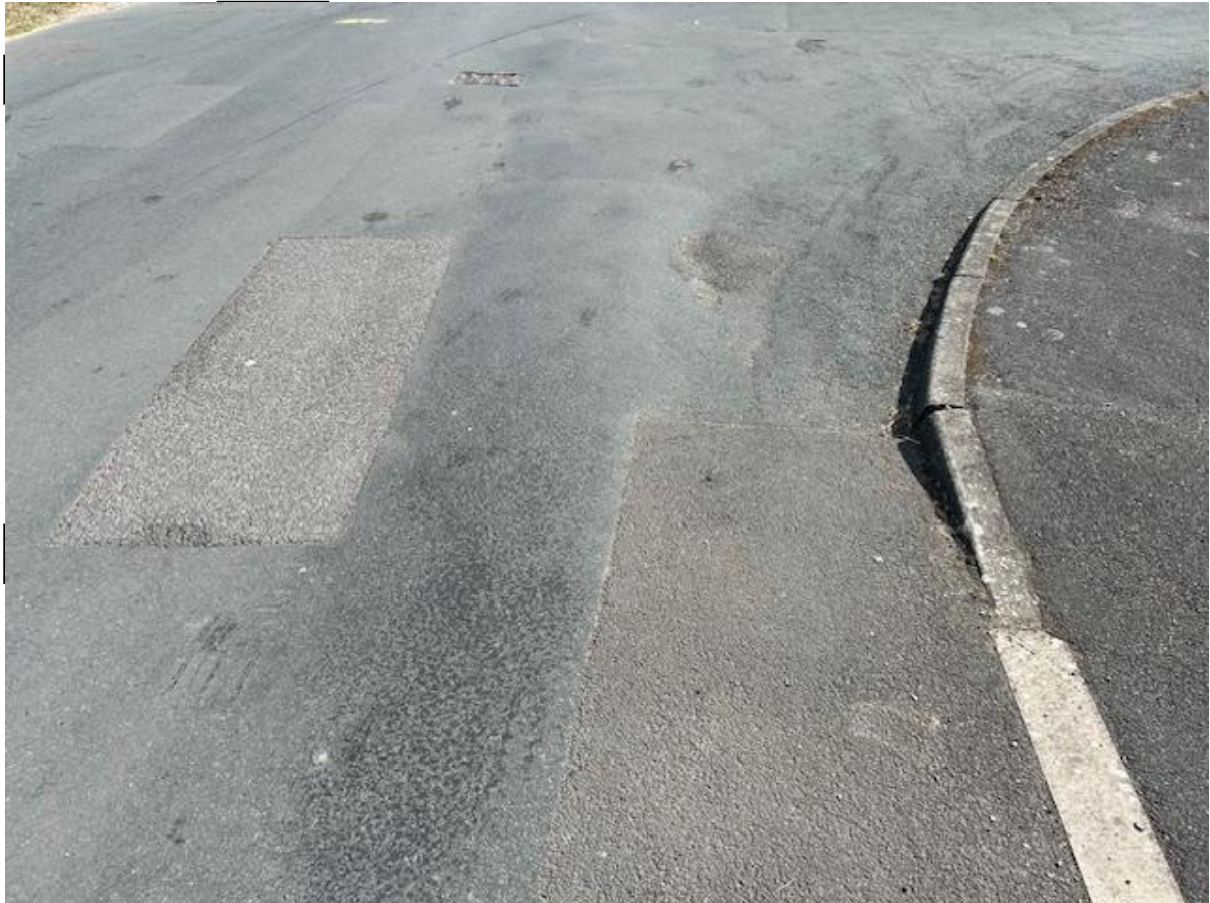
Comments as above.

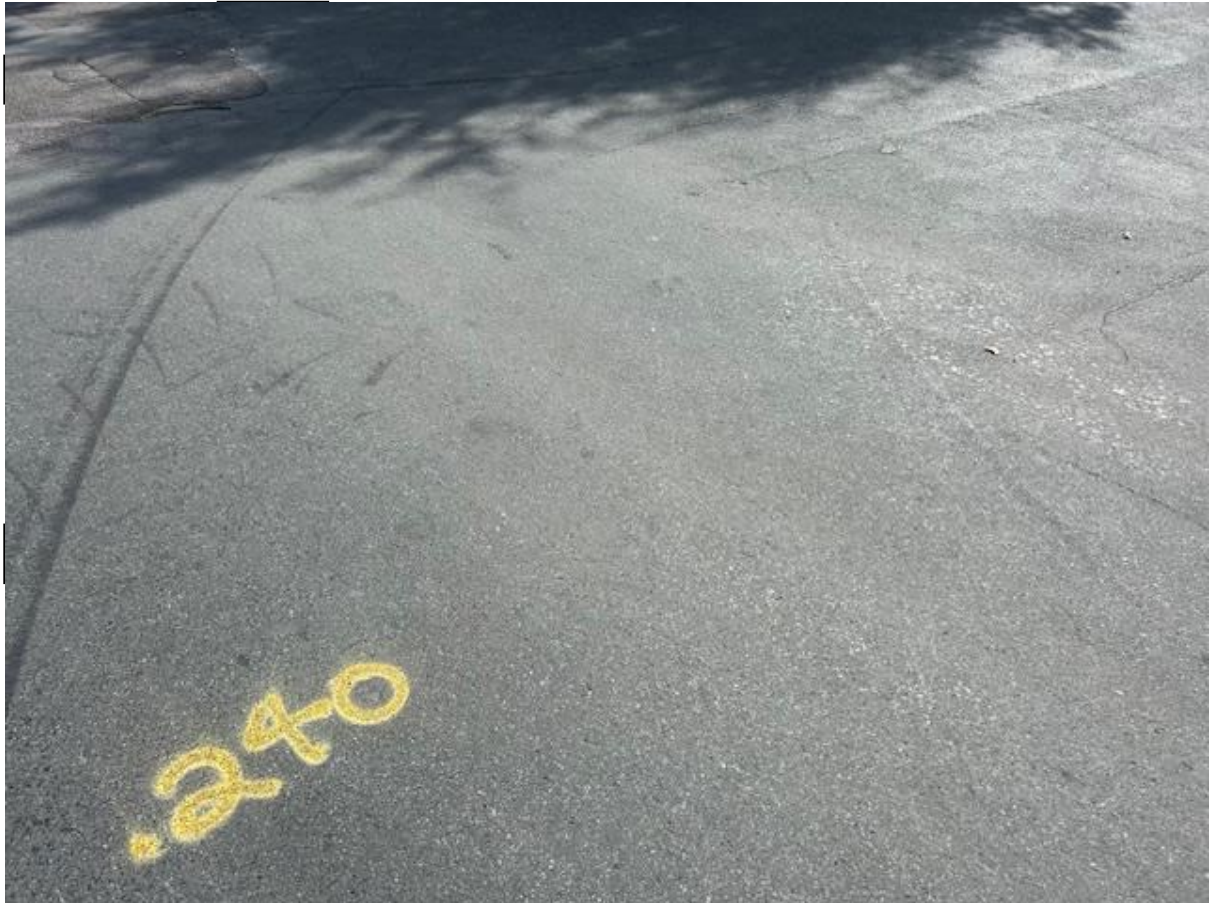
Comments – Poor surface course patch repair and deterioration of surface course leading to emerging potholes.

Comments – as above.

Recommendation – Highway Authority Inspection and monitor internally.

REMEDIAL ACTION REQUIRED.

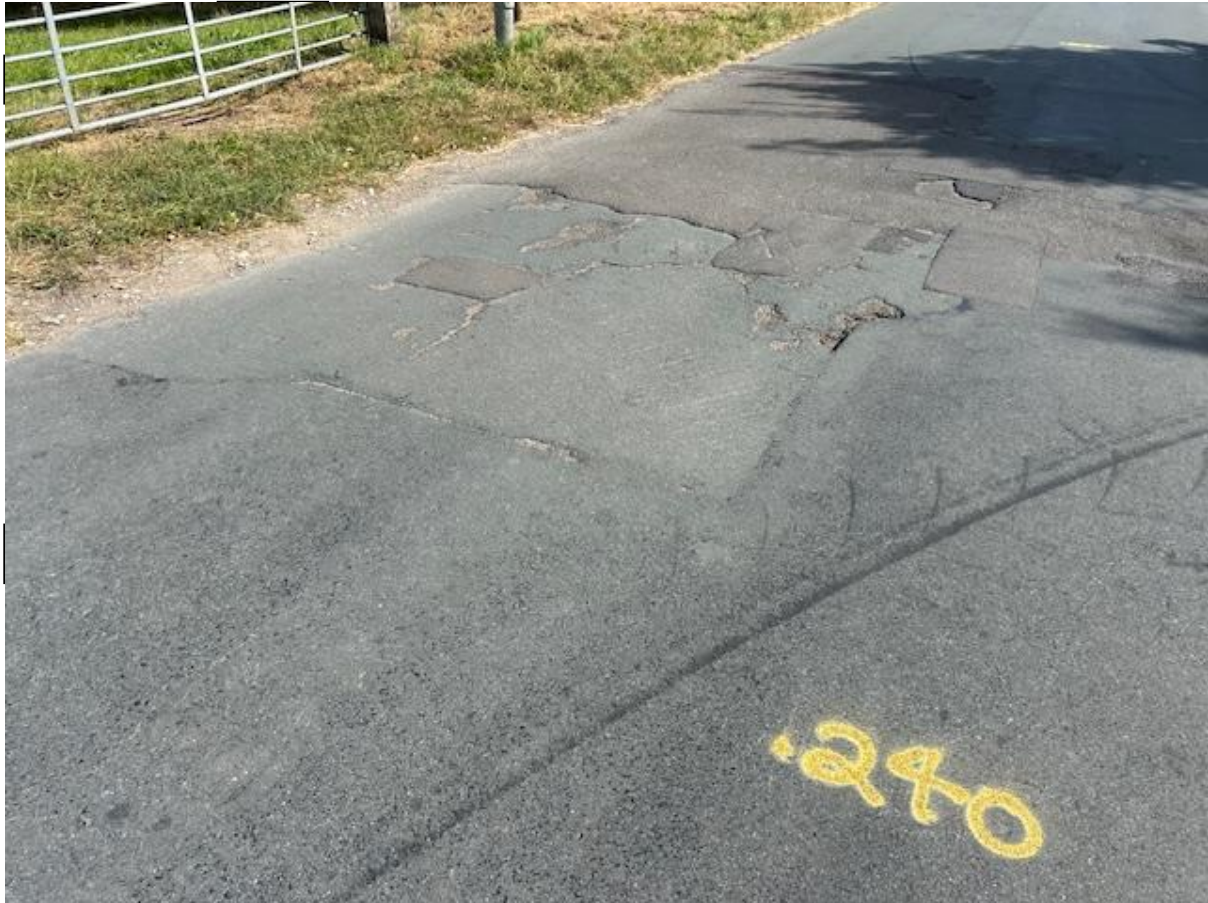
Comments – as above.

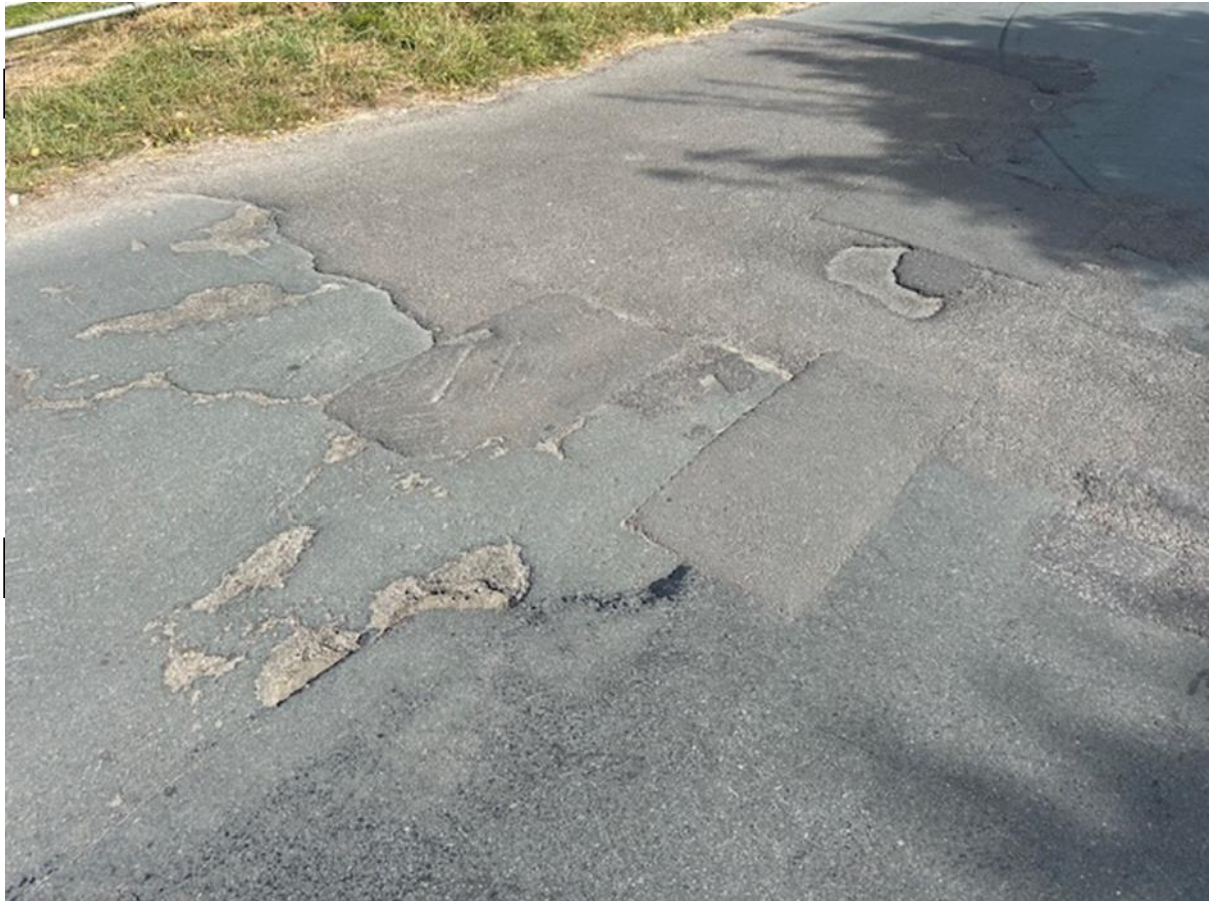
Comments – as above.

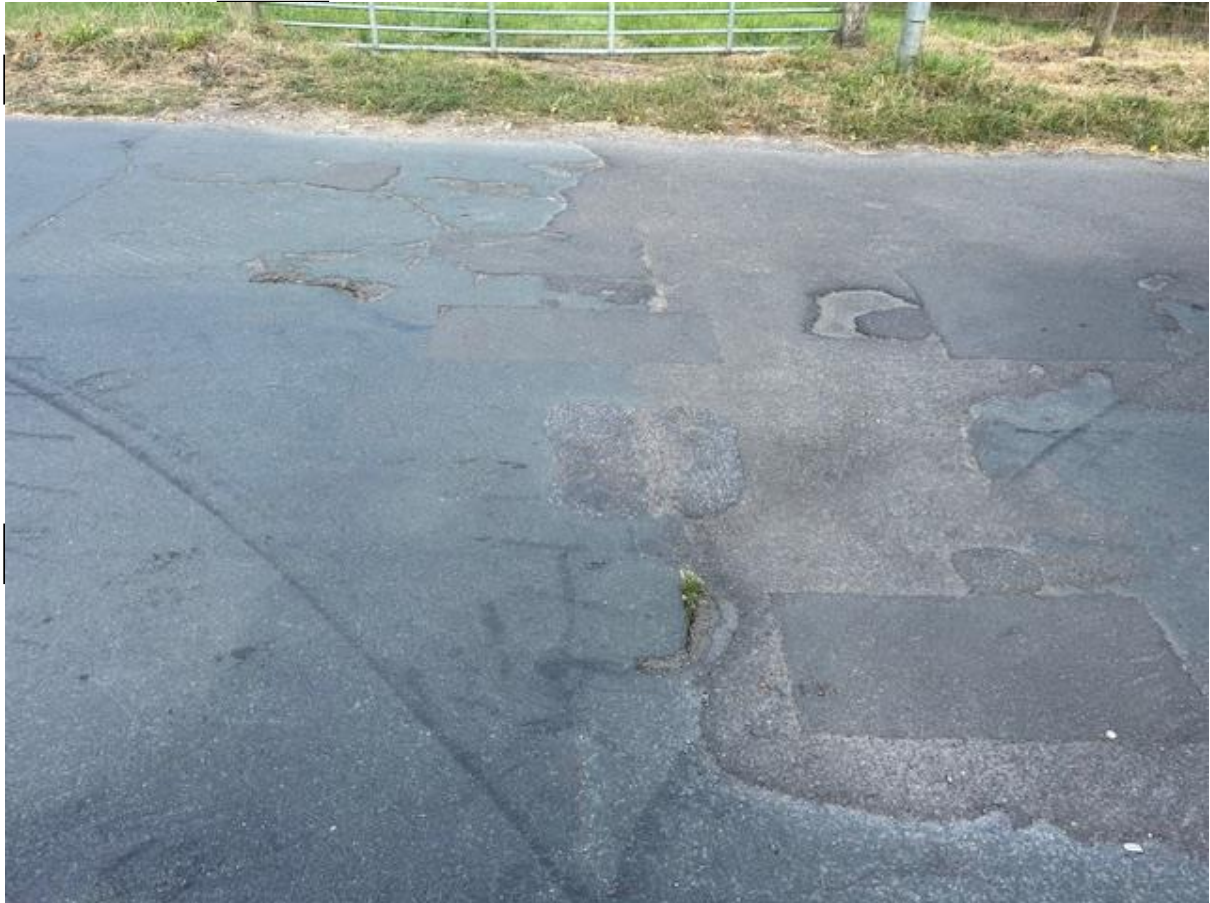
Comments – as above.

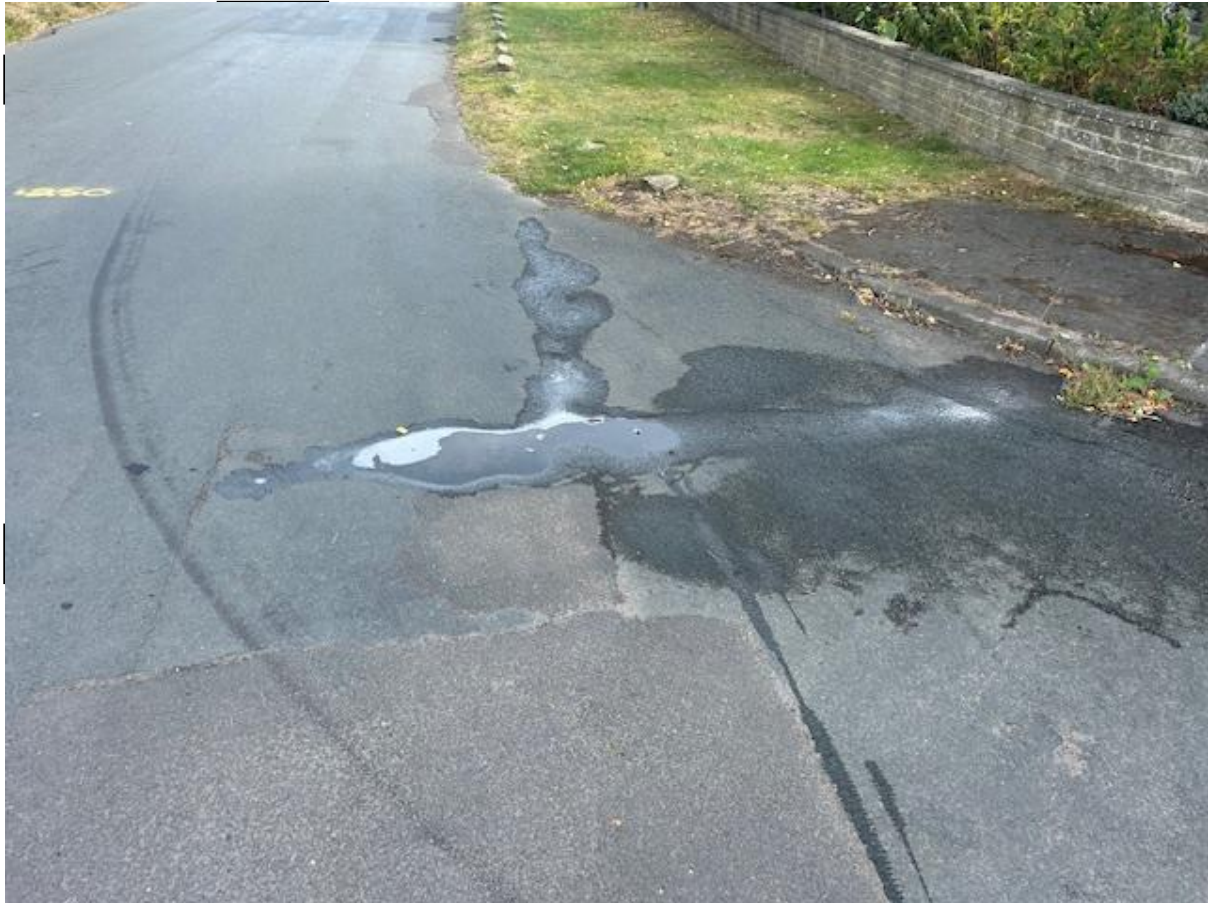
Comments – as above.
