## RICS LEVEL 3 EXECUTIVE SUMMARY BUILDING SURVEY

45 Fenay Bridge Road  
Fenay Bridge  
Huddersfield  
HD8 0AY

**Date of inspection:** 14<sup>th</sup> January 2025

**Reference:** 25-1997/JD/ER

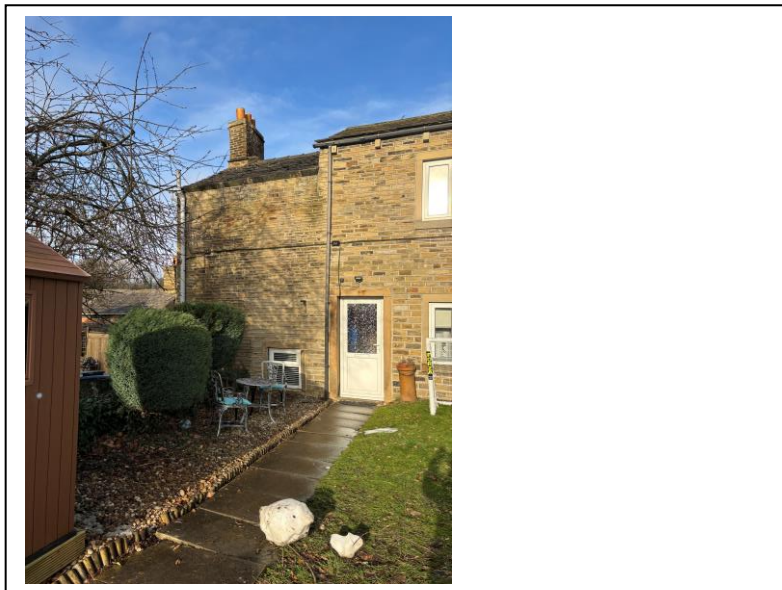
Plate 1

The front elevation appears to have been recently repointed by way of strap pointing, in a cement-based mortar. This type of mortar and style of pointing can be detrimental to York stone. We recommend that the cement-based pointing is removed and the elevations are repointed using a lime-based mortar as this is more porous than cement mortar and will allow the pointing to absorb any water from the stone and release it, rather than the stone holding the water, freezing and delaminating the stone surface. There are areas of missing pointing to the elevation. We recommend that these are repointed in a lime-based mortar to prevent any water ingress.

General overview of front elevation.

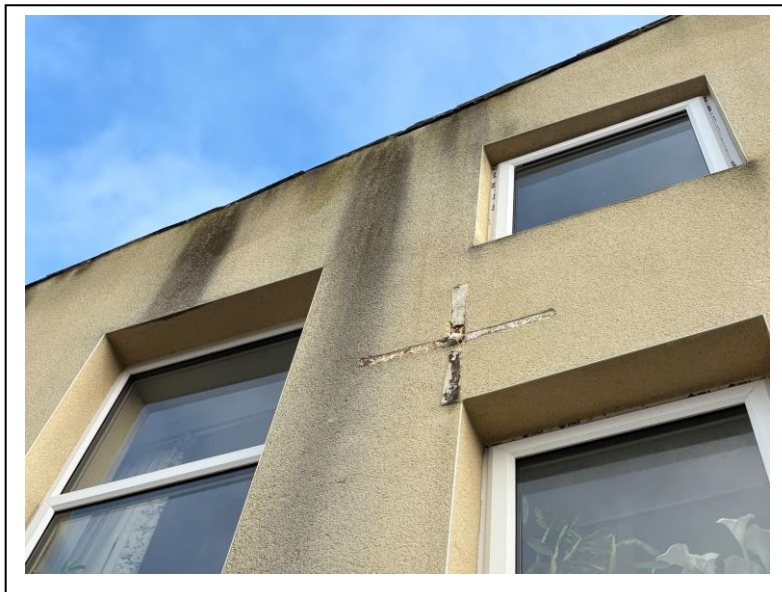
Plate 7

There are areas of water staining at high level to this elevation. We believe that this is due to the lack of overhang by the verge roof tiles. We recommend that the roof tiles be repositioned to provide a minimum overhang of 50mm and the verge repointed to prevent any water ingress.

Due to the internal cracking and the direction of it (identified in the internal section), we believe that the left elevation lacks restraint which has subsequently caused structural movement of the elevation. We recommend that tie restraints are installed to help the stability of the elevation.

Water staining at high level to left elevation. Wall restraints to pull the structure into shape. Cracking at high level at the top of the stairs at second floor.

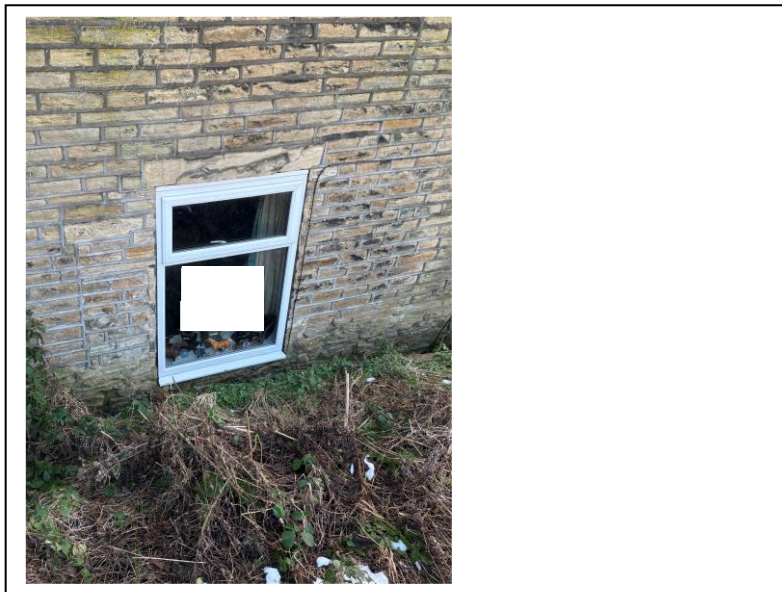
Plate 10

The external ground level is significantly higher than the internal ground level within the property. This could cause damp related problems as properties of this age do not benefit from a damp proof membrane.

Lounge rear window in comparison to external floor level.

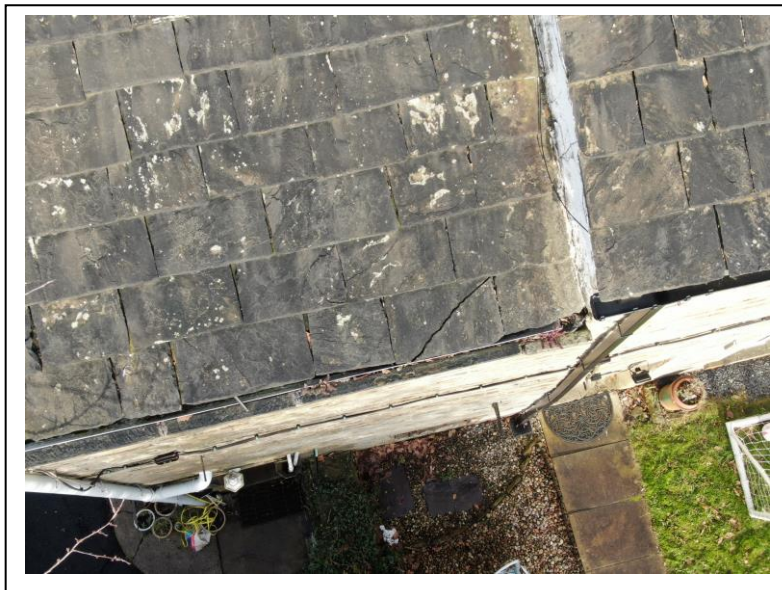
Plate 13

To roof 1, there are a number of cracked, missing and slipped tiles which we recommend are replaced and repositioned to prevent any water ingress to the property. To the front pitch, one tile has broken into two pieces and is being held in place by the guttering. From a health and safety perspective, we recommend that this tile is immediately replaced to mitigate the risk of harm or injury should it fall. There is moss growth to the roof throughout which we recommend is cleaned down with herbicide to prevent the potential risk of water ingress.

Front roof pitch showing build-up of dirt and debris in guttering and broken roof tile.

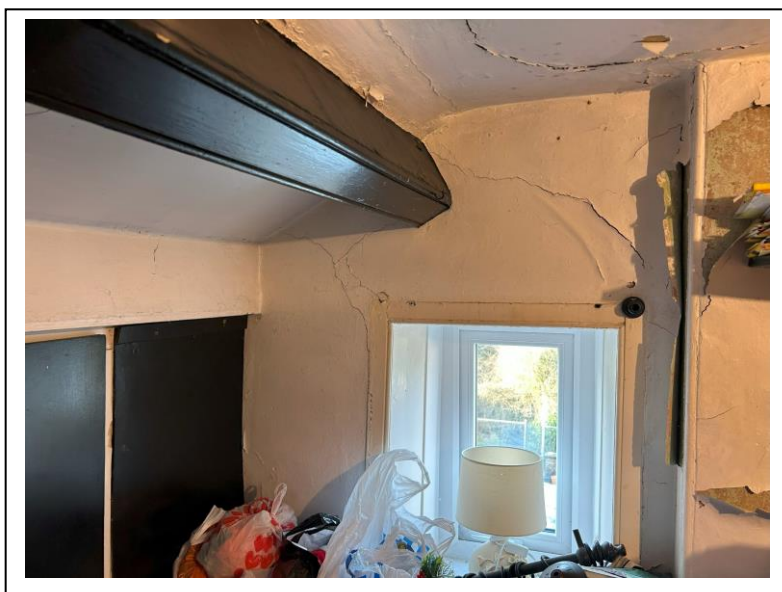
Plate 18

Cracking around structural openings to gable wall.

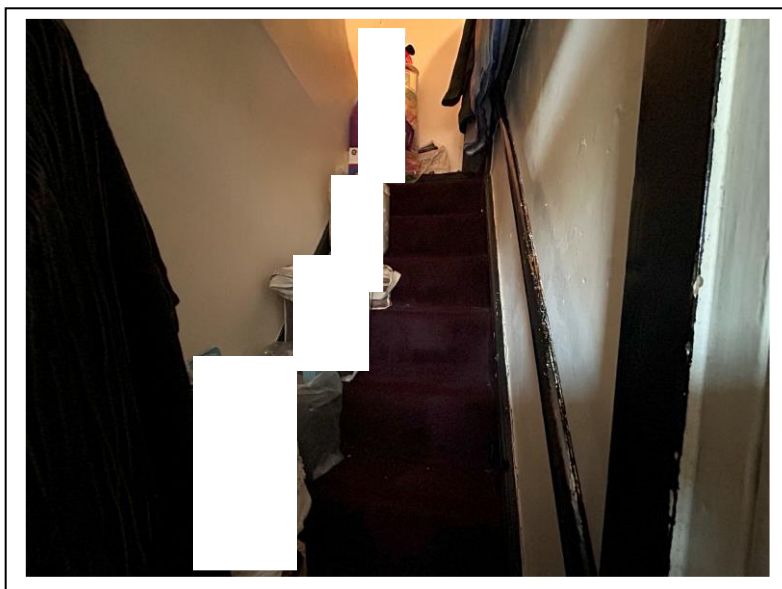
Plate 23

General overview second floor staircase with handrail which does not comply with building regulations.

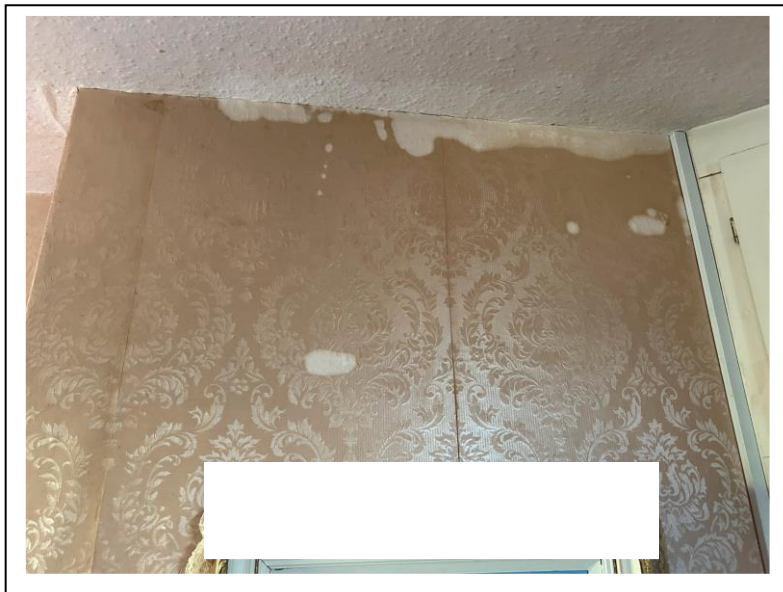
Plate 25

Water ingress to party wall chimney stack in bedroom.

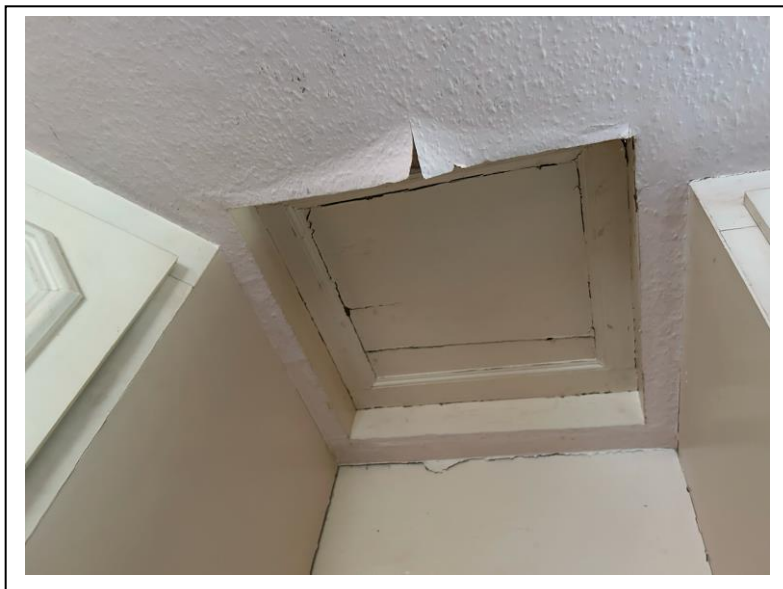
Plate 32

We were unable to gain access to the loft space due to the access restrictions caused by the tenant's possessions.

Loft access hatch.

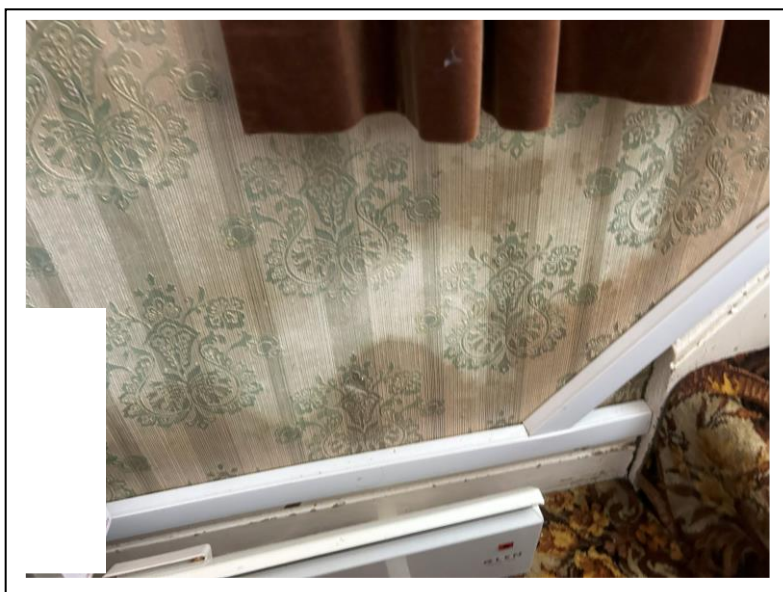
Plate 33

Damp below window to first floor landing.

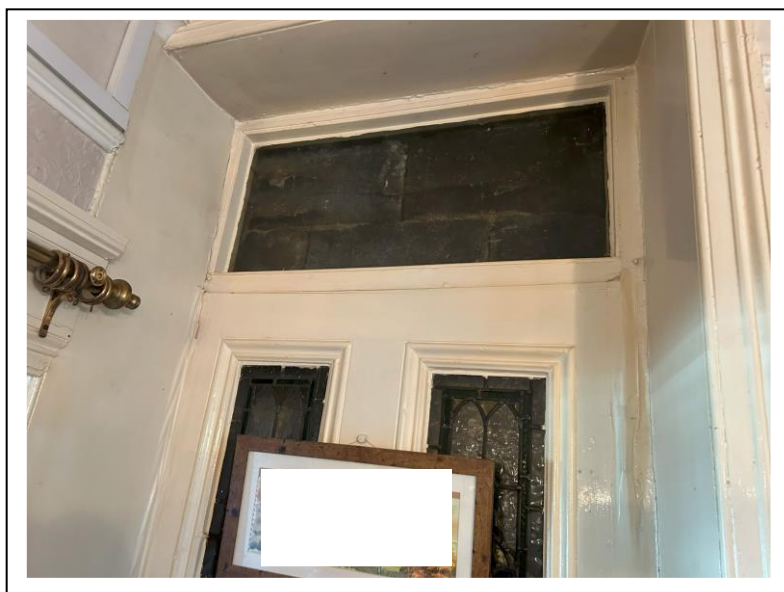
Plate 42

Historic opening infilled.

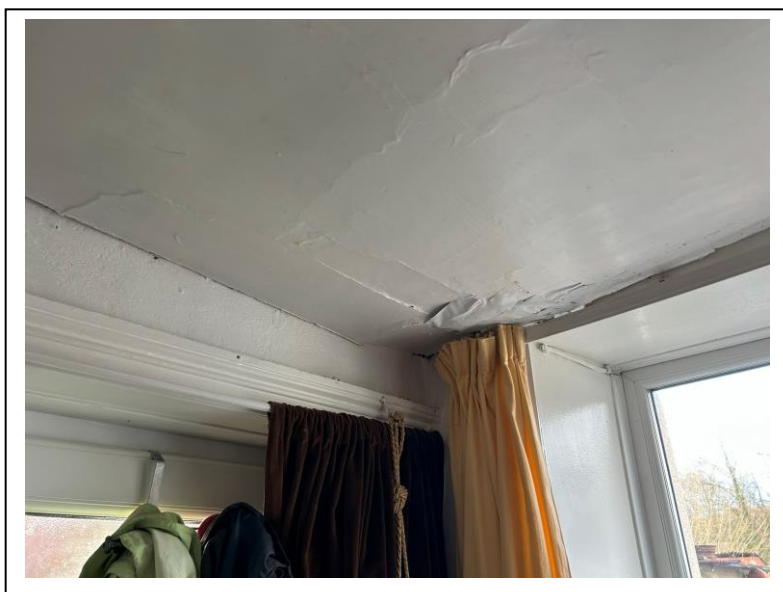
Plate 48

Partially dropped ceiling  
to front right corner of  
kitchen.

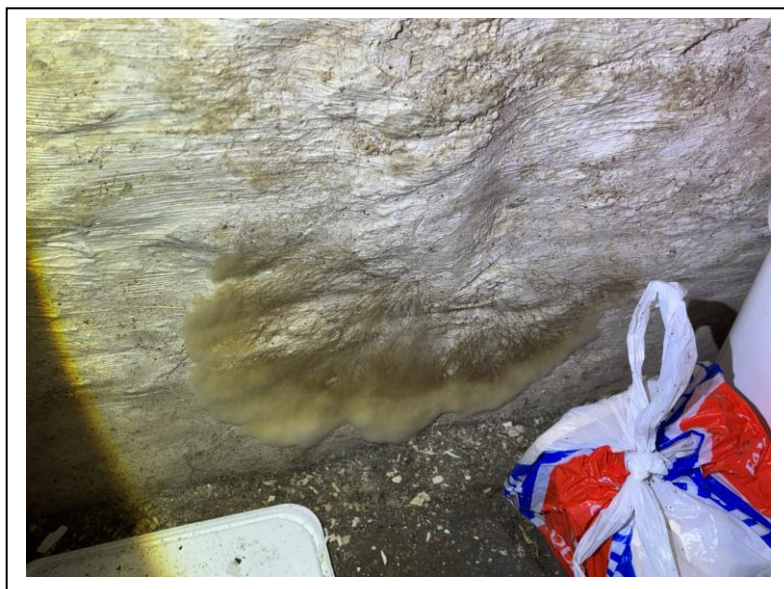
Plate 50

If the dry rot in the cellar is not rectified as a priority, this could spread to the neighbouring property causing further structural issues.

Dry rot to cellar.

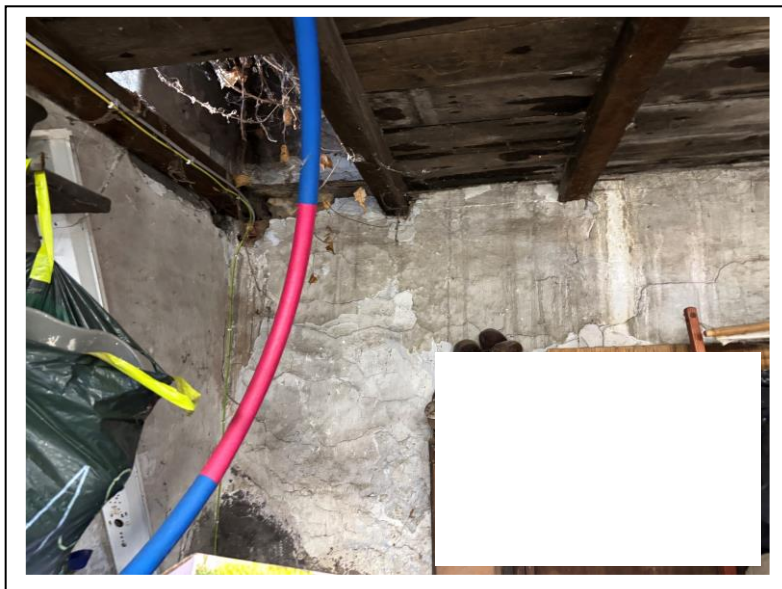
Plate 56

Cracking to render in first section of outbuilding 1.

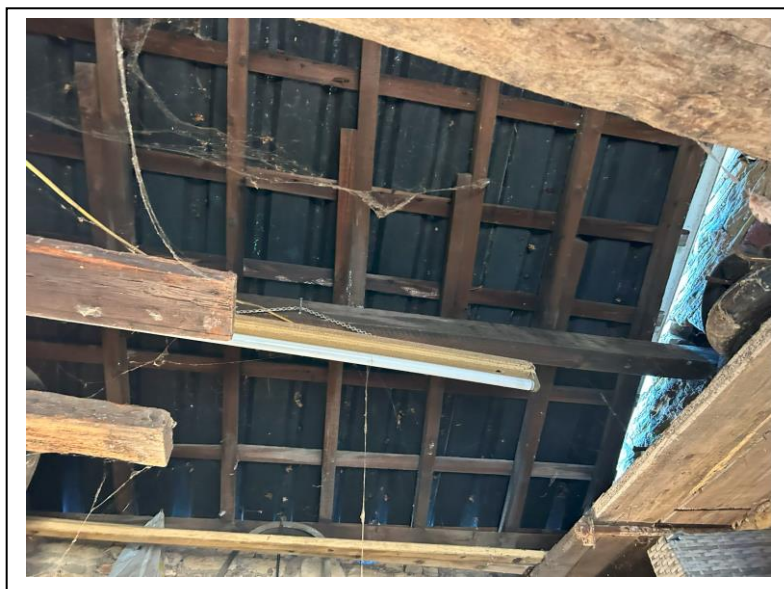
Plate 59

Gap between profile steel roof and middle section of outbuilding 1.

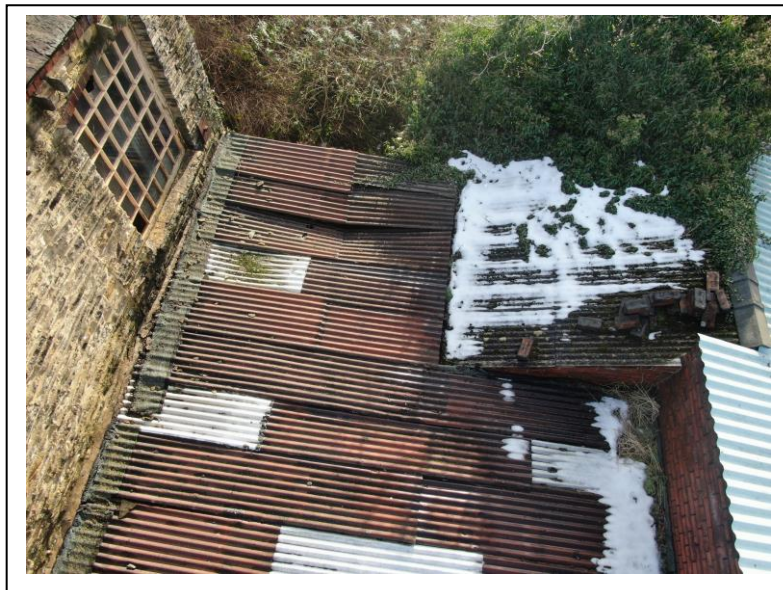
Plate 64

General overview of flat roof to outbuilding 2 with collapsed section below window.

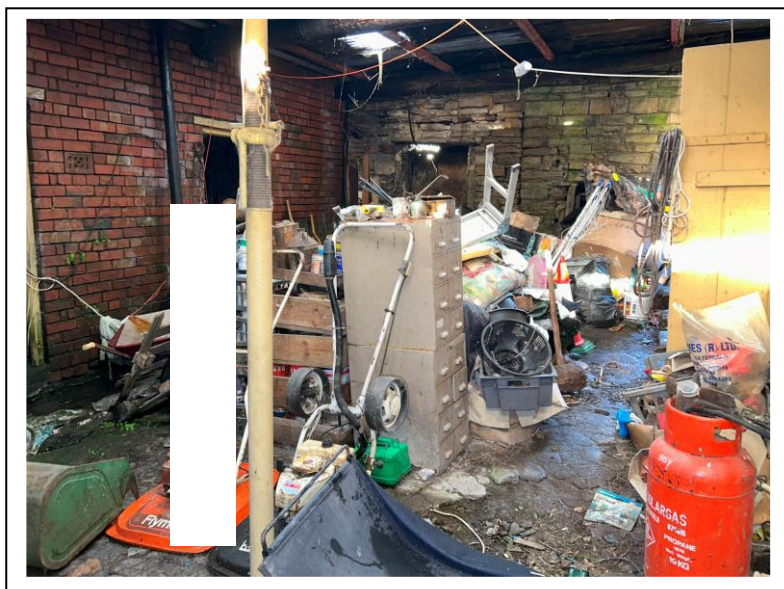
Plate 68

General overview of outbuilding 2, showing acro propping the flat roof up.

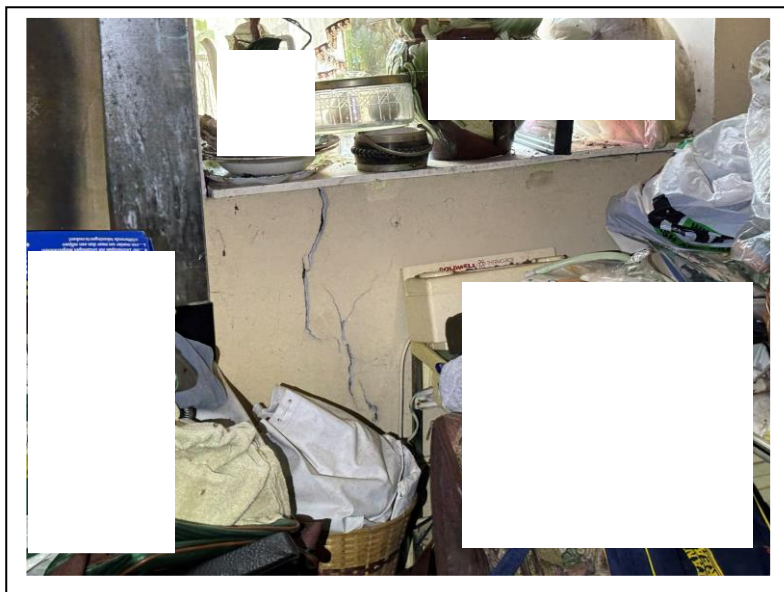
Plate 73

Cracking to first floor of stables.

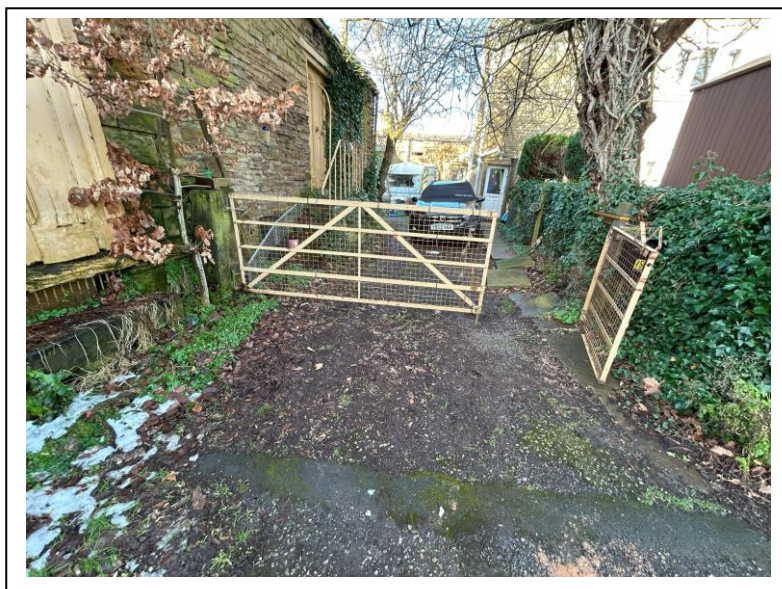
Plate 77

Rusting iron gate.

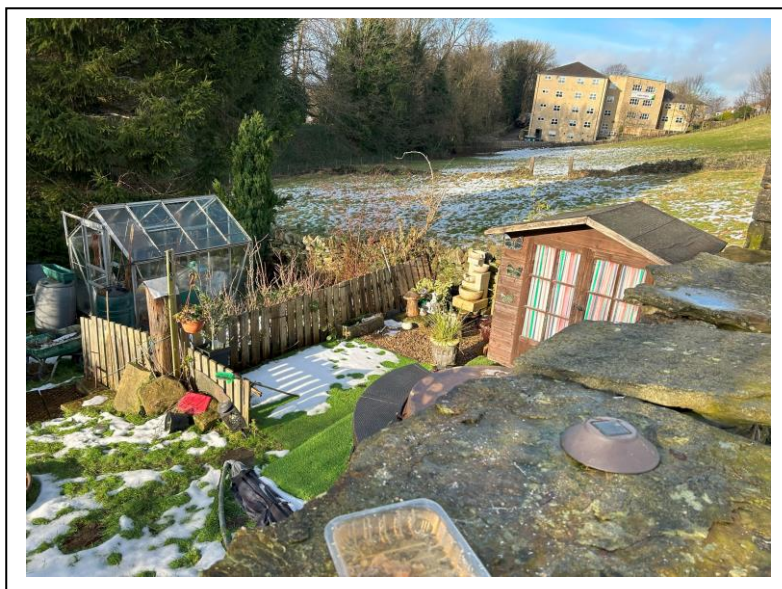
Plate 83

Dry stone wall to the rear of the area.

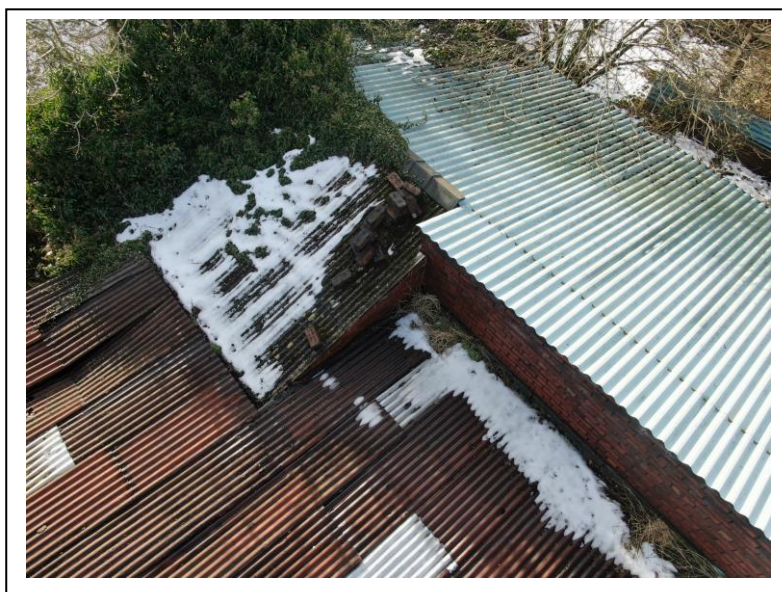
Plate 84

Suspected asbestos profile sheeting to outbuilding 2 roof.
