## GOMERSAL ST MARYS PRIMARY SCHOOL

### Sustainable Drainage Strategy

Hexa ref: SRP1134-HEX-XX-XX-T-C-0001

Revision: P02

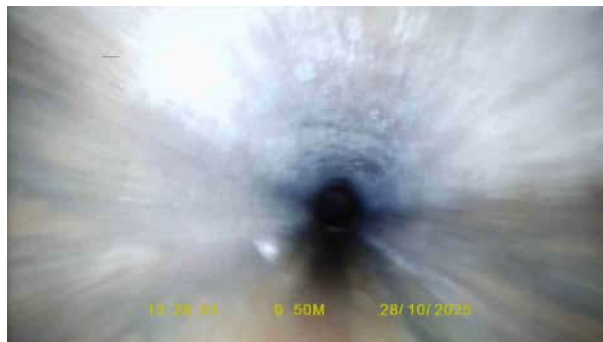
FW10X\_20bd3924-e9d3-4552-9ea4-787c0de0be64\_20251112\_092212\_407.jpg, 00:00:05, 1.40 m  
Joint displaced, medium

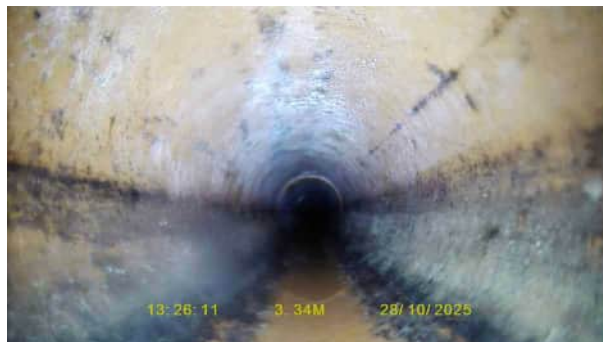
FW10X\_cfc3630a-7400-42c8-9e54-89902061ba3a\_20251112\_093636\_321.jpg, 00:00:14, 4.00 m  
Joint displaced, medium

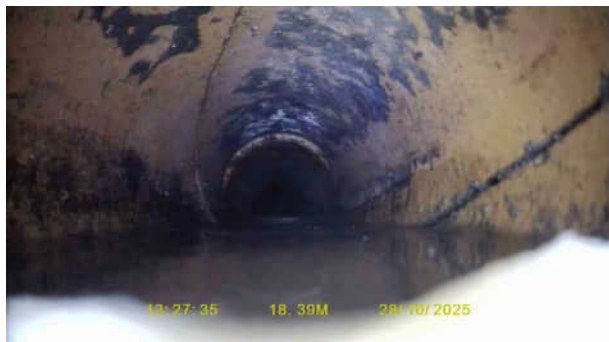
FW10X\_69e5f6ae-08e1-45af-9fc6-638c67ddbe9d\_20251112\_102045\_864.jpg, 00:01:39, 18.60 m  
Joint displaced, large

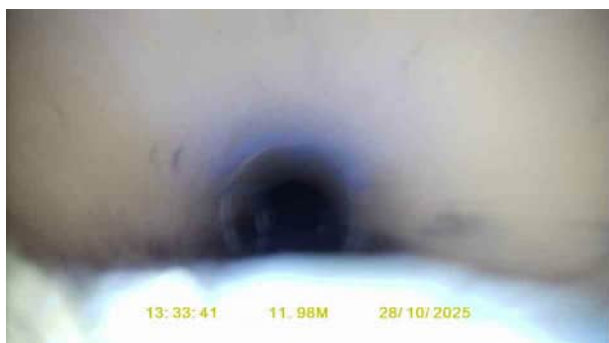
FW5X\_d4d2ce8c-e55e-44de-b628-a2b478a5d3fd\_20251112\_105053\_872.jpg, 00:00:46, 12.10 m  
Joint displaced, medium

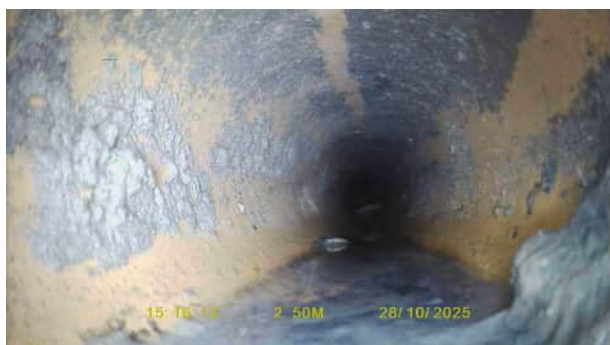
F12X\_fb06563c-58f2-4a4c-a0e7-9ae1542b9ff6\_20251120\_085035\_502.jpg, 00:00:36, 2.50 m  
Survey abandoned, Silt

For removal of silt, I recommend using a jet vac tanker where access allows, this can be carried out by EDI via quote request.

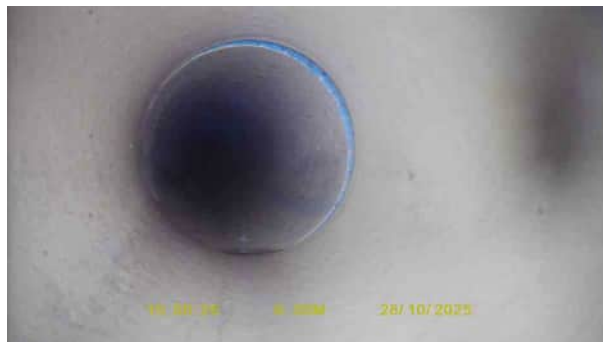
F16X\_0a61345b-0ac1-41b1-8dbf-4b5e32534f95\_20251120\_094648\_141.jpg, 00:00:00, 0.10 m  
Joint displaced, medium

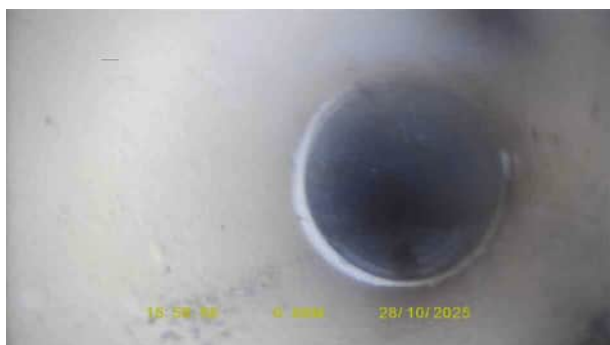
F19X\_735fbdf6-34e5-4209-ac70-a1b61ea1732f\_20251120\_101353\_138.jpg, 00:00:05, 1.00 m  
Joint displaced, medium

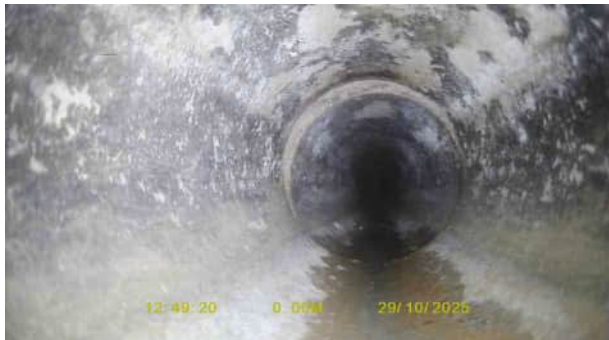
F29X\_98031fc3-af66-4d90-8314-d916c44ec4f3\_20251120\_14  
2201\_856.jpg, 00:00:00, 0.00 m  
Start node, inspection chamber, reference: FW15

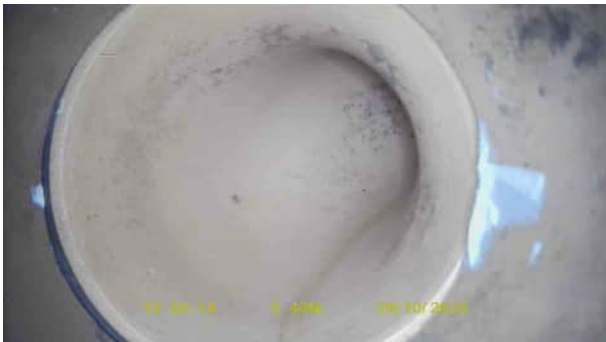
F30X\_9c459517-e71a-4071-aa0a-1fc820f9a94f\_20251120\_142521\_876.jpg, 00:00:24, 5.50 m  
Finish node, other special chamber, reference: F30, WP

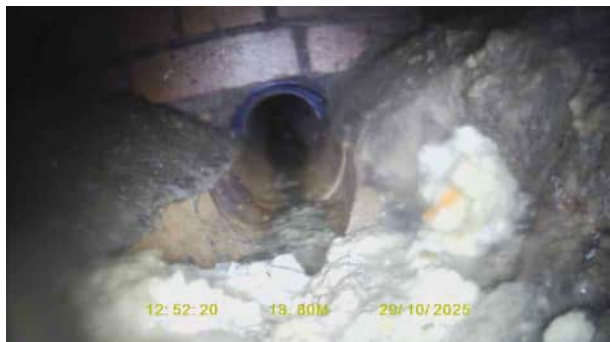
FW15X\_e75204ff-93de-43d6-b12c-5e9c4a74d0ab\_20251120\_142856\_554.jpg, 00:01:01, 13.80 m

Finish node, inspection chamber, reference: FW14

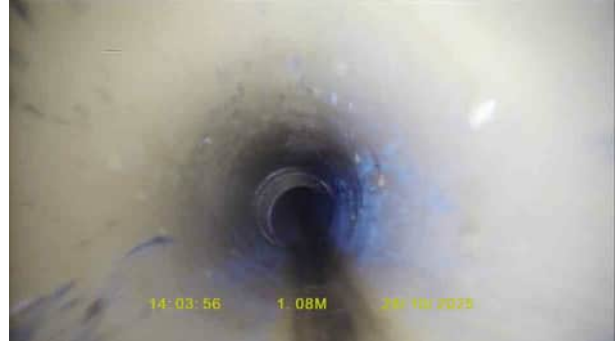
S4X\_6d5067f4-d3fd-4022-8af4-fcdee841e3e4\_20251112\_121  
053\_909.jpg, 00:00:07, 1.70 m  
Line deviates up

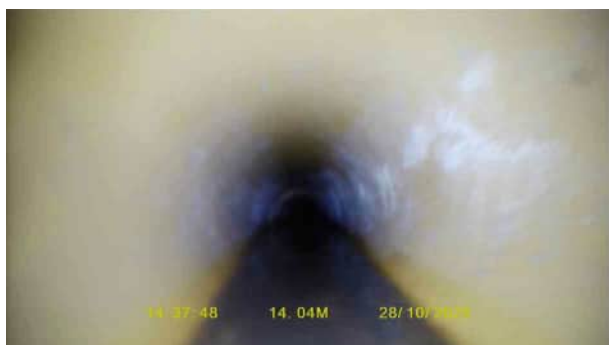
SW5X\_db62401e-328e-4946-b53c-390c227c1f6d\_20251113\_090617\_144.jpg, 00:01:29, 14.40 m  
Water level, 30% of the vertical dimension

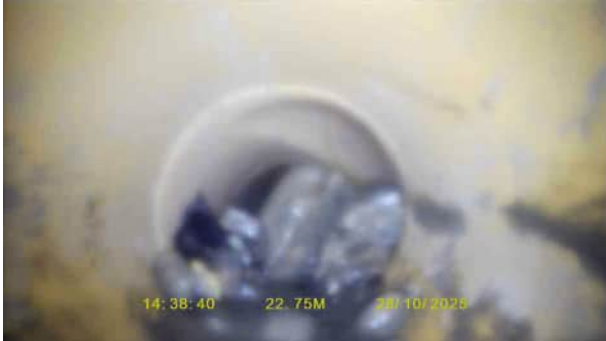
SW5X\_616cdb56-87db-4ce4-a5ad-02f2ea750538\_20251113\_091828\_642.jpg, 00:02:20, 23.00 m  
Finish node, inspection chamber, reference: SW5, Blocked

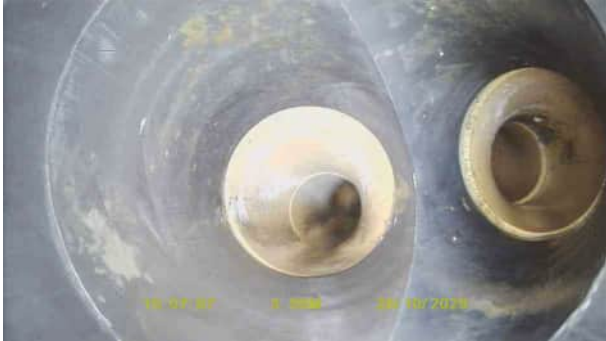
S9X\_efdc2c65-5616-4b7f-85c4-15e11c5daba4\_20251120\_08  
3101\_697.jpg, 00:00:52, 3.95 m  
Survey abandoned, Traction

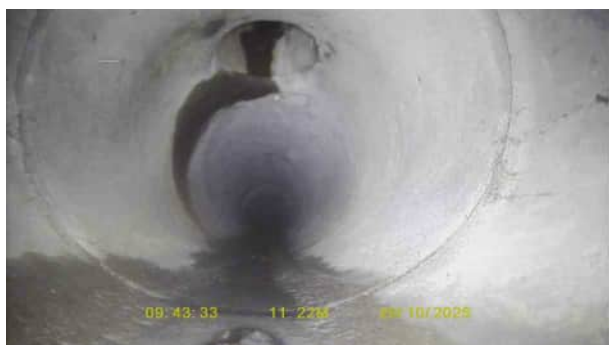
SW6AX\_9839222a-57af-4c83-aab5-e550e588e05e\_20251120\_104538\_865.jpg, 00:03:10, 12.40 m  
Survey abandoned, Traction

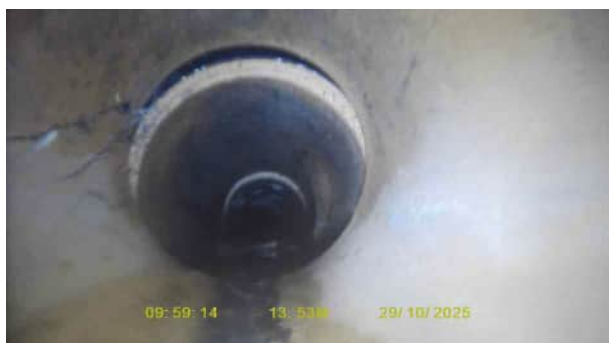
SW8X\_4de8e657-5545-49fc-8a57-f15be91d021d\_20251120\_112035\_248.jpg, 00:01:05, 14.15 m  
Junction at 3 o'clock, 100mm dia

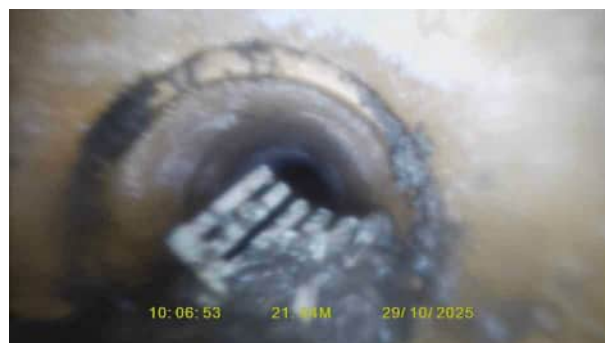
S15X\_abfa47d0-0b22-45b1-b541-ebcfbccd7dea\_20251120\_1  
13018\_978.jpg, 00:01:43, 21.70 m  
Survey abandoned, Silt & objects
